**1000 Sample Report  
Dallas TX 75289**

Tristan Eager  
AUGUST 17, 2018

# PROPERTY INSPECTION REPORT

Concerning: 1000 Sample Report, Dallas TX 75289

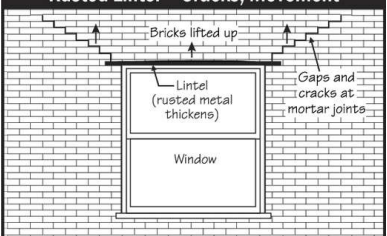
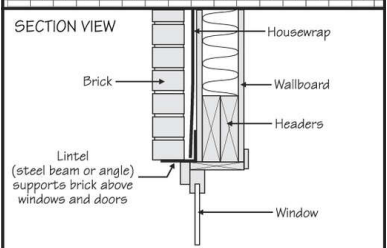
**Rusted Lintel - Cracks, Movement**

When lintels rust, they thicken and lift the masonry, causing cracks at mortar joints.
