MOUNTAINS TO SOUND HOME INSPECTION LLC

HOME INSPECTION REPORT COPY

1806 S 9th St
Tacoma WA 98405

Jennifer Garner
SEPTEMBER 4, 2019

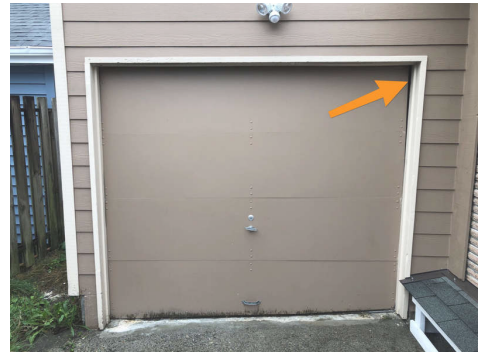
5.3.2 Garage Door & Hardware

GARAGE DOOR MOISTURE DAMAGE

The bottom edge of the garage door has some moisture damage. Recommend repairs or replacement as needed.

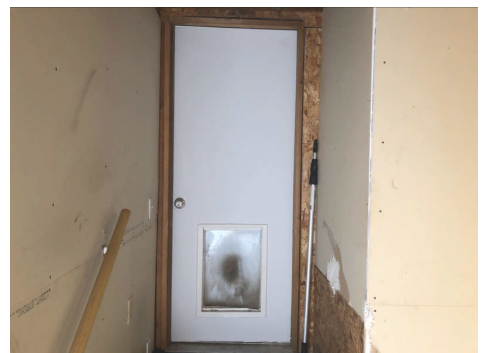
5.4.2 Entry Door Into the House

PET DOOR

The pet door installed in the main entry door eliminates the doors function as a fire rated door. We advise repair or replacement of the door to return it's use as a fire rated door.

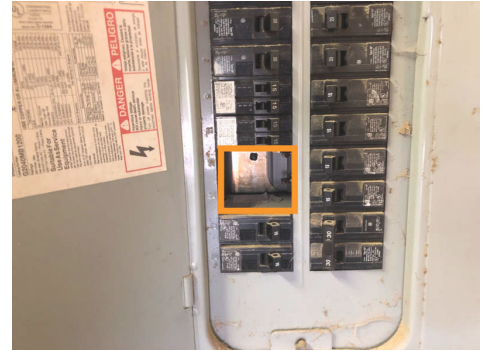
6.4.2 Panel Cover Condition

POINTED OR IMPROPER SCREWS

The main electrical main interior panel cover includes pointed or improper screws which should be replaced with ones appropriate for electrical use. This is important to help prevent damage to wiring within the panel.

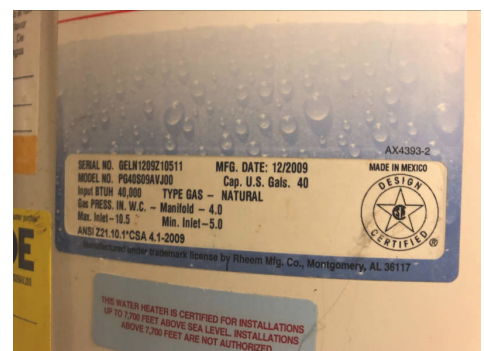
8.1.2 Water Heating System

MISSING FLAME COVER

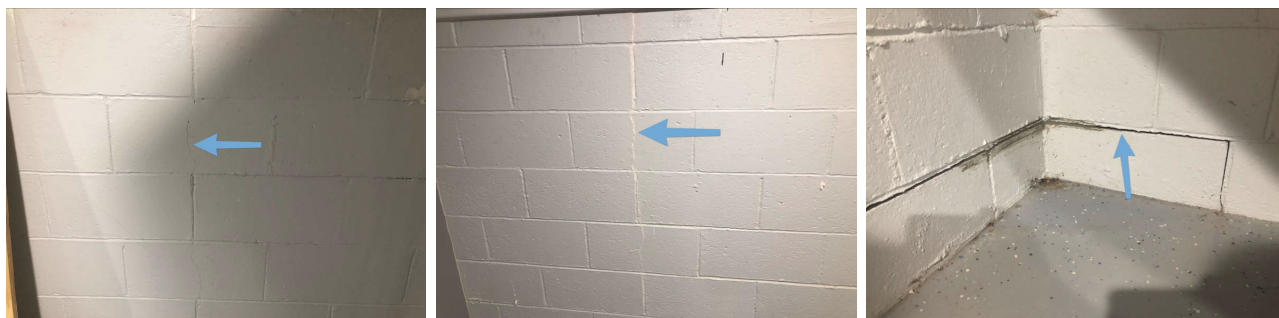
15.3.1 Basement

BASEMENT FLOOR CRACKS

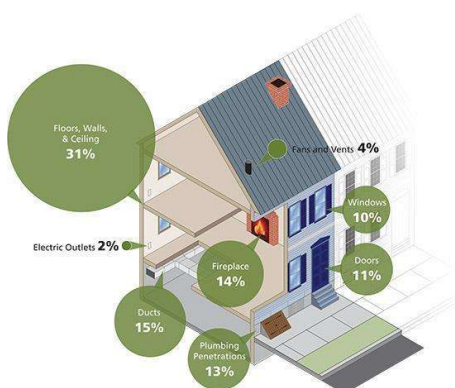
Thermal Energy Audit: Heating & Cooling

The heater/cooling systems appear to be providing adequate temperatures for conditioning the interior.

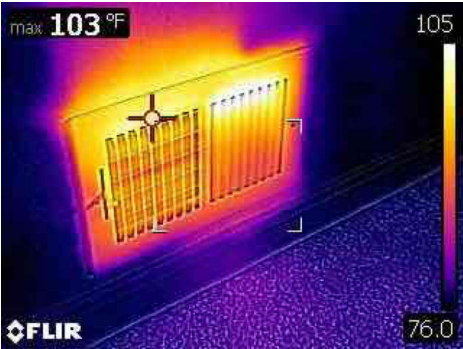
Moisture Survey: No Interior Leaks

A Thermal survey of the Ceilings, Walls, and floors showed no significant evidence of leakage or water intrusion. Areas of focus are below roof valleys, skylights, chimneys and other penetrations. Additionally, below any second floor bathrooms, laundry rooms and other water fixtures. We have included several photos from our infrared camera for your information. Any deficiencies will be noted below.

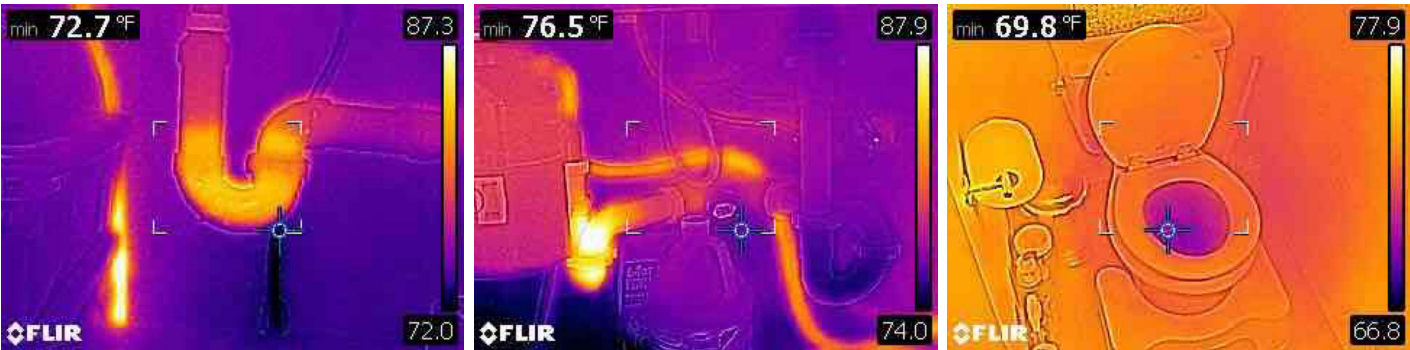
Moisture Survey: No Plumbing Leaks

A Thermal survey of the accessible plumbing system showed no evidence of moisture accumulation or leaks.
