ELEVATE HOME INSPECTION

123 Court St
Columbus OH 43221

NOVEMBER 4, 2021

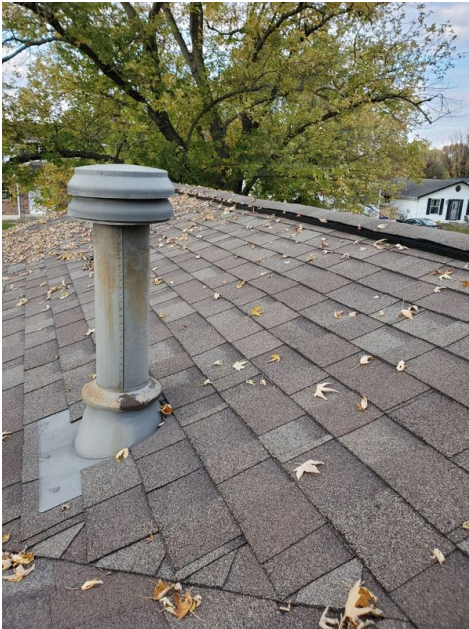
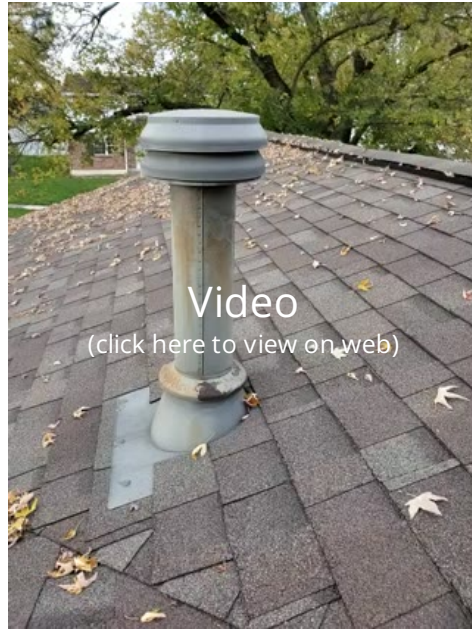
We observed that the gas vent pipe that extends above the roof surface seemed to be too short. The gas vent pipe should extend at least 1 foot above the roof surface for a pitched roof & should be at least 2 feet above anything within 10 feet of the vent. This is a safety concern.

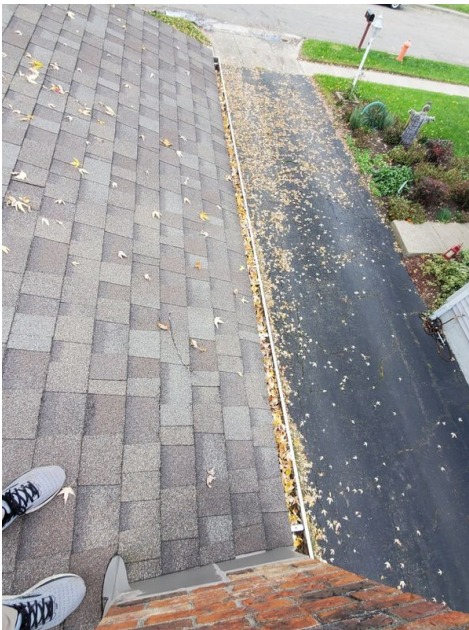
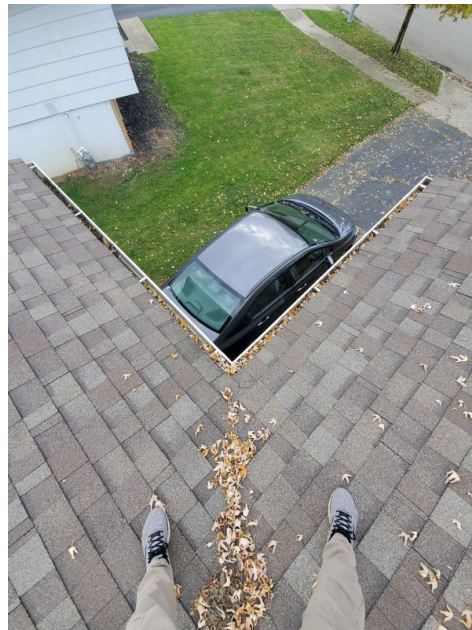
3.5.1 Gutters & Downspouts

DEBRIS IN GUTTERS

We observed debris in the gutter. We recommend regular cleaning & maintenance.

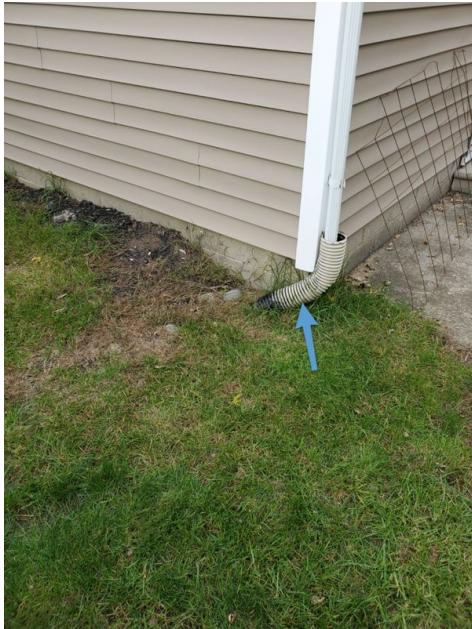
3.5.2 Gutters & Downspouts

DOWNSPOUT DRAINAGE CONCERN

We observed a downspout with a buried drain. It is unclear where the pipe drains to, so we suspect it is not draining properly. We recommend you monitor this area during a rain shower to see if it is draining properly.

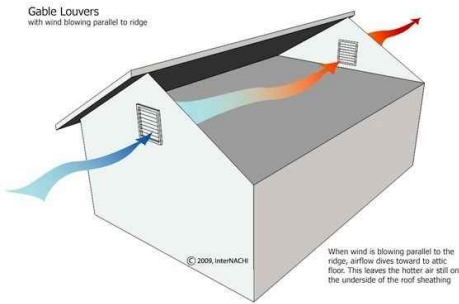
Gable Venting

IMPROPER VENTILATION

We observed that the attic ventilation system appears to be improperly installed compared to best practices. The system's openings may be competing with each other and interfering with proper ventilation of the roof and attic systems. This can lead to shorter lifespans of materials in the attic and roofing systems.

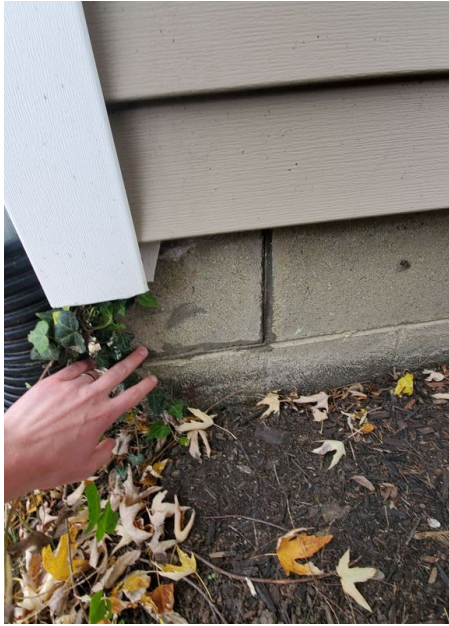
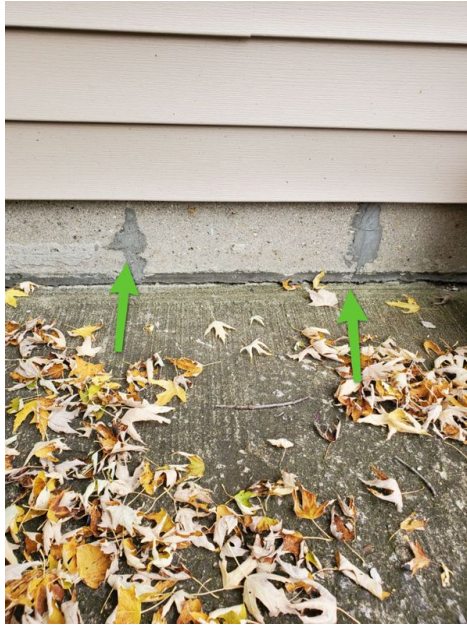
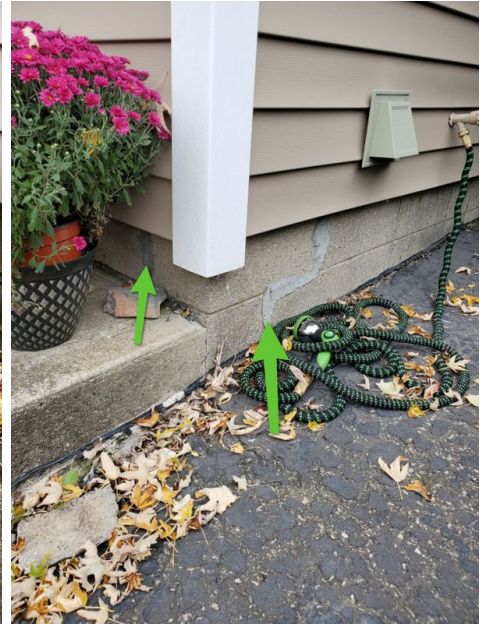
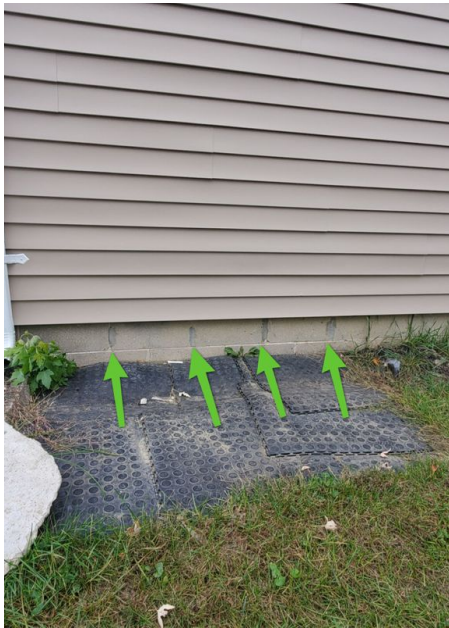
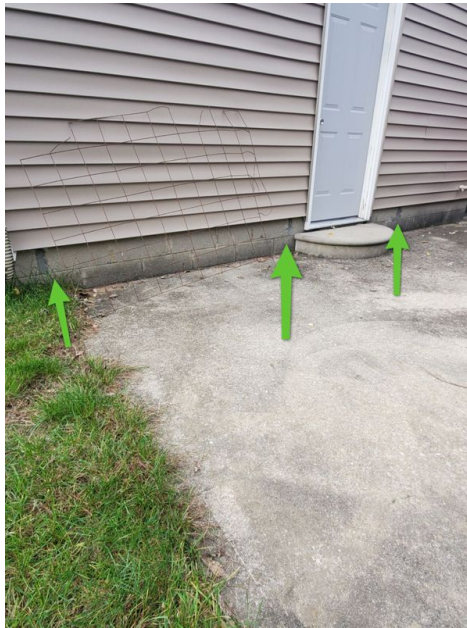
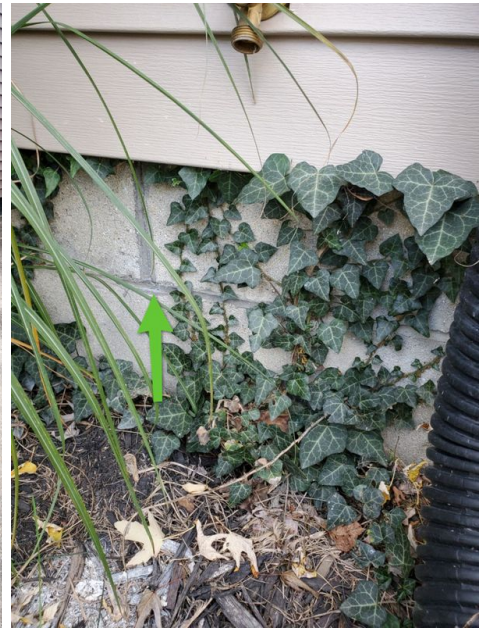
Exterior Foundation: Foundation Repairs

We observed previous foundation repairs that were likely due to minor foundation and settling issues. We recommend you monitor these areas for new cracking or movement and ask the sellers what they know about the repairs.

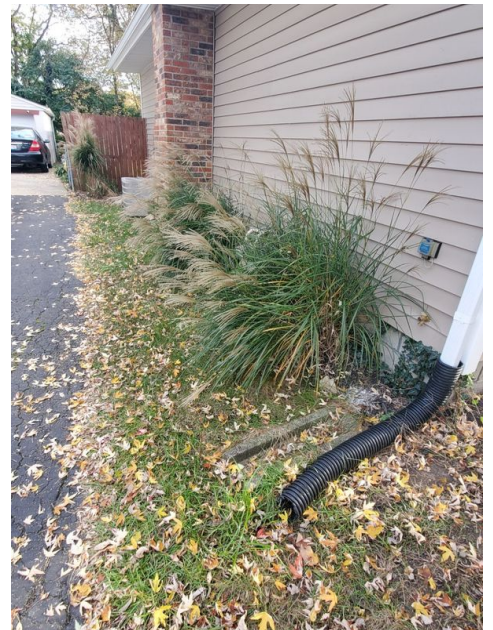
Exterior Foundation

VEGETATION RESTRICTION

At the time of the inspection, dense vegetation near the house restricted our ability to closely inspect some areas of the foundation. Defects may be hidden from view by the dense vegetation and this was an inspection restriction.

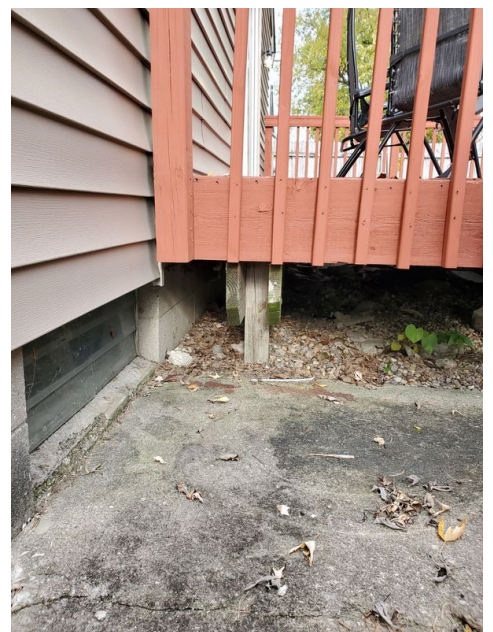
Exterior Foundation

DECK/PATIO BLOCKED VISIBILITY

The attached deck/patio blocked visibility to potential defects that were not visible at the time of the inspection. This was an inspection restriction.

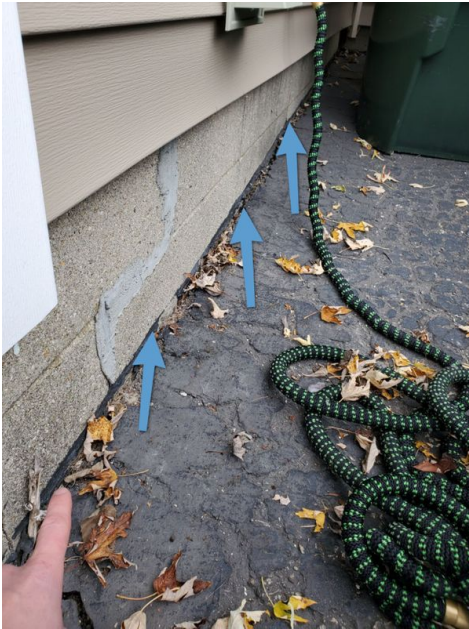
SEALANT NEEDED

We observed an area where we recommend sealant is added to keep water from entering. Continued water entry may lead to further deterioration.

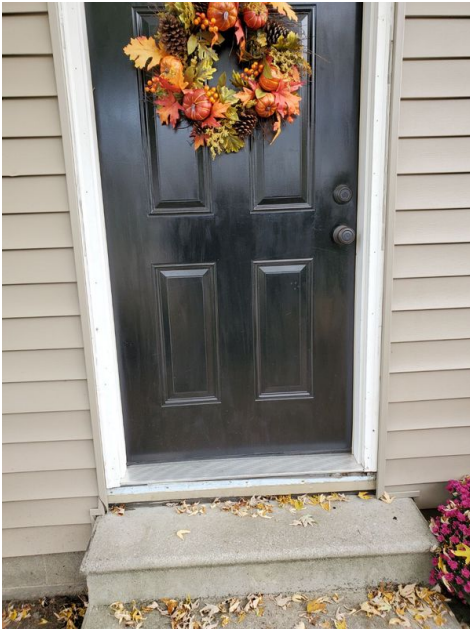
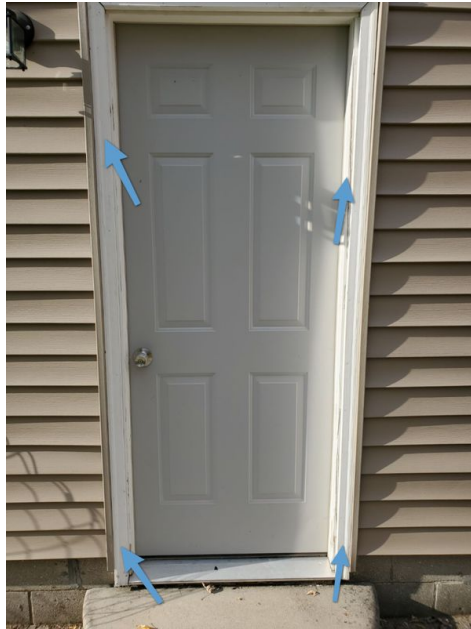
Garage Back Door

PAINT IN POOR CONDITION

We observed paint in poor condition. This should be corrected to avoid further damage to wall-covering/trim materials.

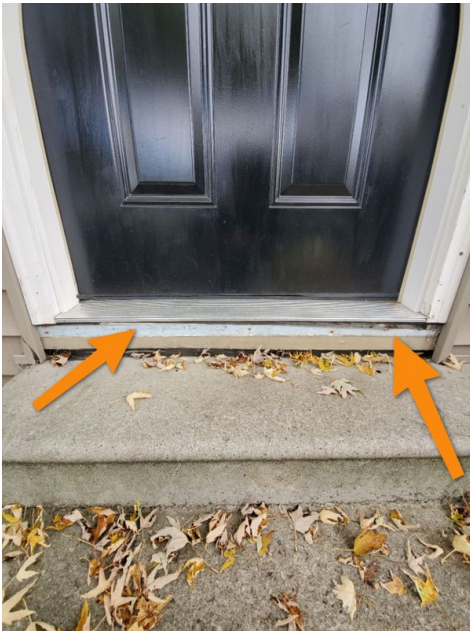
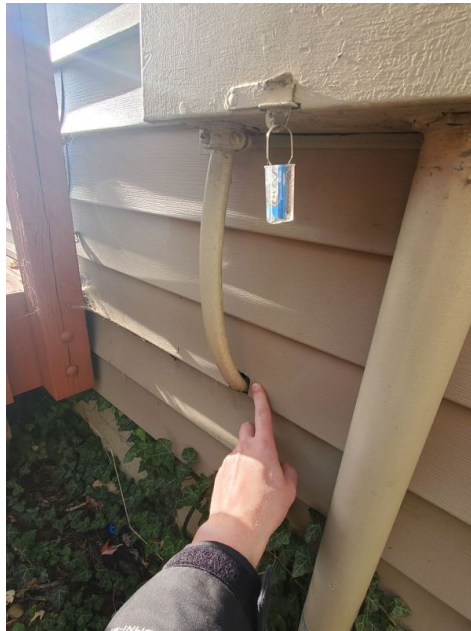
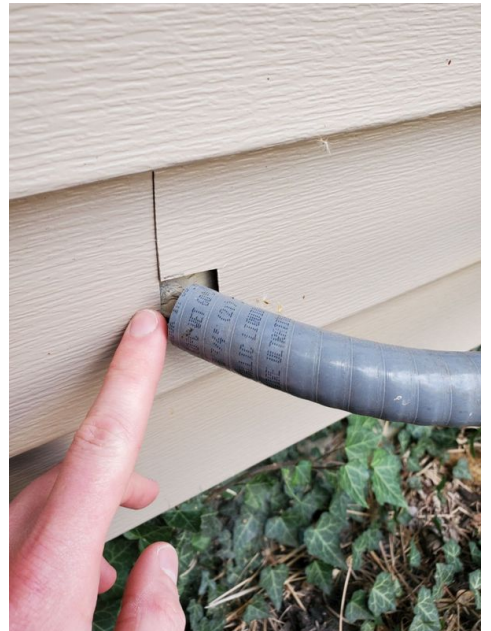
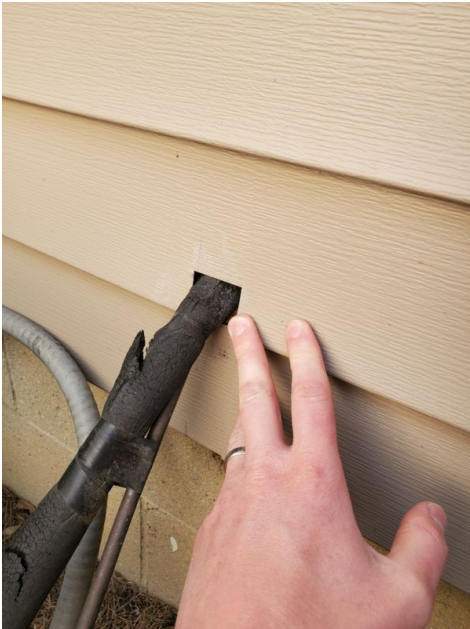
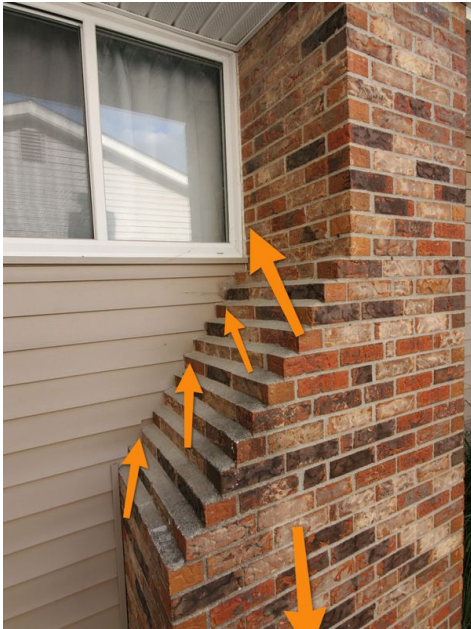
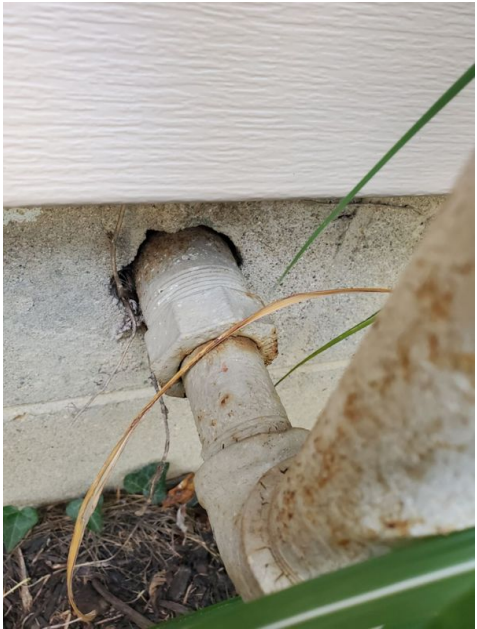
5.4.2 Wall-Covering System

We observed degraded caulking/sealant, which could allow moisture to penetrate into the house. We recommend installing appropriate caulk/sealant and inspecting these conditions regularly to help prevent moisture and insect entry.

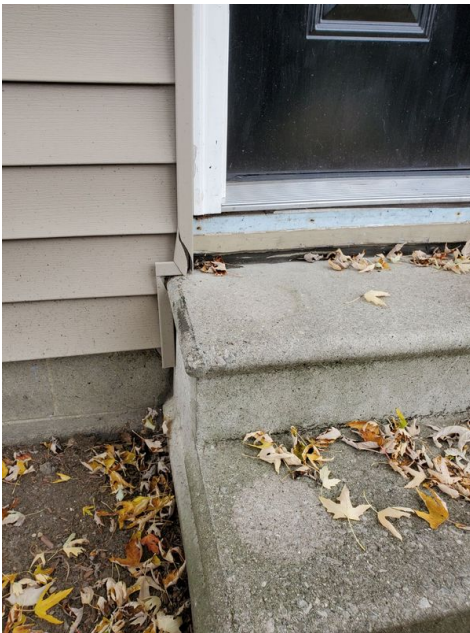
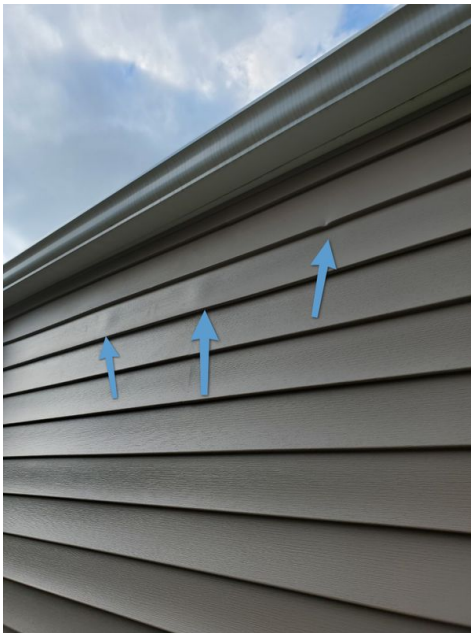
Back

COSMETIC DAMAGE

We observed damage of the exterior wall-covering material that we deemed cosmetic at the time of the inspection.

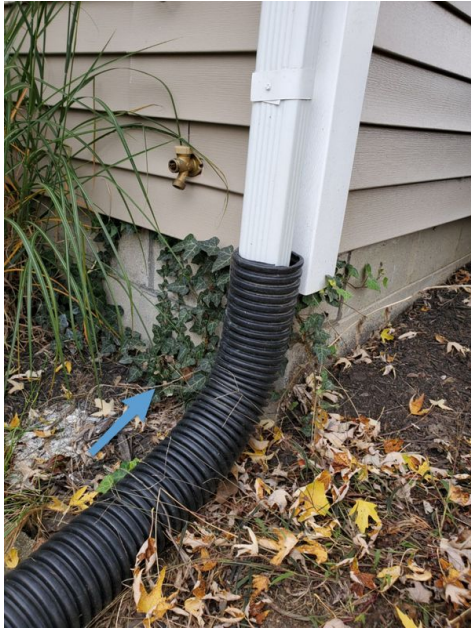
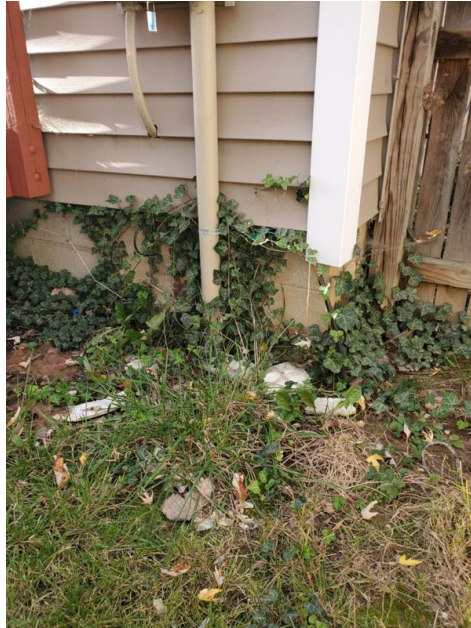
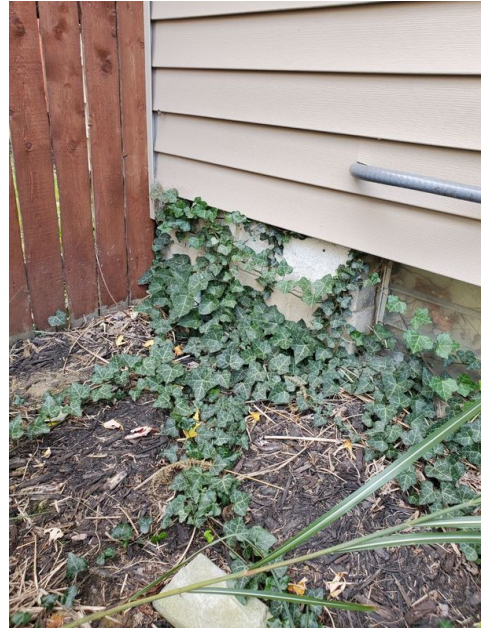
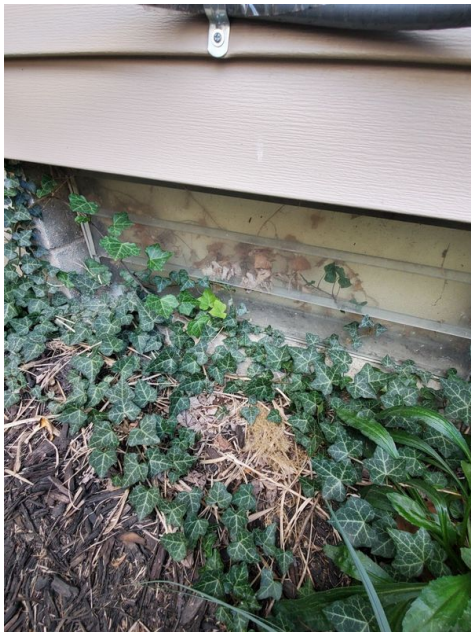
5.4.4 Wall-Covering System

We observed ivy/vegetation which has been allowed to grow and attach to the house's exterior wall-covering materials. Although this is a cosmetic preference by some, we highly recommend against this. This condition is likely to damage wall-covering materials, shorten their useful life, and retain high levels of moisture close to the house's structure. We recommend removal and ongoing maintenance to keep the exterior wall-covering materials free of vegetation.

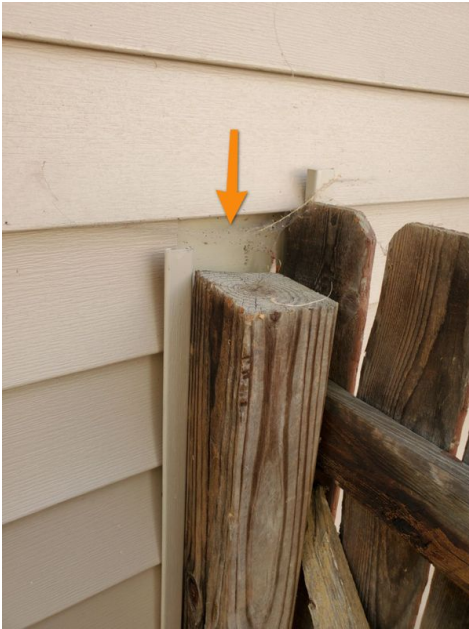
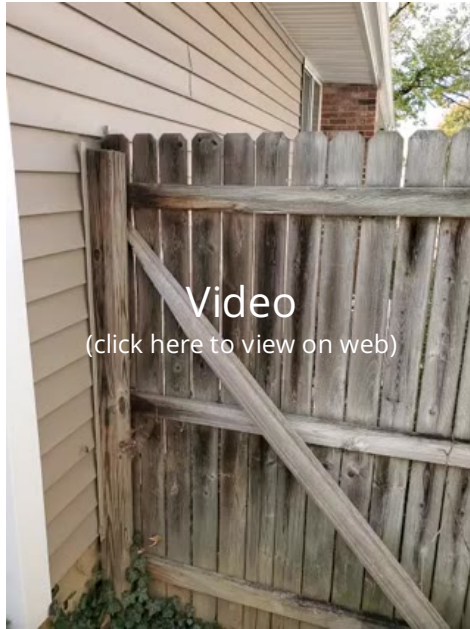
5.4.5 Wall-Covering System

MISSING SIDING

We observed an area of missing wall-covering material that is likely to cause moisture damage.

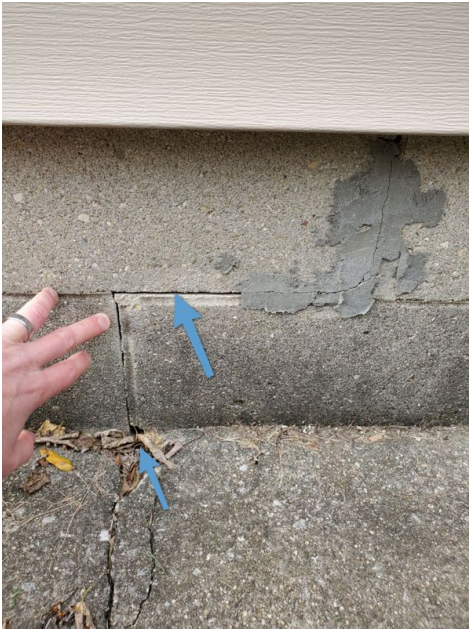
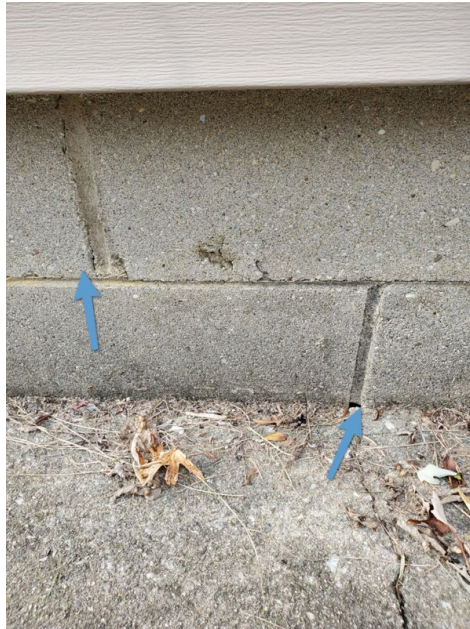
5.7.2 Exterior Foundation

MINOR CRACKING

We observed minor cracking in one or more areas of the exterior foundation. We recommend monitoring the area for additional cracking/expansion and sealing the cracks to avoid moisture entry.

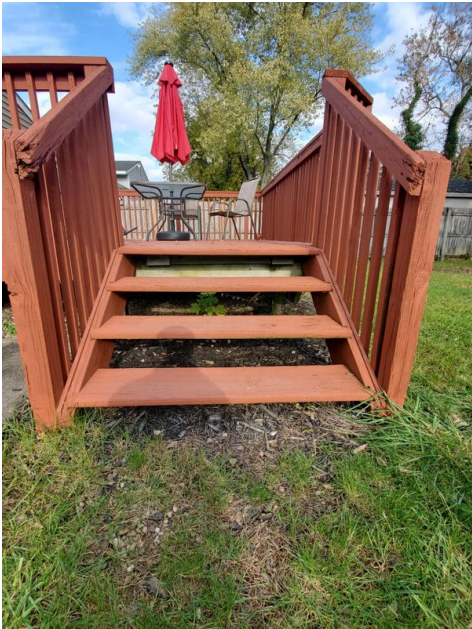
TRIP HAZARD

We observed a trip hazard, which we consider for cracks on walking surfaces with vertical displacement 1 inch or more, or improper riser heights of steps. This condition is a safety concern.

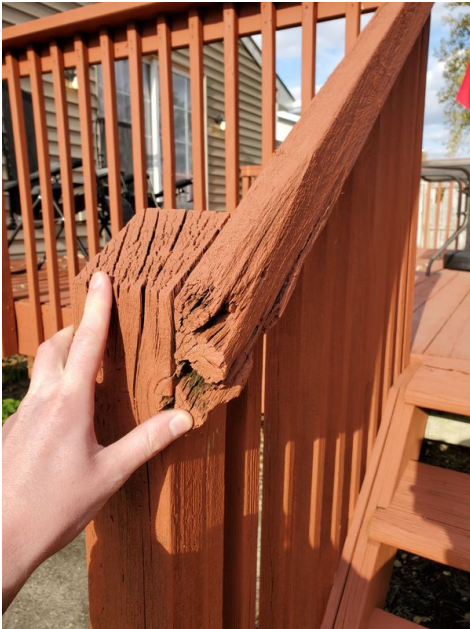
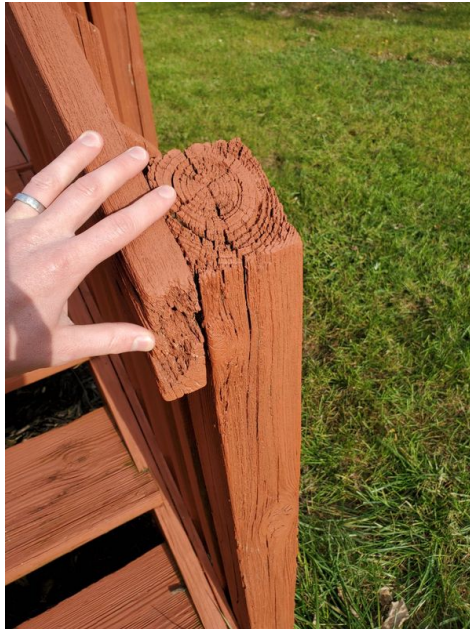
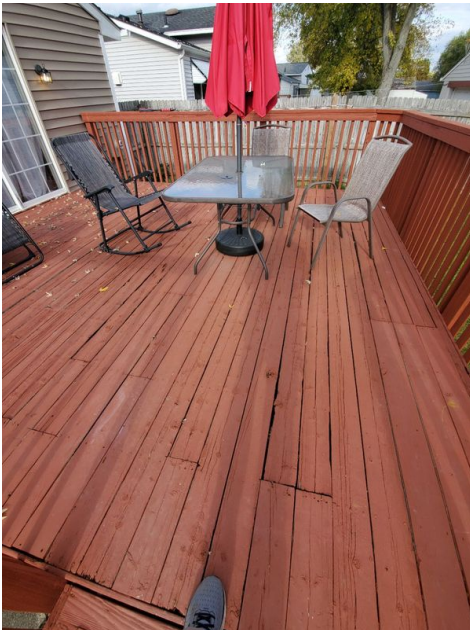
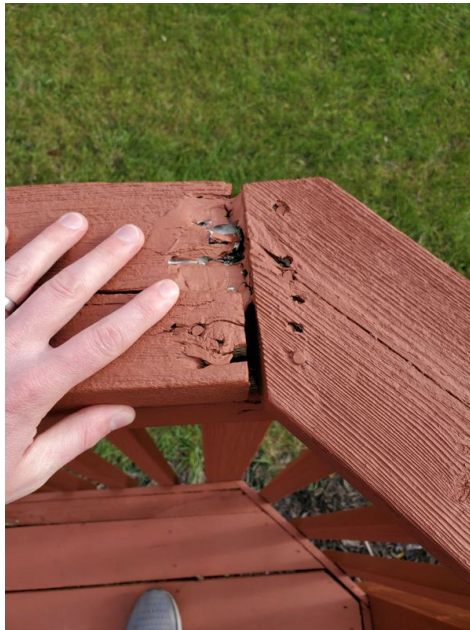
WOOD ROT

We observed wood rot at the deck. This is a safety concern.

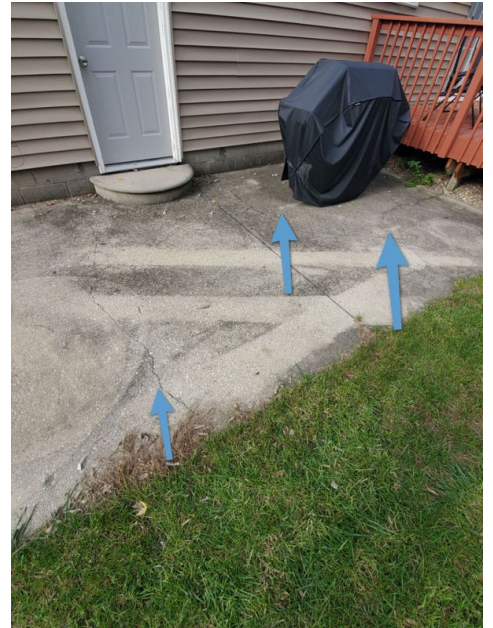
Back

HARD SURFACE CRACKING

We observed cracking at a hard surface indicating that it may be near the end of its useful life.

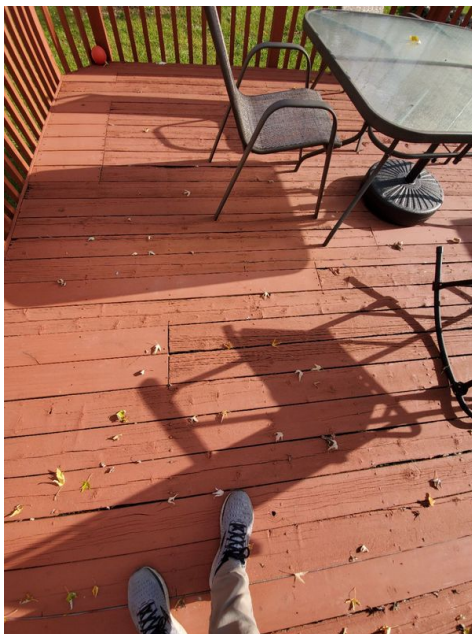
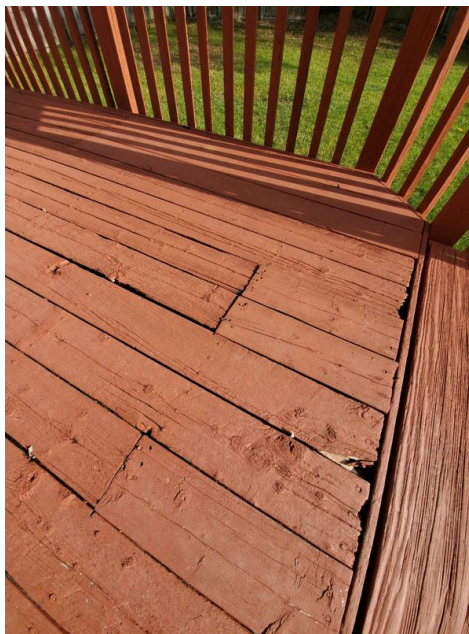
5.9.4 House-Adjacent Structures

DETERIORATED SURFACES

We observed indications of worn out surfaces. Paint, stain, or sealant is recommended to avoid further deterioration of the components.

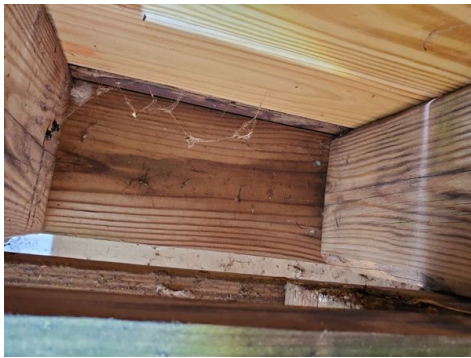
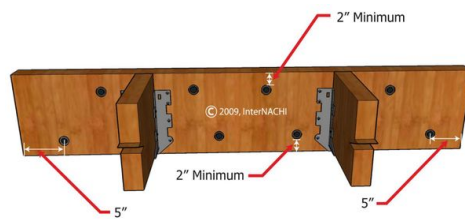
5.9.5 House-Adjacent Structures

LEDGER BOARD FASTENING ISSUE

We observed a ledger board that wasn't installed according to best practices. We didn't observe any indication of structural damage at the time of the inspection, but we recommend that correct fasteners be added.

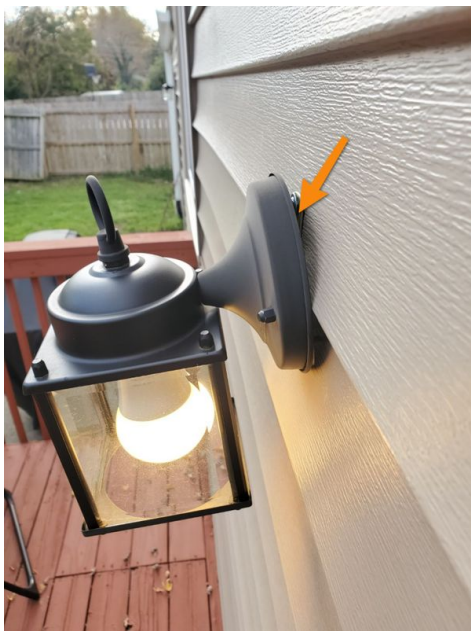
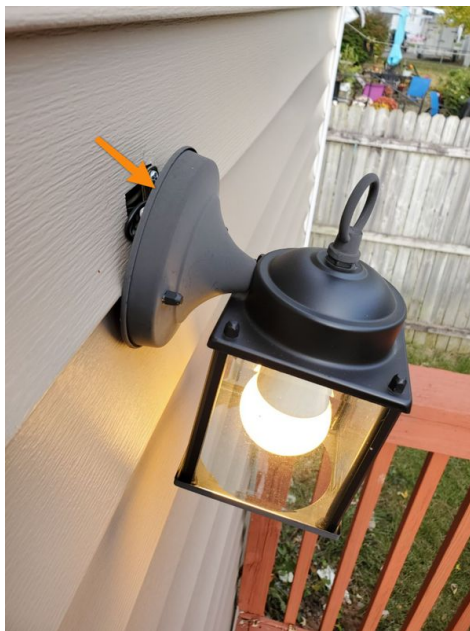
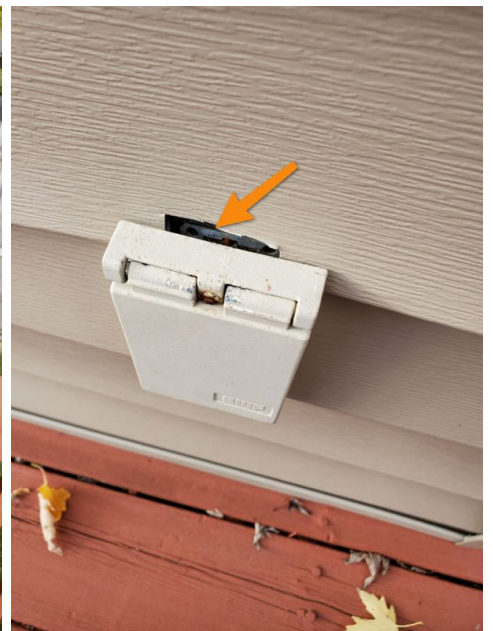
5.10.1 Receptacles & Lighting

ELECTRIC NOT WATER-TIGHT

We observed receptacles or fixtures that were not water-tight.

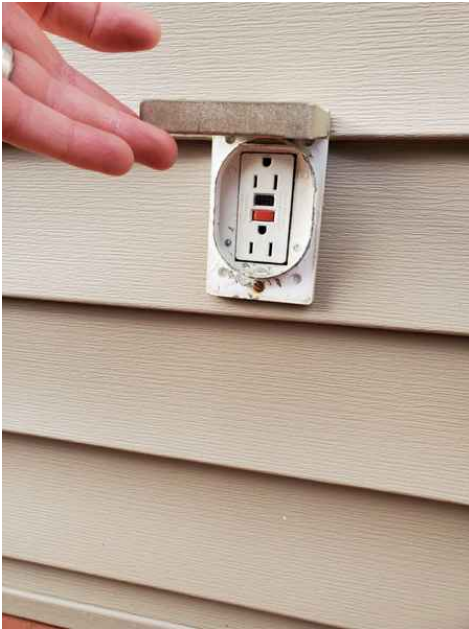
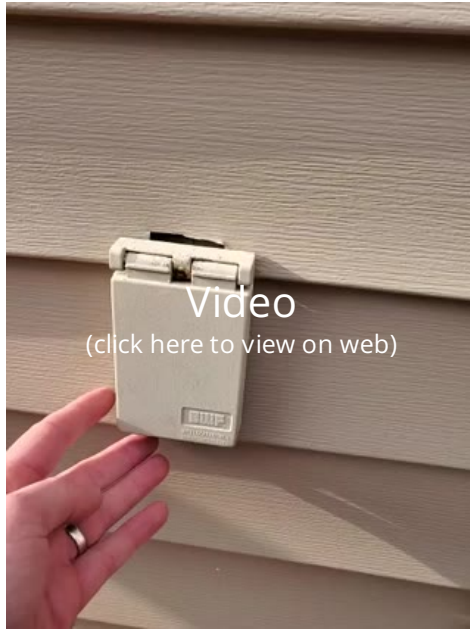
5.10.2 Receptacles & Lighting

GFCI DEFECT

We observed a GFCI receptacle that did not trip or reset properly.

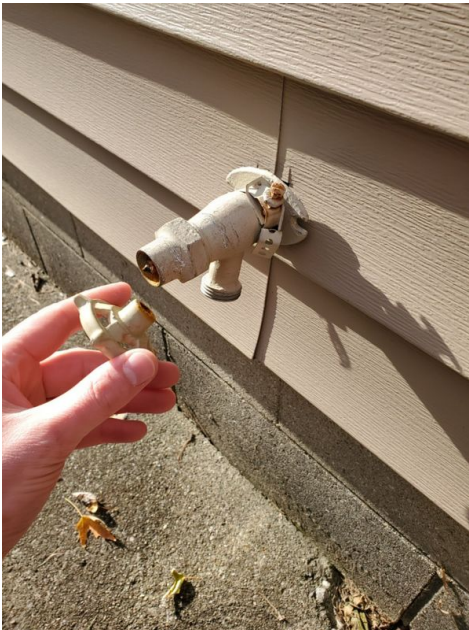
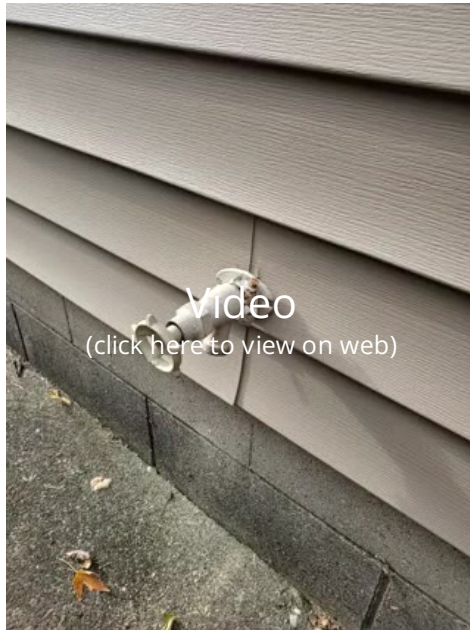
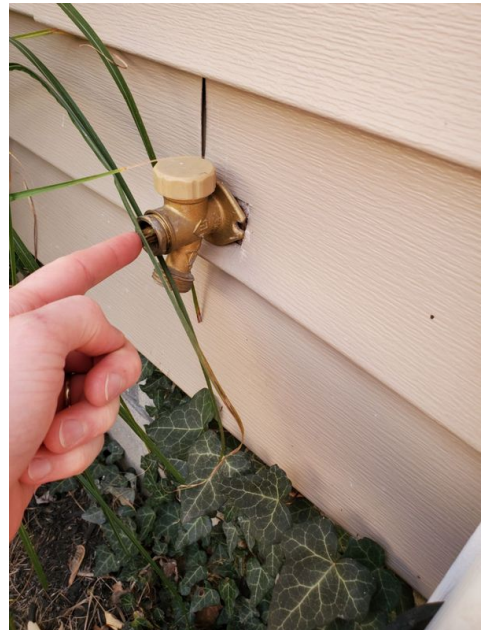
5.11.1 Exterior Plumbing

SPIGOT DAMAGED

We observed that one or more hose bibs were damaged at the time of the inspection.

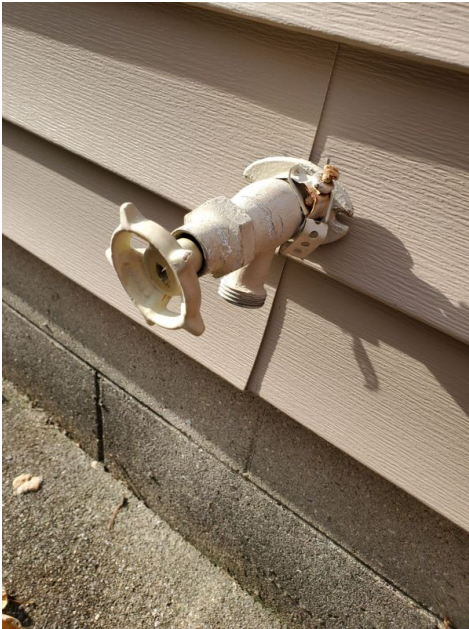
5.11.2 Exterior Plumbing

We observed that the spigot/hose bib appeared aged and may be near the end of its service life. As such, it may not perform reliably. We recommend budgeting for replacement. [Check out this helpful guide for estimating the service life of home systems.](#)

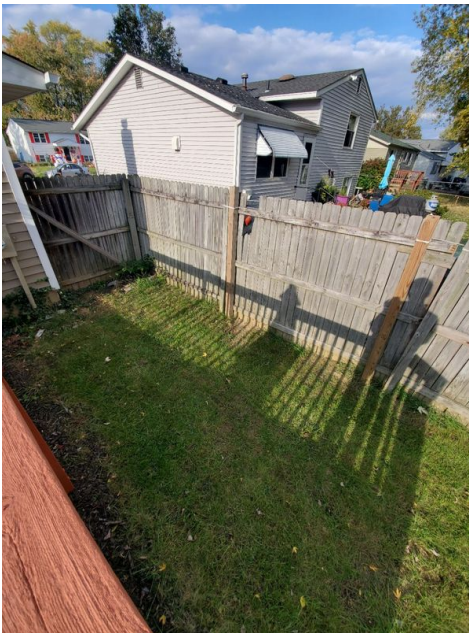
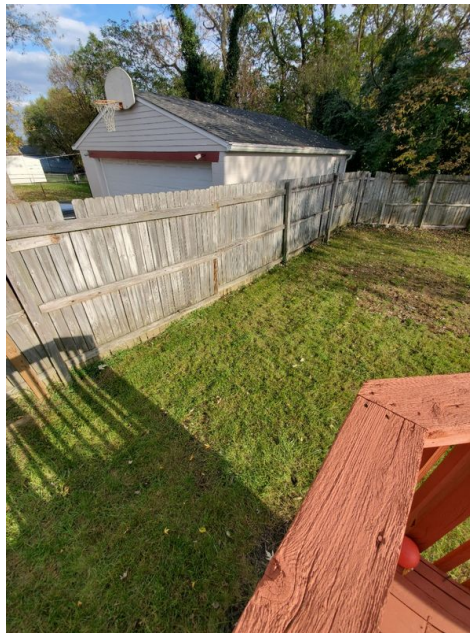
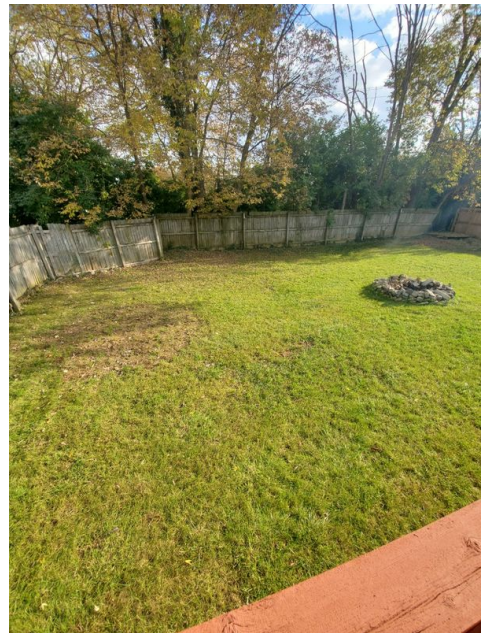
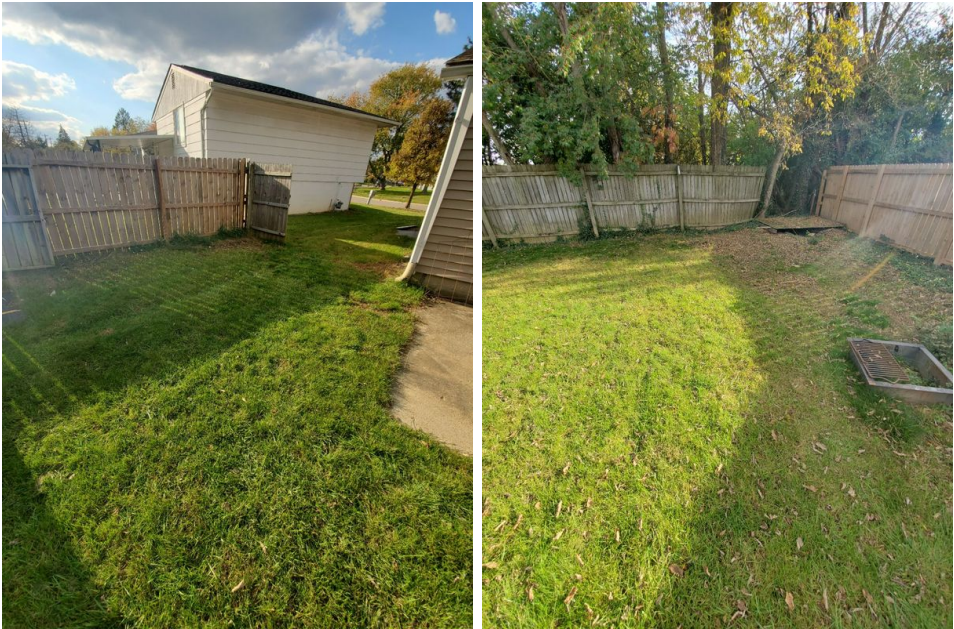
FENCE DETERIORATION

We observed a poor condition of the fence that may affect its function. We recommend you use extra care in these areas and monitor the issue for further deterioration.

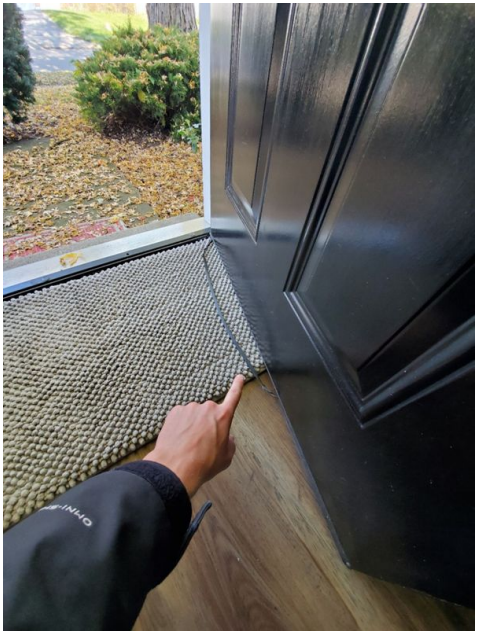
Front Door

MISSING WEATHER STRIPPING

We observed that the door is missing weather stripping, which can result in energy loss, moisture intrusion, and/or pest control issues.

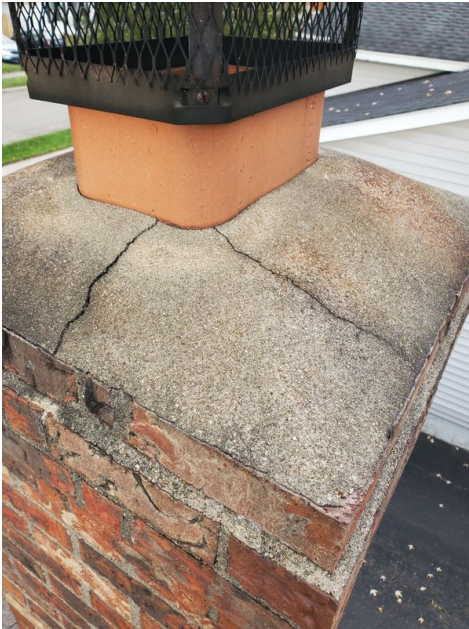
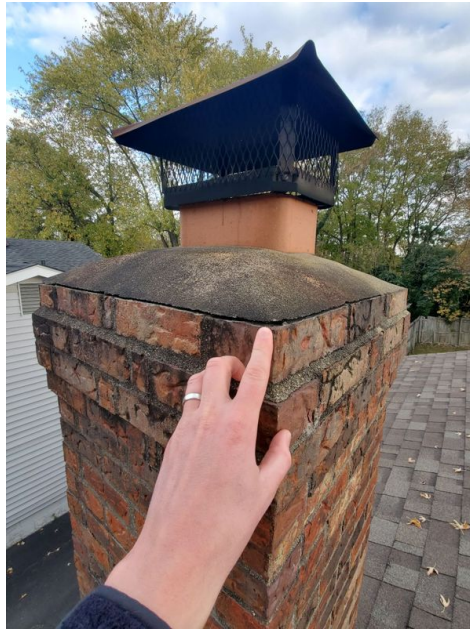
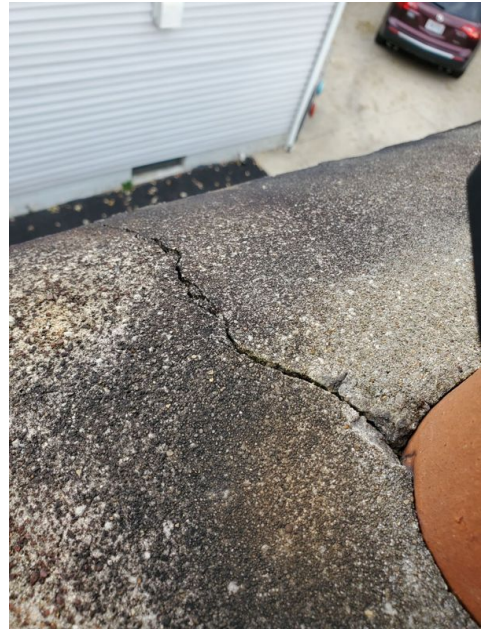
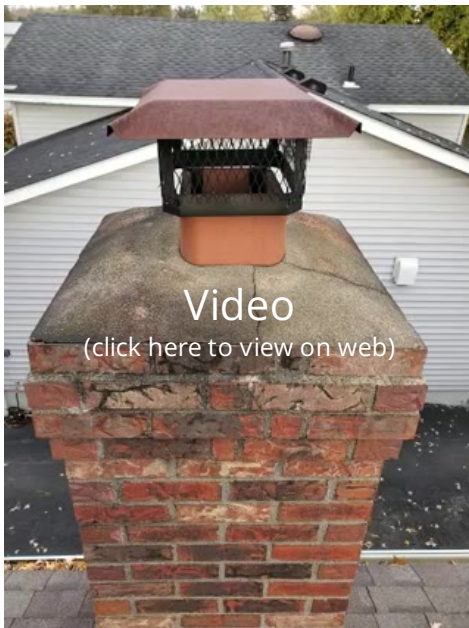
CROWN/CAP DAMAGED

We observed damage at the chimney cap. This is the top of the chimney that is sloped to divert water away from the top of the chimney stack. If a cap on top of the chimney is not properly sloped or is extensively cracked, defective, spalled, or displays rust stains, it should be replaced. Sheet metal caps/crowns with minor rust or corrosion should be repaired, but if rust or corrosion is extensive, replacement is recommended.

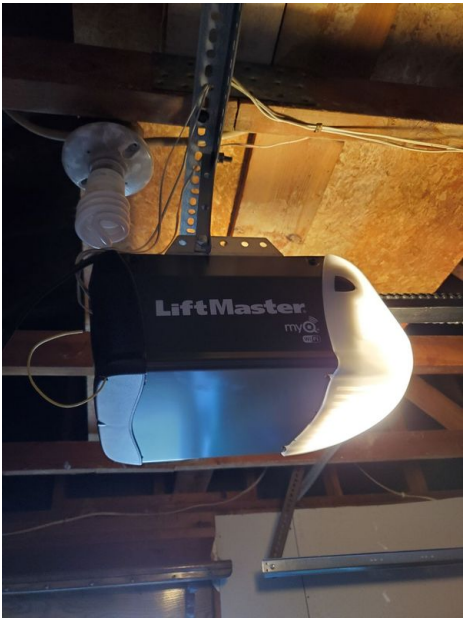
Vehicle Door: Description of Door	Vehicle Door Opener: Type of Operation
Uninsulated, Metal	Automatic Opener

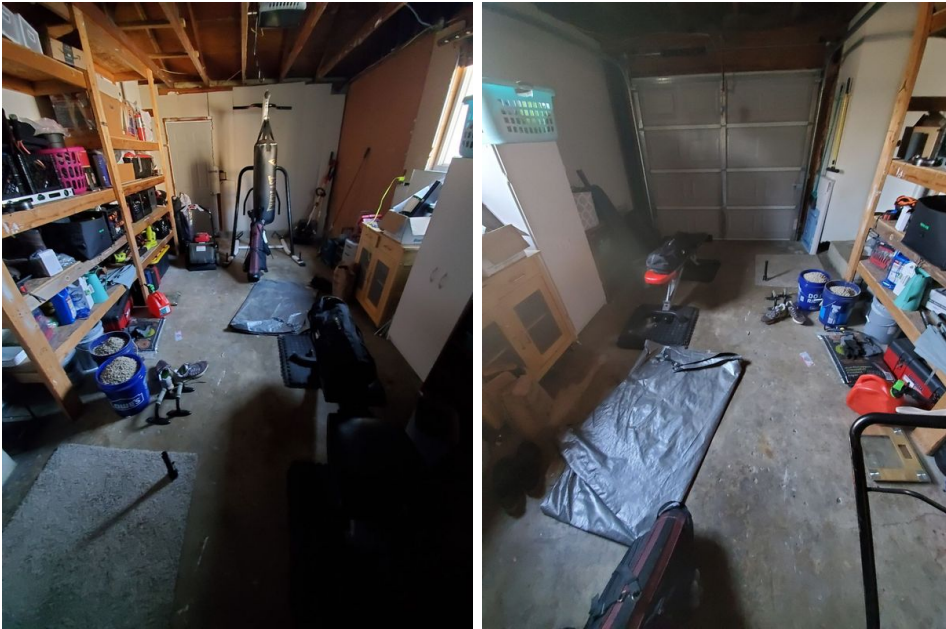
Garage Floor

INSPECTION RESTRICTION

At the time of the inspection, there was a vehicle and/or a lot of items stored in the garage that presented an inspection restriction.

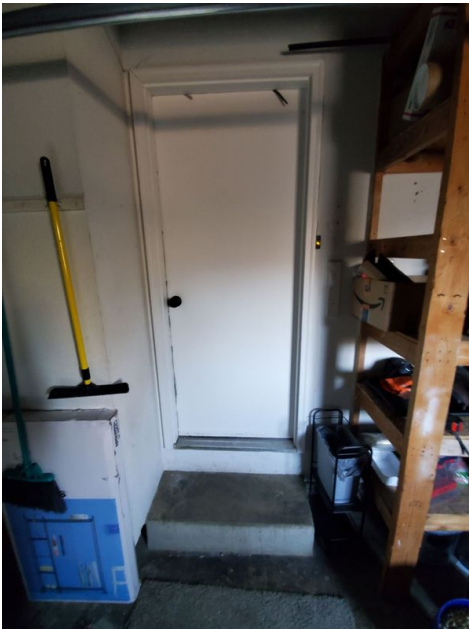
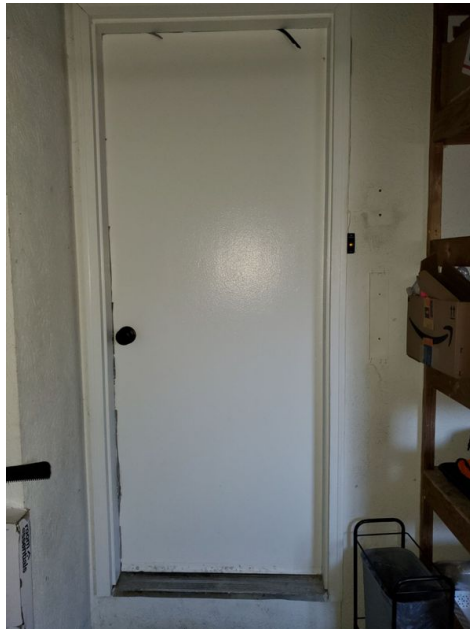
We observed that the door between the garage and the house was not self-closing. This is a safety concern. We highly recommend a closer or self-closing hinges be installed to keep harmful fumes out of the home and maintain an intact fire-separation wall.

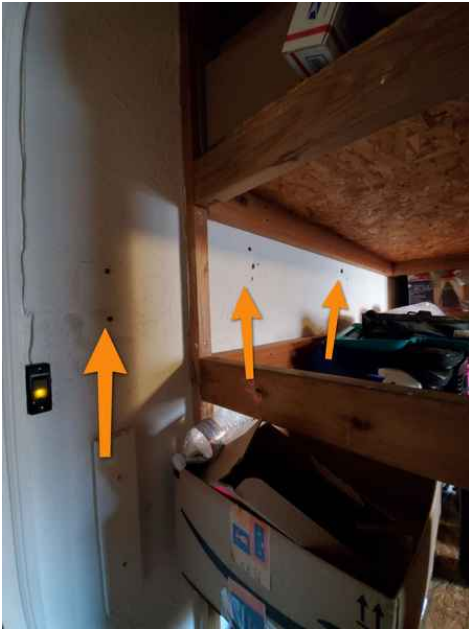
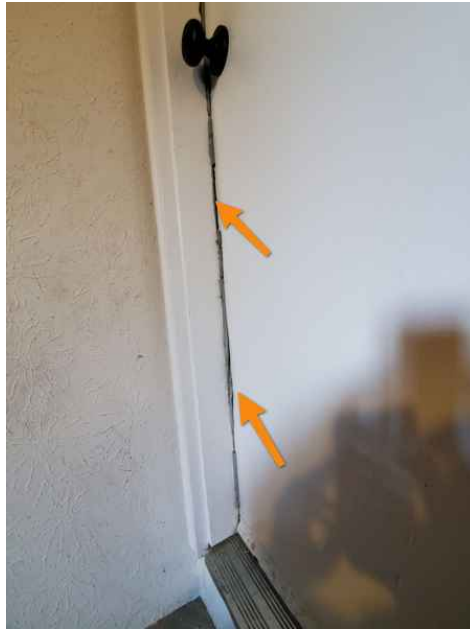
FIRE-SEPARATION BREACH

We observed a breach/deficiency in the garage fire-separation wall. There must not be any openings in this wall of the garage and the fire-separation wall must be made of approved materials. This is a safety concern. [Here is a link to more information about garage fire-separation walls.](#)

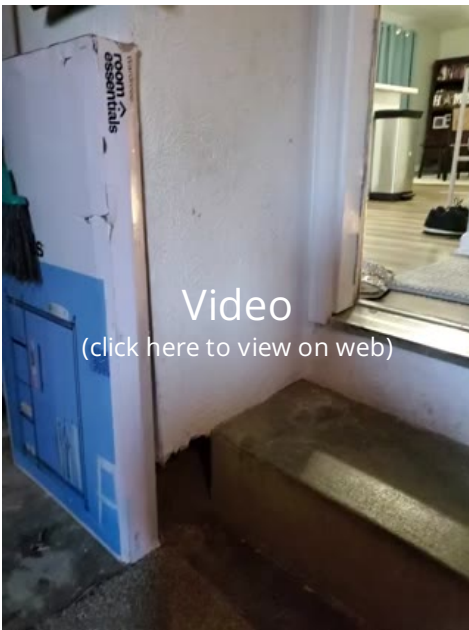
DAMAGED DRYWALL

We observed that a garage area (not a firewall) had damaged drywall. One section of drywall was installed backwards.

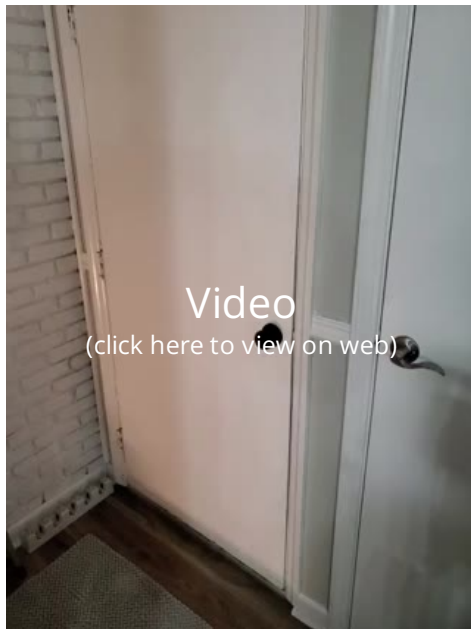
We observed that the garage door rubbed against the frame making it difficult to use.

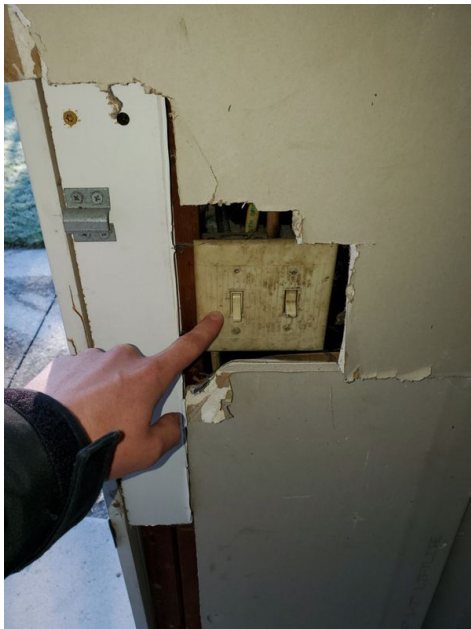
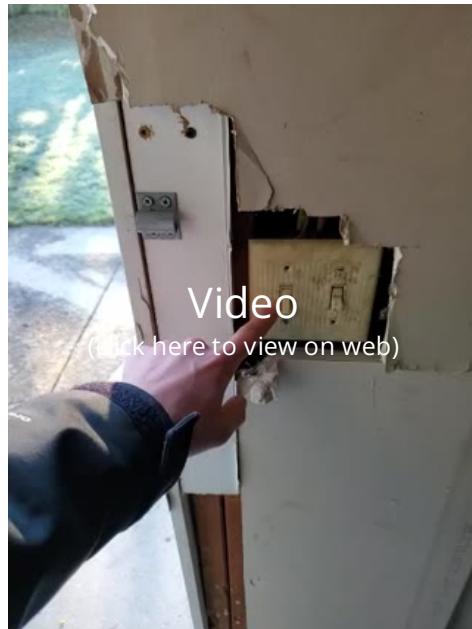
SWITCH INSTALLED IMPROPERLY

We observed that one or more switches were installed improperly.
