ELEVATE HOME INSPECTION

123 Court St
Columbus OH 43221

NOVEMBER 4, 2021

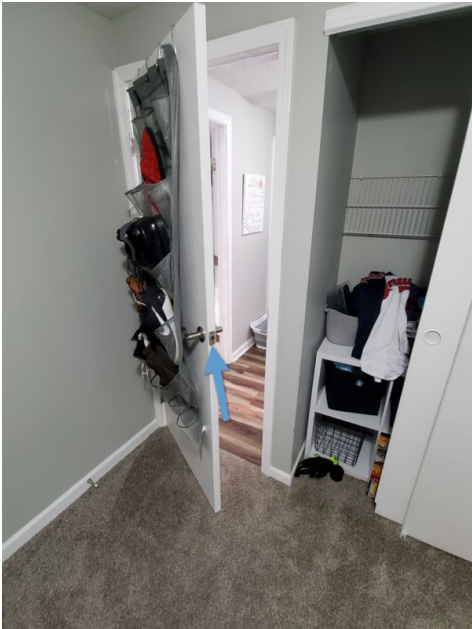
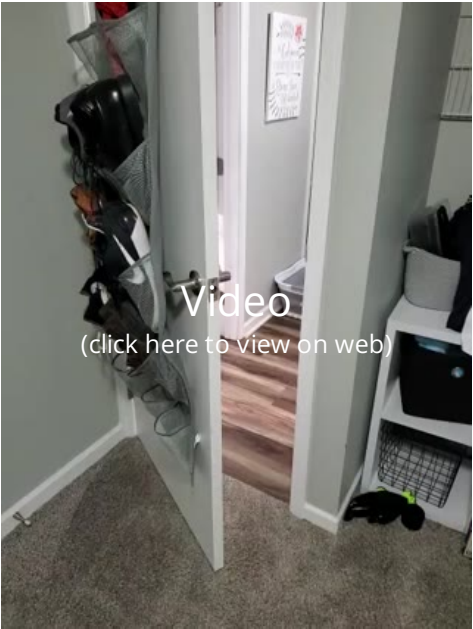
Guest Bedroom

We observed that a door does not latch properly.

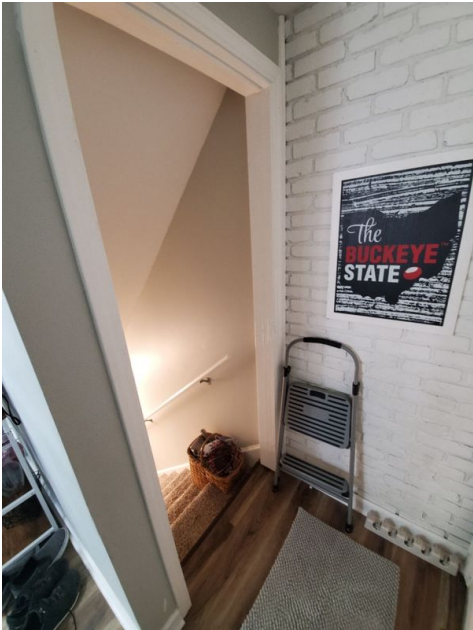
MISSING

We observed that a door is missing.

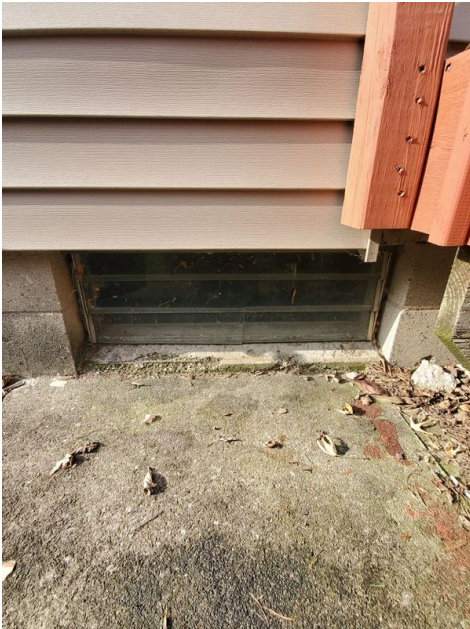
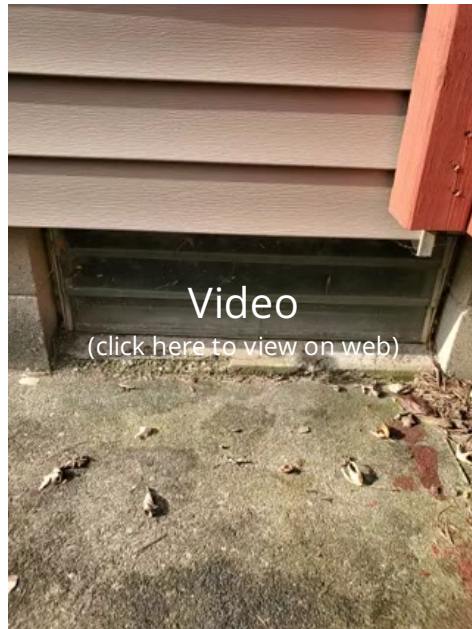
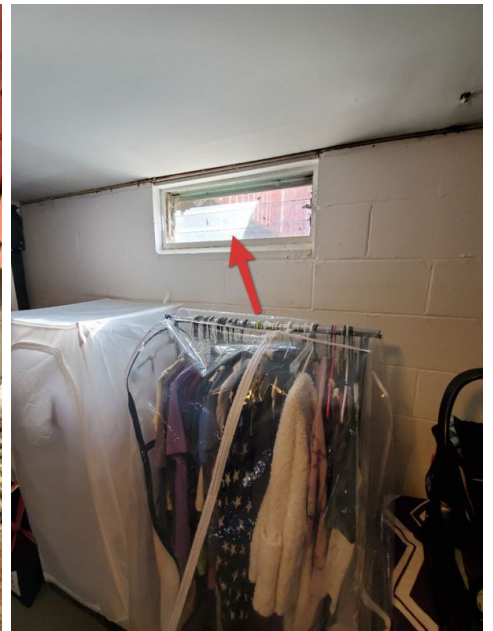
GLASS CRACKED

We observed cracked glass at a window. This is a safety concern.

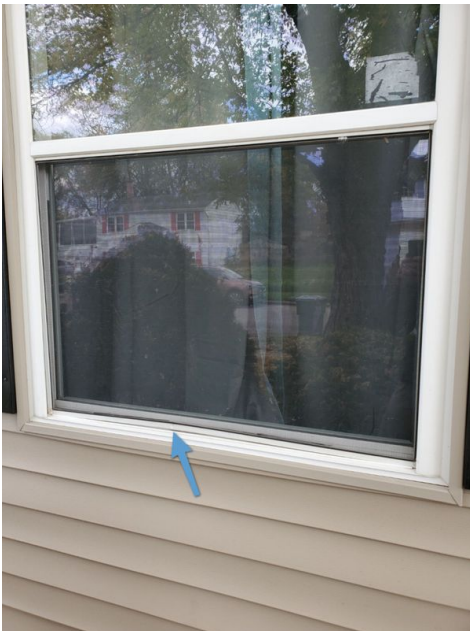
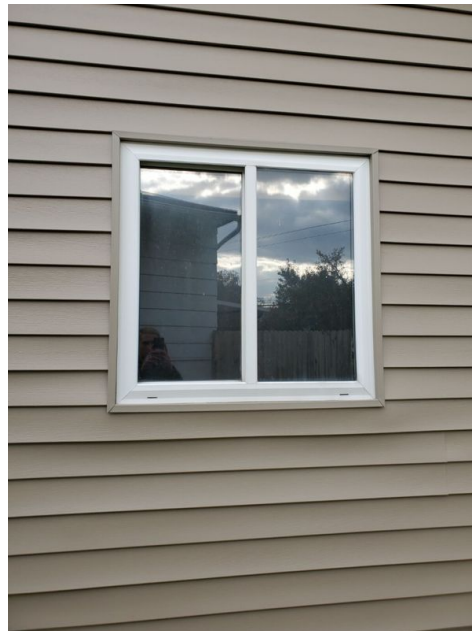
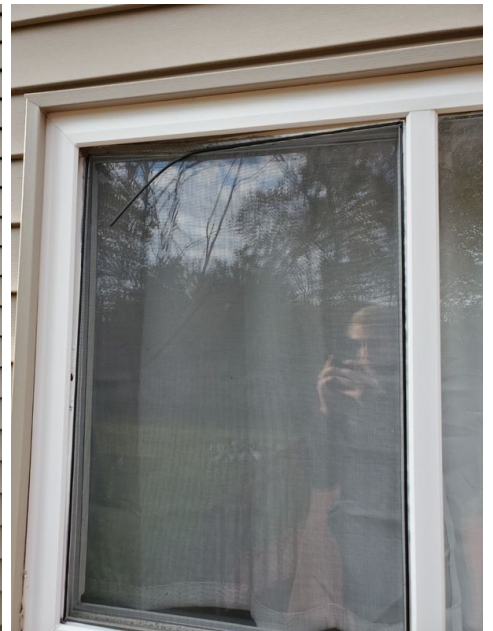
DAMAGED/MISSING WINDOW SCREEN

We observed a damaged or missing window screen. We did not closely inspect all windows screens at the time of the inspection, so there may be additional screens with defects.

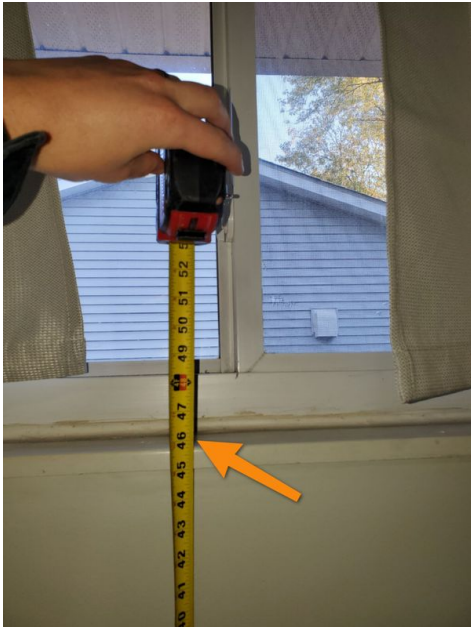
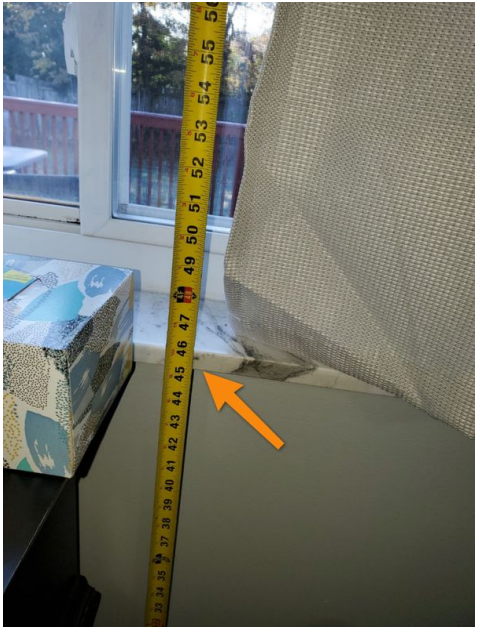
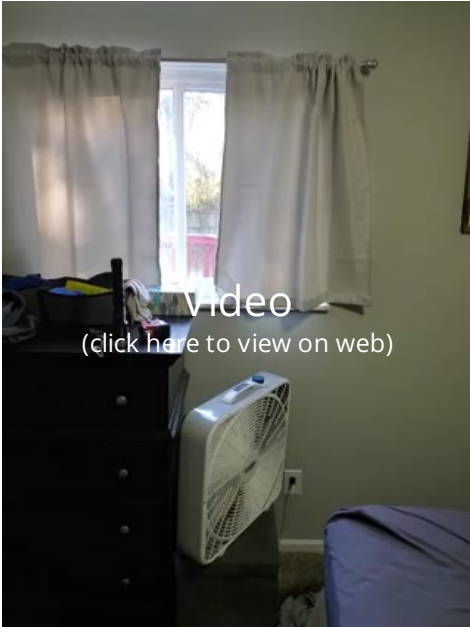
We observed an issue with the emergency egress window(s). Each bedroom should have a secondary means of emergency egress that satisfies modern building standards. This is a safety concern.

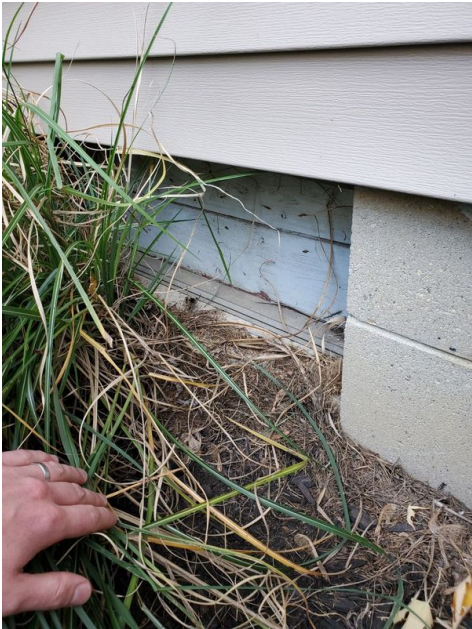
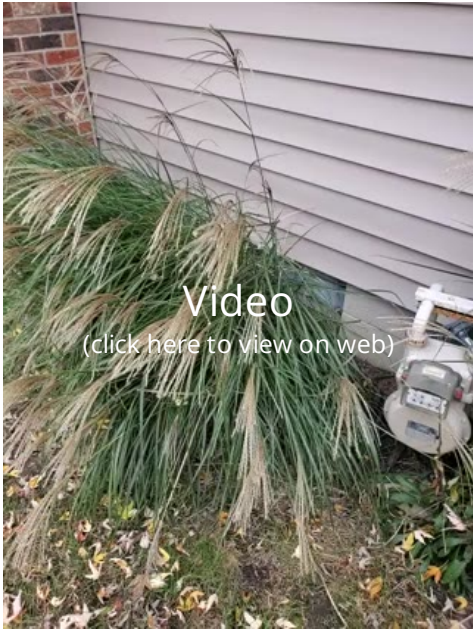
IMPROPER INSTALLATION

We observed that one or more windows appear to be installed improperly. Window was improperly blocked/closed in for a finished basement area and water intrusion is likely.

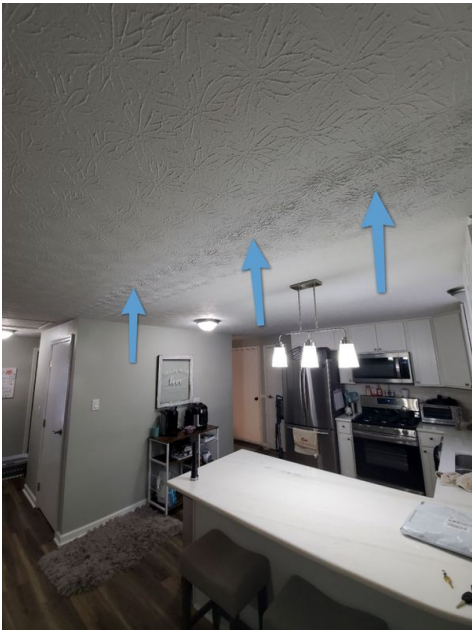
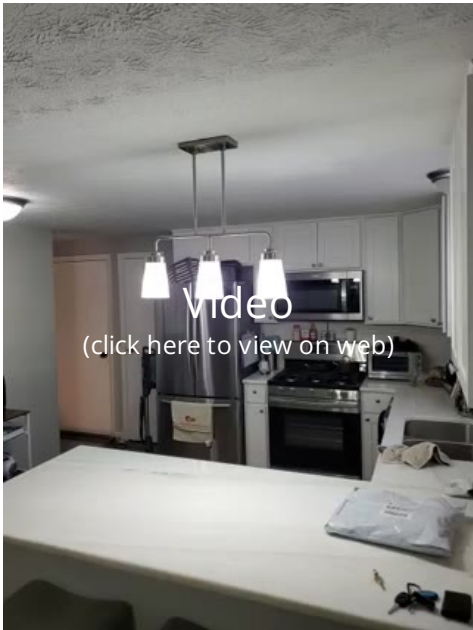
Kitchen

EVIDENCE OF STRUCTURAL MODIFICATION

We observed an area that appears to have been modified from its original layout. We recommend asking the sellers about this area and whether a structural engineer was consulted on the changes. No evidence of defects were observed.

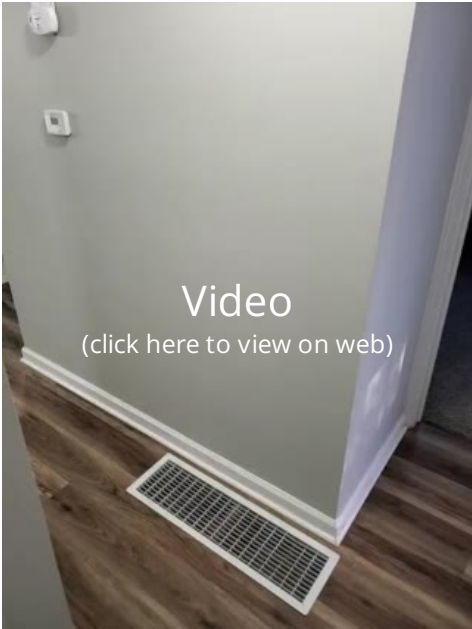
Basement

MISSING SMOKE DETECTOR

We observed that a smoke detector is missing from an area where it is recommended. Each bedroom should have a smoke detector and there should be at least one on each floor of the house. This is a safety concern.

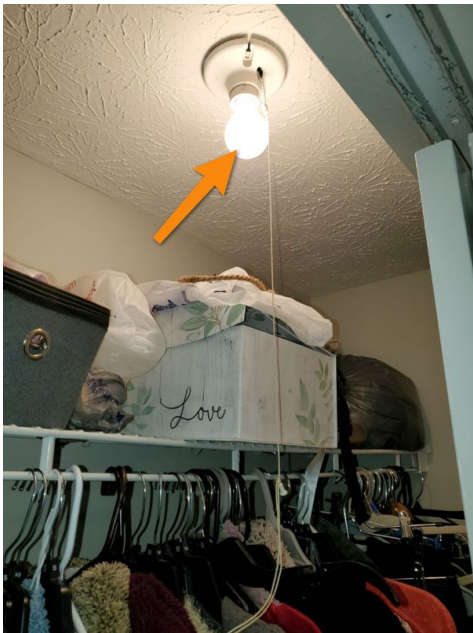
Master Bedroom Closet

CLOSET LIGHT FIRE HAZARD

We observed a light fixture installed in a closet that is a potential fire hazard due to bulb type and/or location. We recommend you switch the incandescent bulb to an LED bulb.

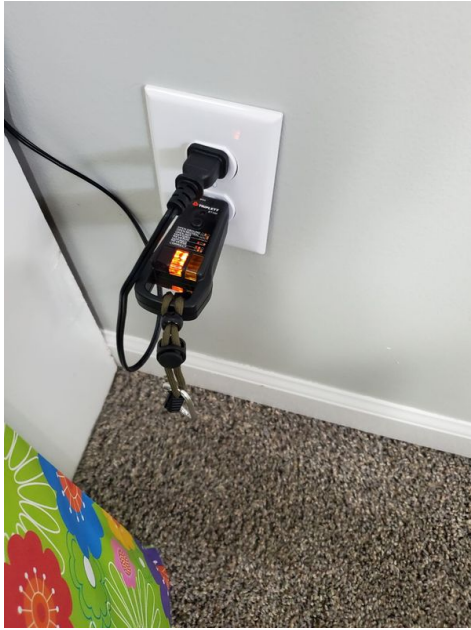
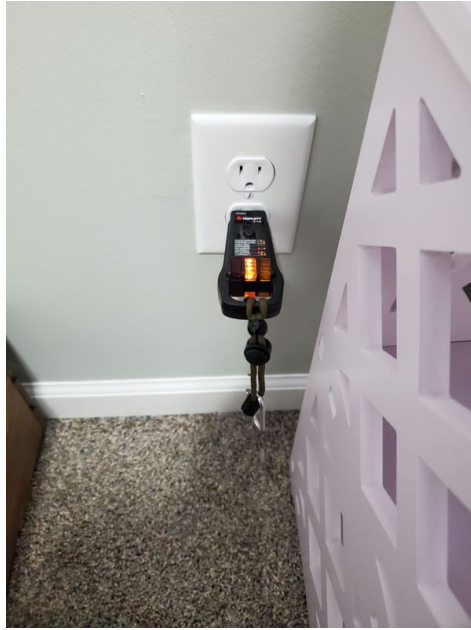
Guest Bedroom

We observed a receptacle that when tested showed as having an open/missing ground at the time of the inspection. In older homes, sometimes old 2-slot ungrounded electrical outlets are replaced with newer 3-prong outlets for ease-of-use with modern plugs. This is incorrect unless the electrical wire was upgraded to current standards as well. This should be further evaluated and corrected by a qualified professional.

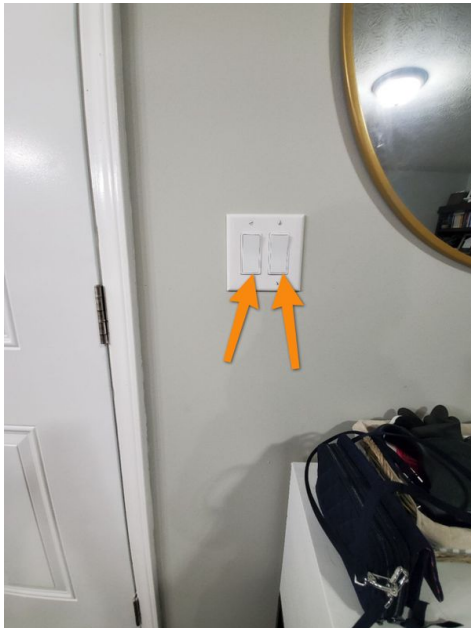
Dining Room

SWITCH INSTALLED IMPROPERLY

We observed that one or more switches were installed improperly.

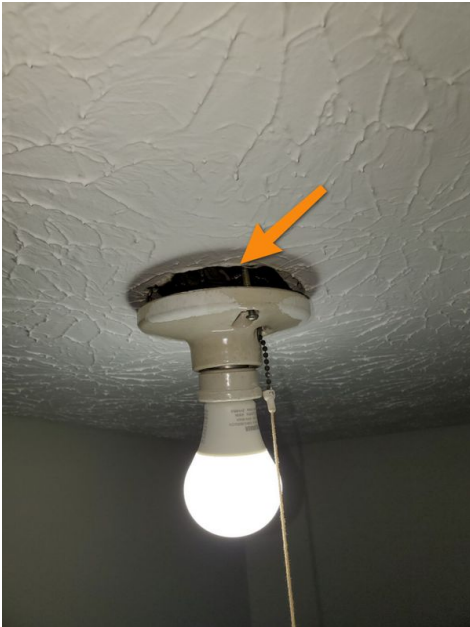
Guest Bedroom Closet

We observed electrical wiring that was loose and/or unprotected. This can be an indication of "handyman work" that is often incorrectly installed.

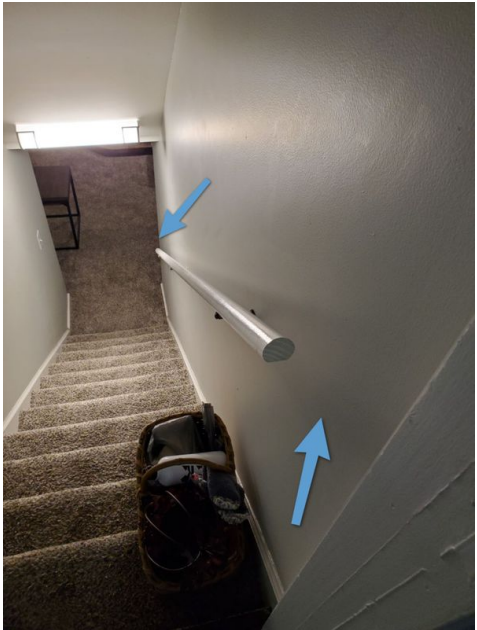
HANDRAIL NOT CONTINUOUS

We observed that the handrail is not continuous. Handrails for stairs should be continuous for the full length of the stairway. The ends should return to the wall, or terminate in a newel post. We recommend that you use this area with increased caution.

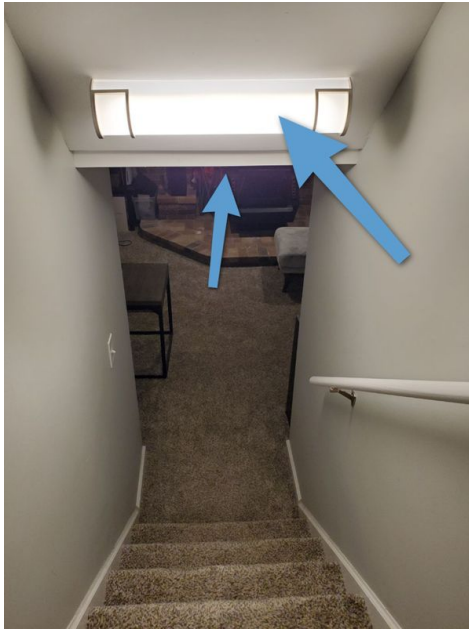
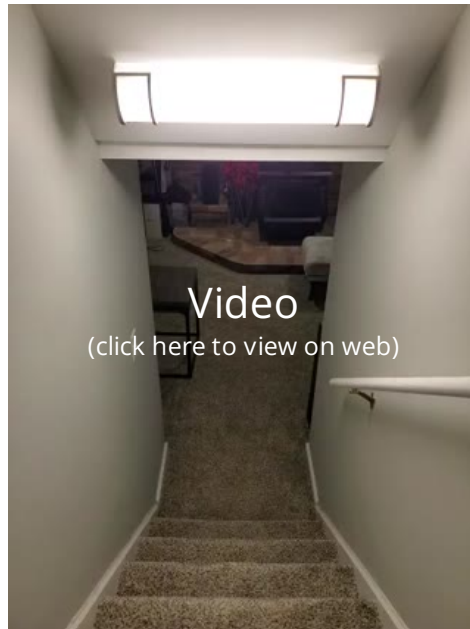
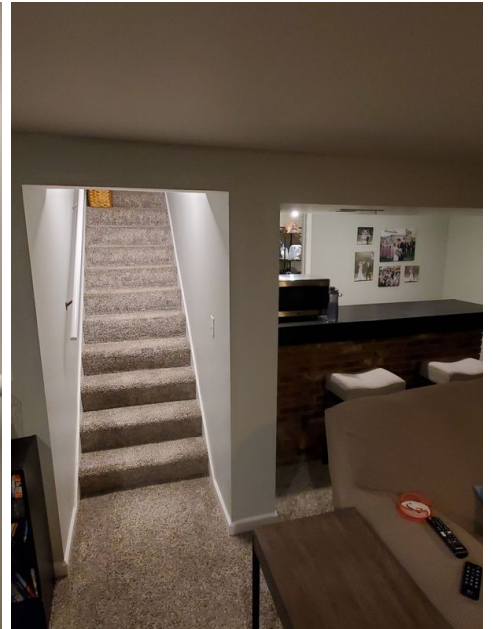
LOW HEADROOM (<6' 8")

We observed that the headroom above the stairs is lower than modern minimum of 6 feet and 8 inches. We recommend that you use this area with increased caution.

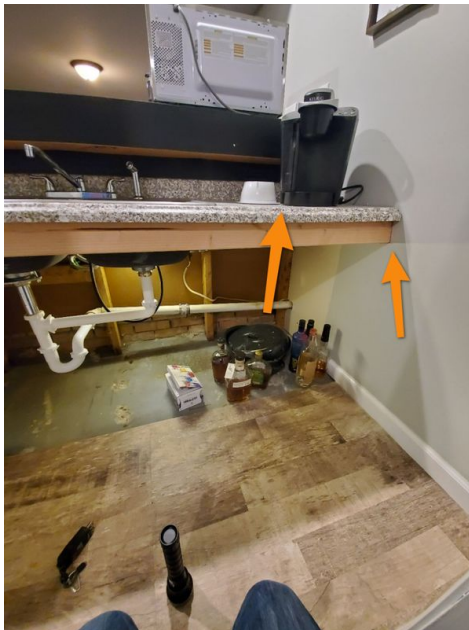
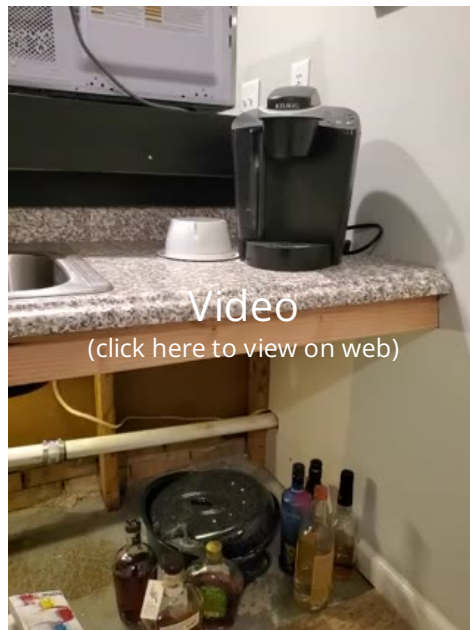
Basement

COUNTERTOP LOOSE/NOT SUPPORTED

We observed a countertop that was loose and/or not properly supported. This is a safety concern.

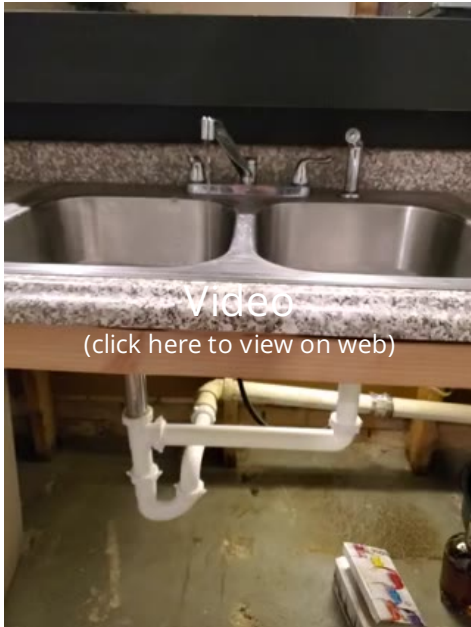
We observed a gurgling pipe when we ran the water that indicated a lack of proper venting for the drain system.

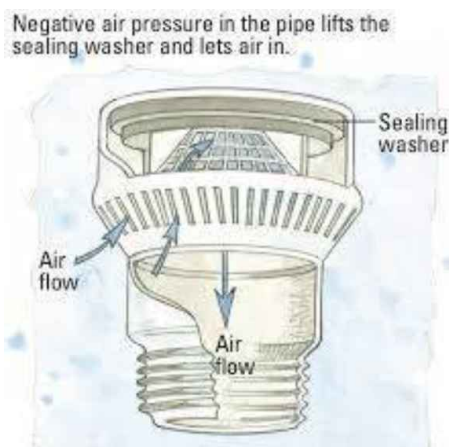
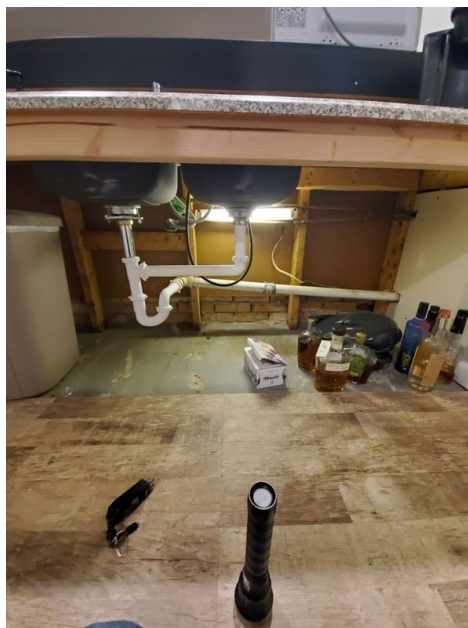
Basement

MISSING AAV IN RECOMMENDED LOCATION

We observed an area where an Air Admittance Valve (AAV) should be installed for proper venting of the drain pipes.

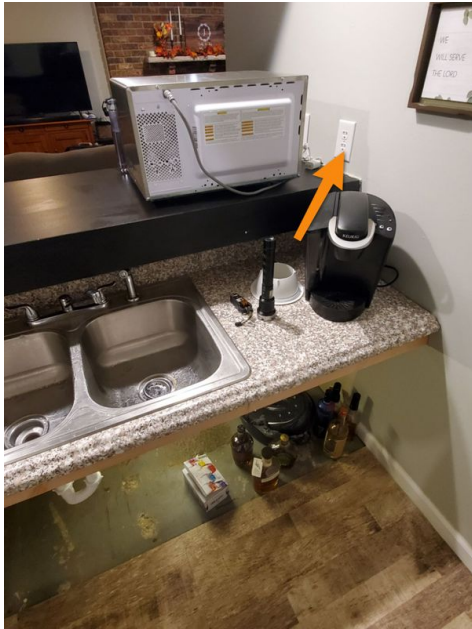
MISSING GFCI PROTECTION

We observed that GFCI protection is missing in an area where it is required. All sink-area receptacles should be on a GFCI-protected circuit, which can be accomplished by a GFCI outlet or a GFCI breaker.

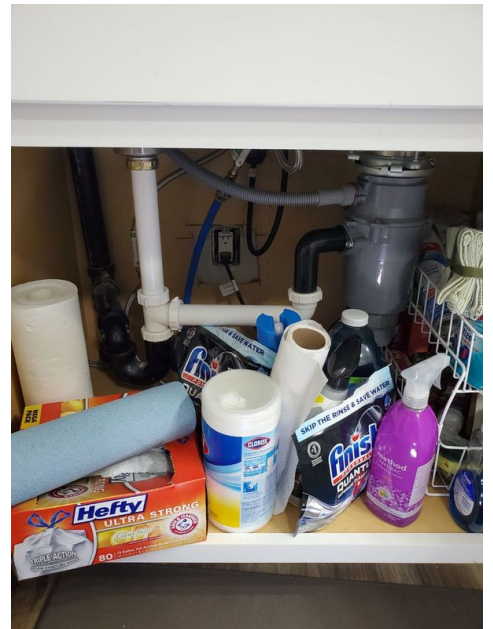
STORAGE RESTRICTION

At the time of the inspection, the cabinet under the sink was full of belongings, which blocked some visual inspection areas. This was an inspection restriction.

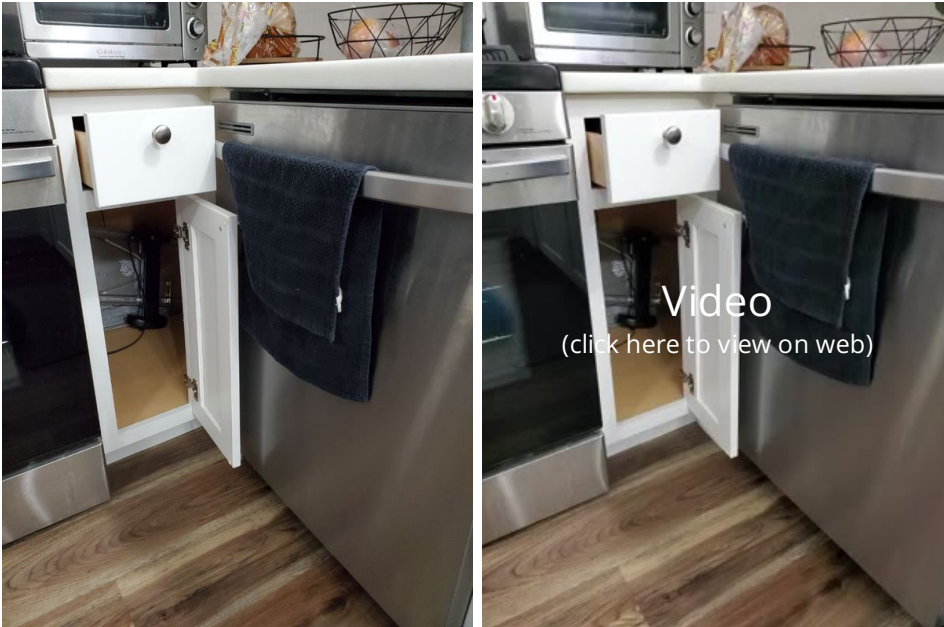
We observed a clearance issue that prevents full usage of a cabinet.

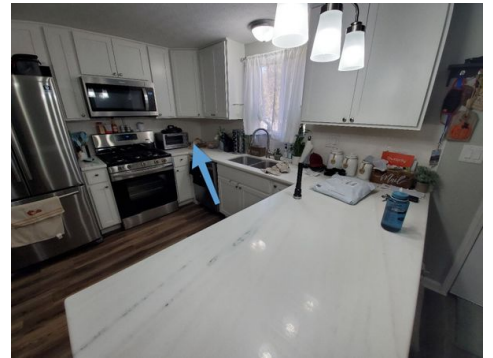
RECOMMEND MORE RECEPTACLES

We observed that there are not many receptacles in the kitchen. There should be at least one receptacle every 4 feet along the countertop areas.

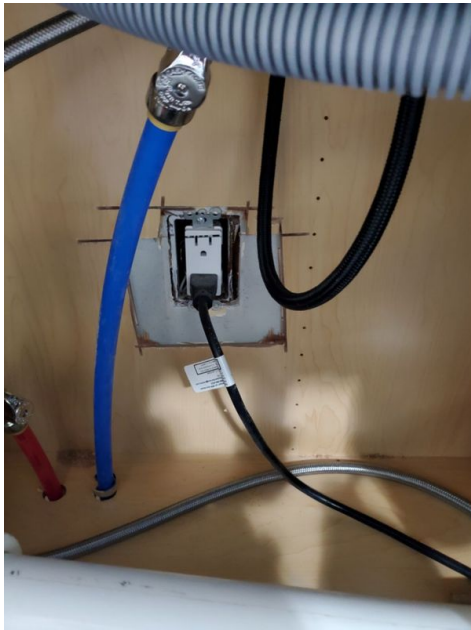
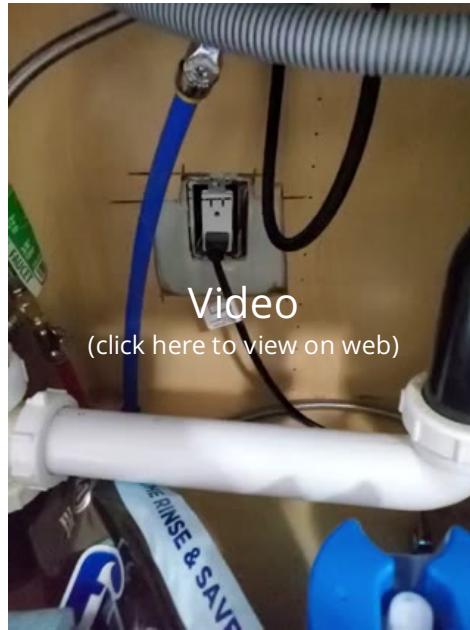
DAMAGED RECEPTACLE

We observed a damaged receptacle that needs replaced. This is a safety concern.

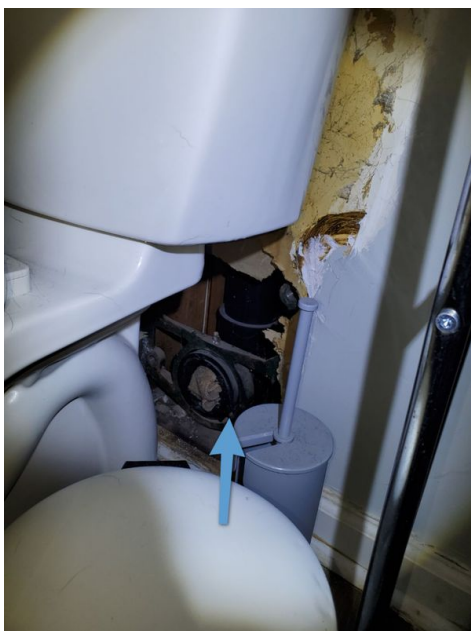
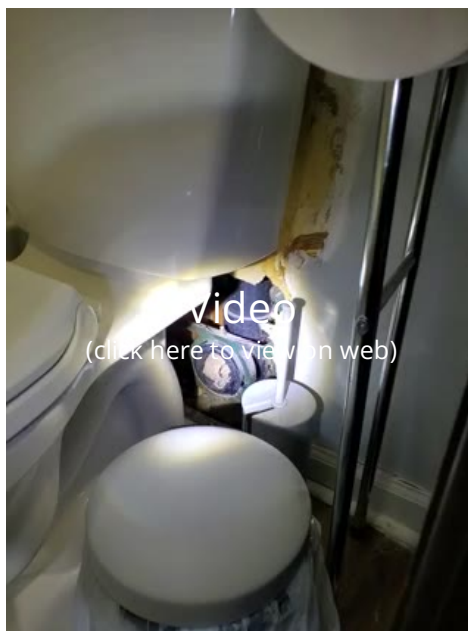
We observed improper installation and/or handyman work at the bathroom plumbing system that may make it more likely to leak and/or fail to perform as intended. We recommend monitoring this area closely and correcting the issue. This condition is likely allowing sewer gas into the home and this is a safety concern.

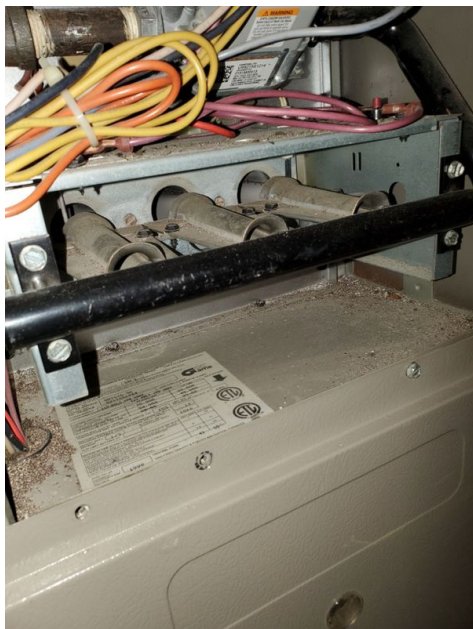
We observed indications of delayed maintenance at the heating system. We recommend that the system be serviced by an HVAC professional annually.

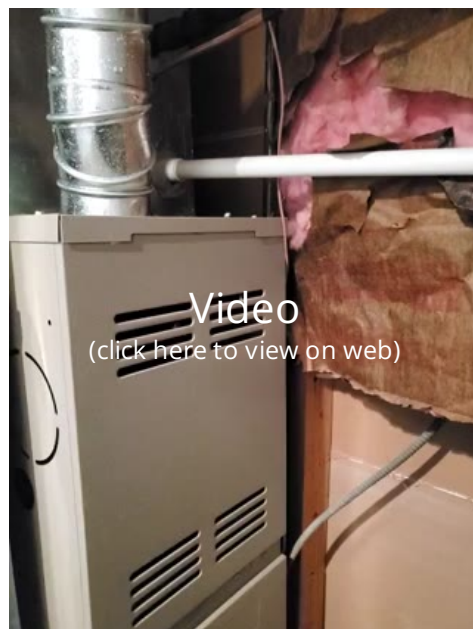
We observed an area with a clearance issue between a combustion appliance and combustible material. This is a safety concern.

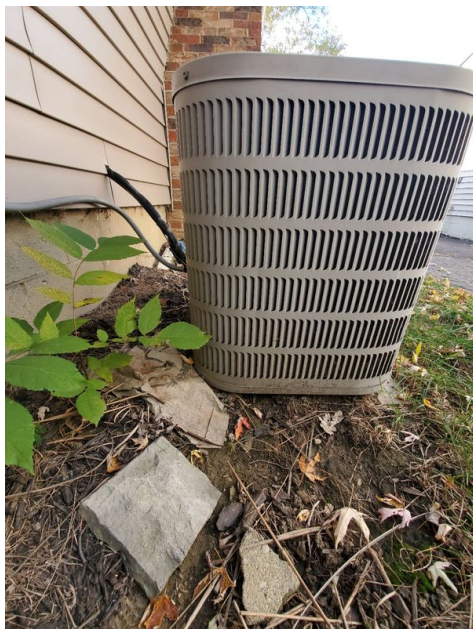
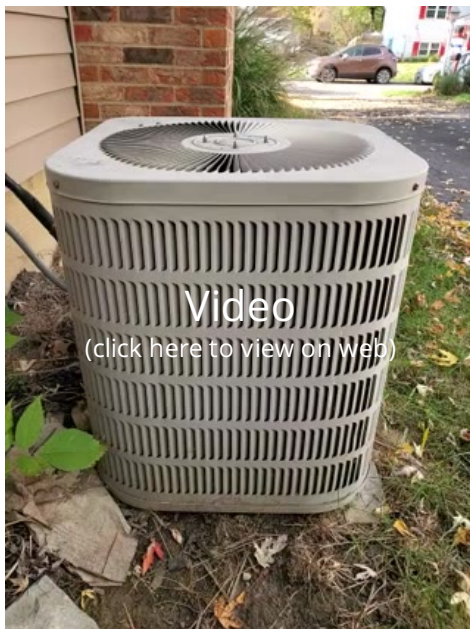
11.2.1 Cooling & Condensate

CONDENSER INSTALLATION ISSUE

We observed that the exterior condenser unit had installation issues at the time of the inspection. The unit should be sufficiently level and installed on a support base or brackets above grade. It should have serviceable clearance from other systems, vents, & vegetation.

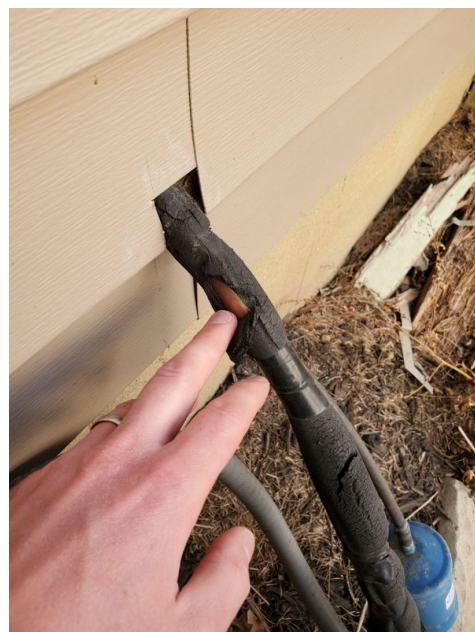
11.2.2 Cooling & Condensate

LINESET INSULATION MISSING/DAMAGED

We observed missing or damaged foam insulation at the cooling system's refrigerant line, which can cause energy loss and excessive condensation.

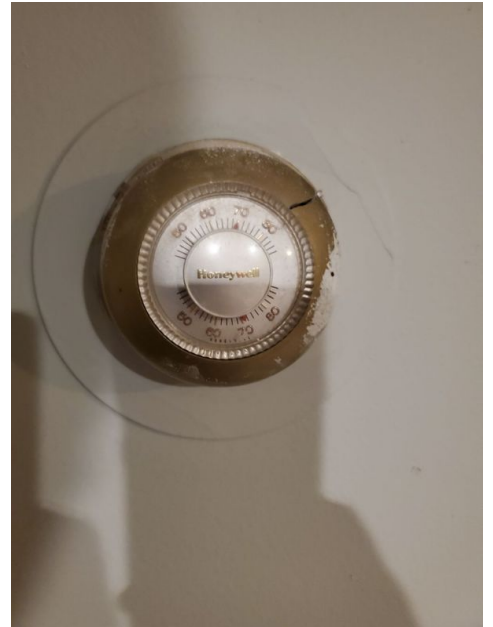
We observed that the thermostat appeared to be old and may be near the end of its service life. As such, it may not perform reliably. Some old thermostats contain mercury and should be disposed of properly. We recommend budgeting for replacement. Check out this helpful guide for estimating the service life of home systems.

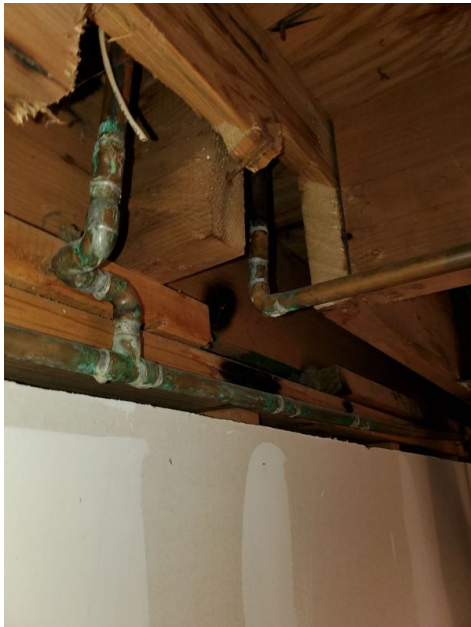
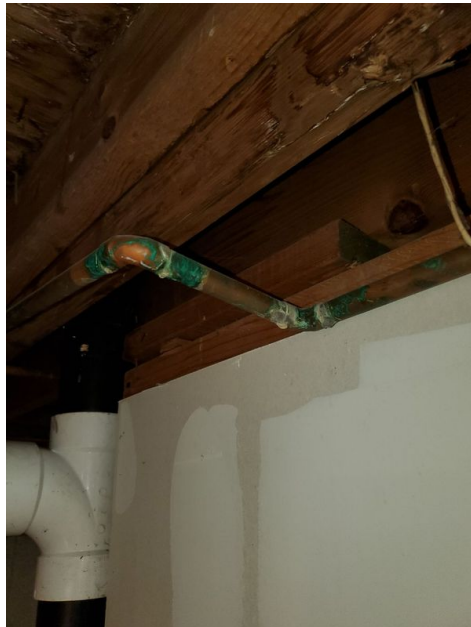
CORROSION

We observed more-than-expected corrosion at pipe fittings in one or more areas. Continued corrosion can cause leaks, but no active leaks were observed. We recommend this is further evaluated by a qualified professional.

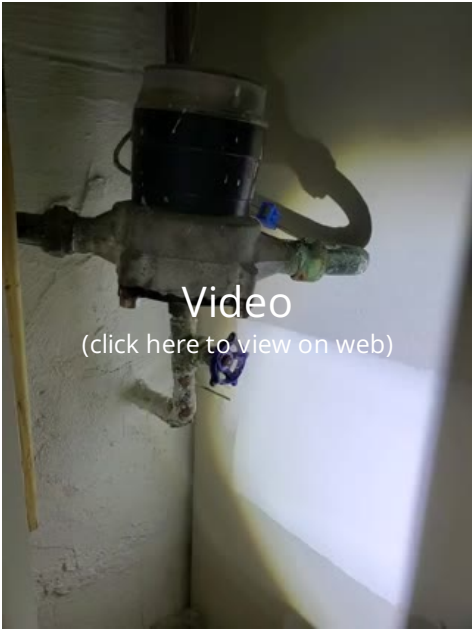
12.1.2 Water Supply System

MAIN VALVE IS OLD

We observed advanced age of the house's main water shutoff valve. It is likely that this valve would have issues fully turning off the water supply in an emergency. We recommend it is replaced with a newer valve by a qualified professional.

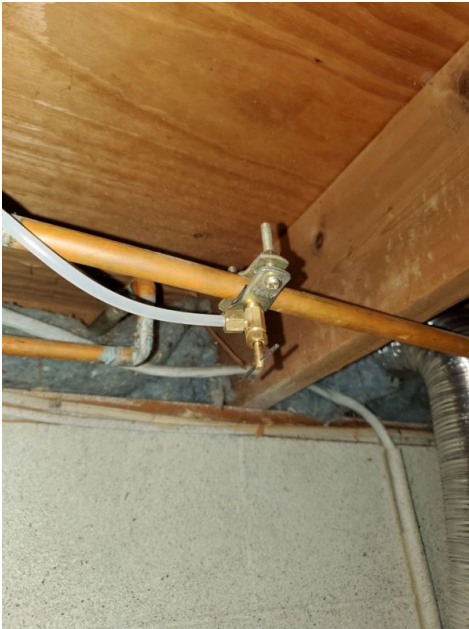
12.1.4 Water Supply System
IMPROPER CONNECTION

We observed one or more supply lines with an improper connection. We recommend you monitor this area closely for leaks and correct the improper connection.

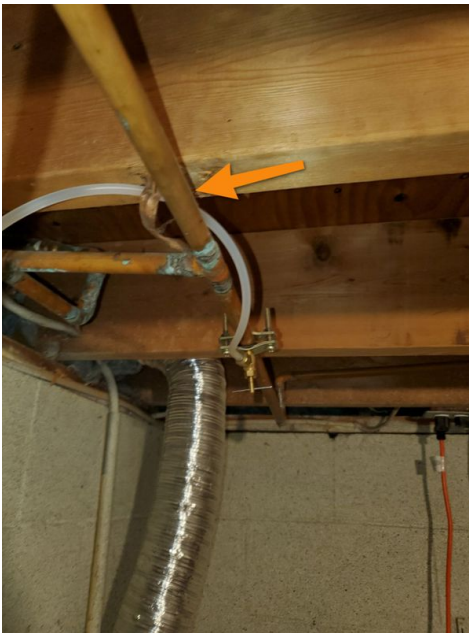
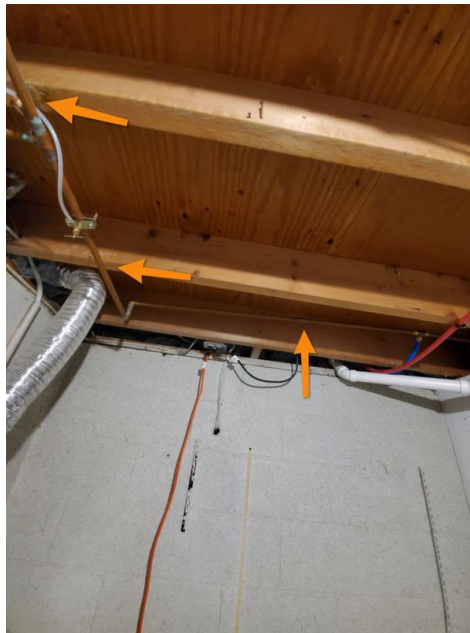
12.1.5 Water Supply System

We observed area(s) where the pipe was not properly supported. This can lead to fitting failures and leaks.

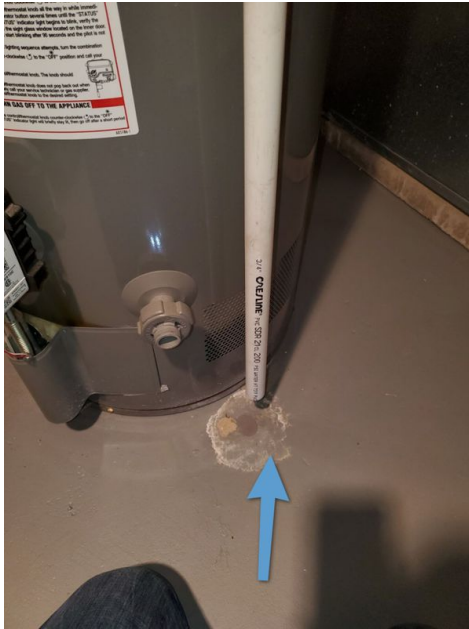
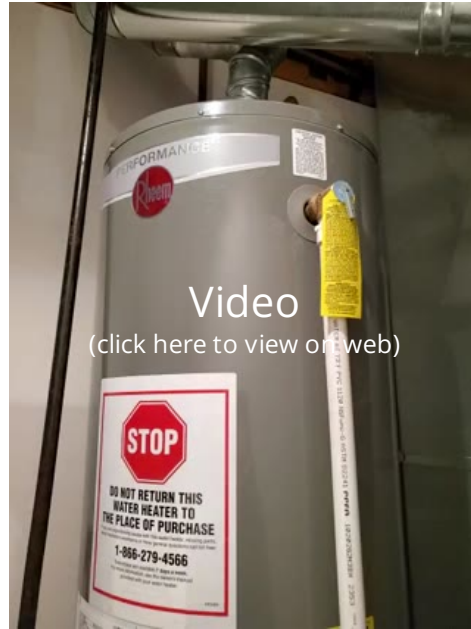
12.2.1 Water Heater

EVIDENCE OF PREVIOUS LEAK

We observed an area where a leak had occurred in the past. No active leaks were observed in this area.

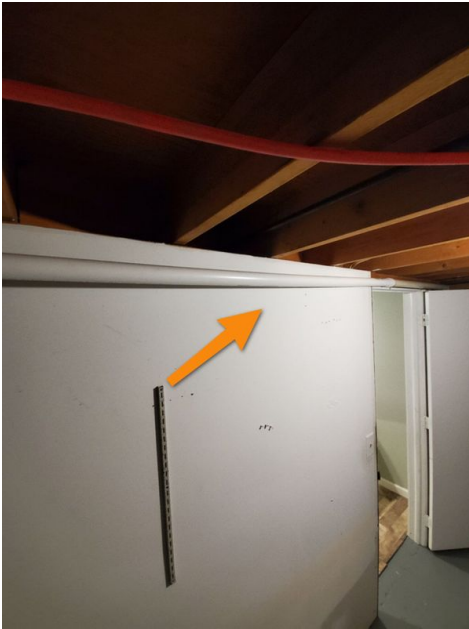
12.3.1 Drain, Waste, & Vent Systems

ABS/PVC CONNECTION

We observed PVC pipe connected to ABS pipe. This is generally not allowed, although there is one type of pipe adhesive for this purpose. We cannot tell if this adhesive was used. We recommend using a rubber Fernco fitting to connect ABS & PVC and monitoring this area for leaks.

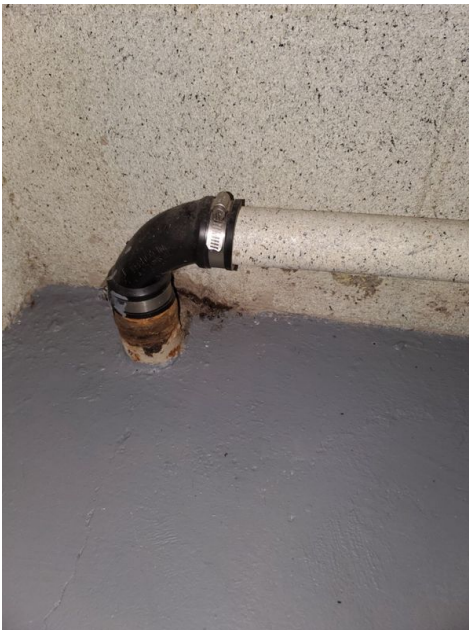
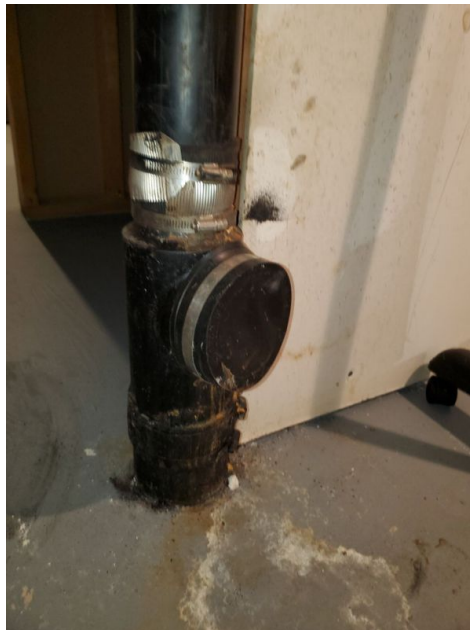
12.3.3 Drain, Waste, & Vent Systems

IMPROPER CONNECTION

We observed an improper drain pipe connection. We recommend you monitor this area closely for leaks.

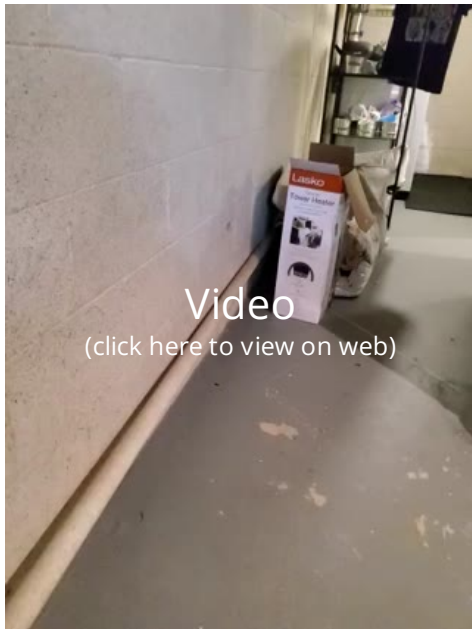
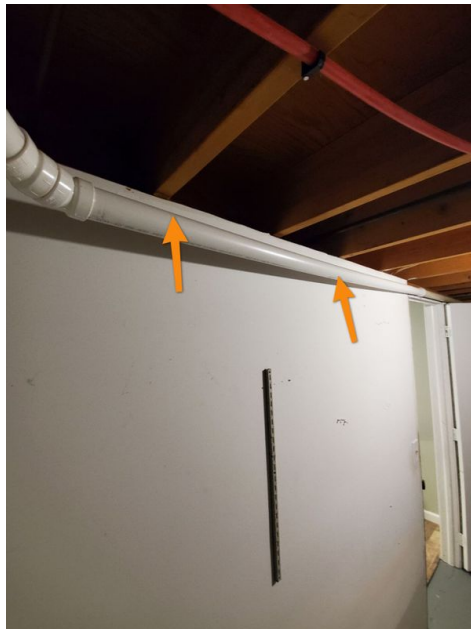
12.3.4 Drain, Waste, & Vent Systems

PIPE SUPPORT ISSUE

We observed a section of pipe that needs more support.

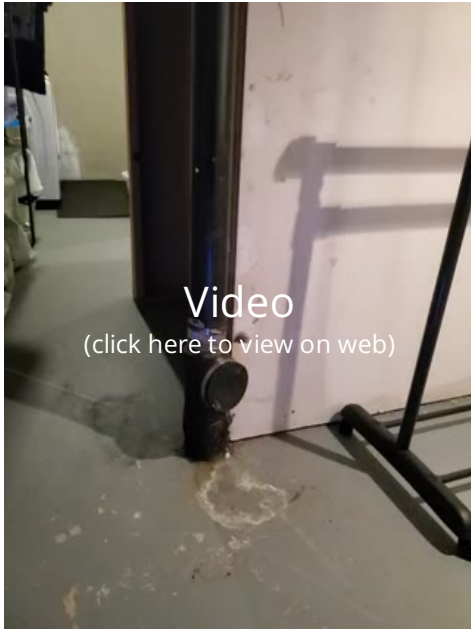
EVIDENCE OF SEWAGE LEAK

We observed evidence of previous sewage leaks. No active leaks were observed during the inspection.

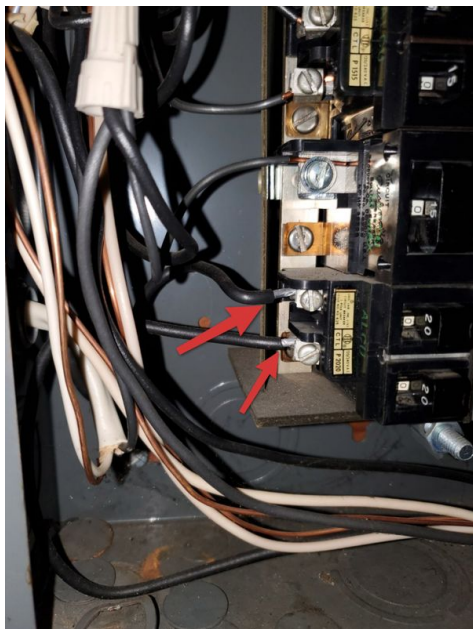
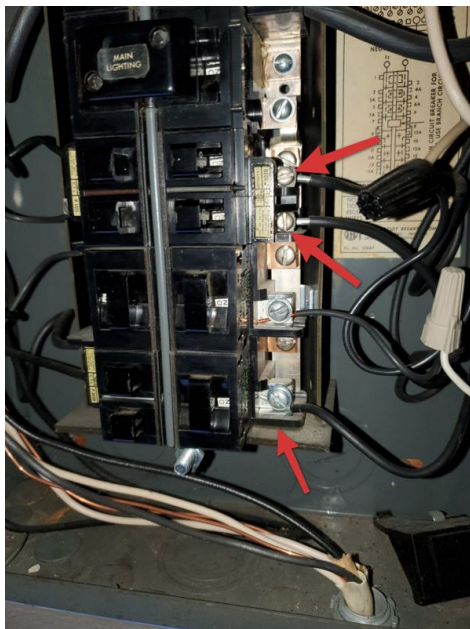
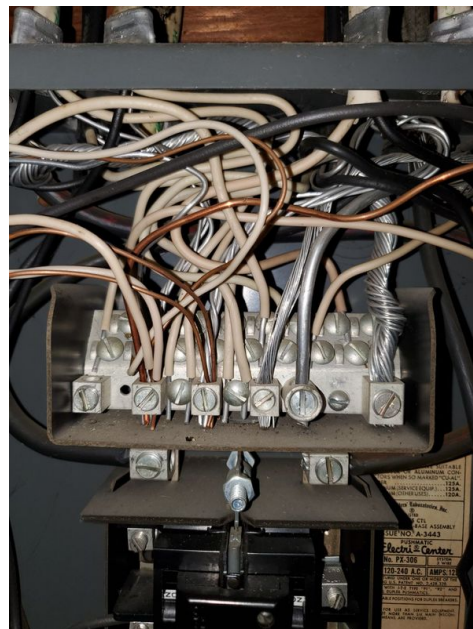
We observed the presence of solid-conductor aluminum branch circuit wiring in the electrical system.

This type of wiring can be a fire hazard if it is not properly remediated with proper components and tools by a qualified professional. We highly recommend that the electrical system be evaluated by a licensed electrician to confirm that approved remediation system(s) were correctly installed.

These single strand, branch circuit aluminum wires were used widely in houses during the mid 1960s and 1970s. According to the U.S. Consumer Product Safety Commission, problems due to expansion can cause overheating at connections between the wire and devices (switches and outlets) or at splices, which has resulted in fires.

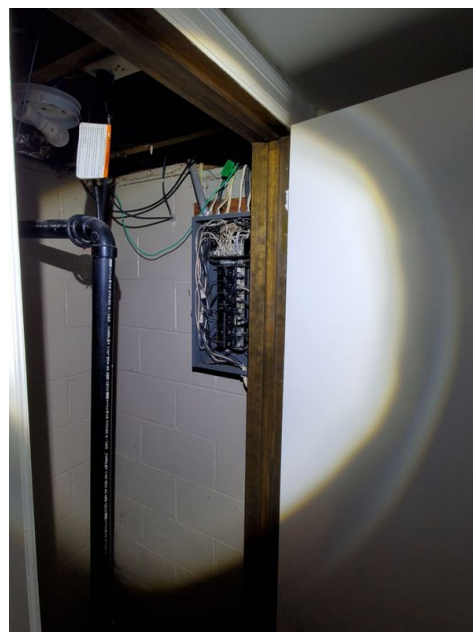
13.2.2 Disconnects, Panels, Breakers, & Wiring

WORKSPACE AT PANELBOARD

We observed limited workspace at the panelboard. A clear space that is 3 feet deep, 30 inches wide, and 6' 6" in height should be provided in front of the equipment.

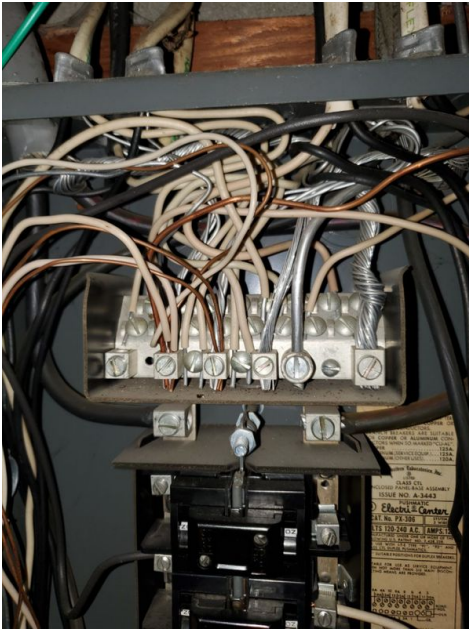
DOUBLED NEUTRALS

We observed doubled neutral wires connected under the same single lug, which is not allowed.

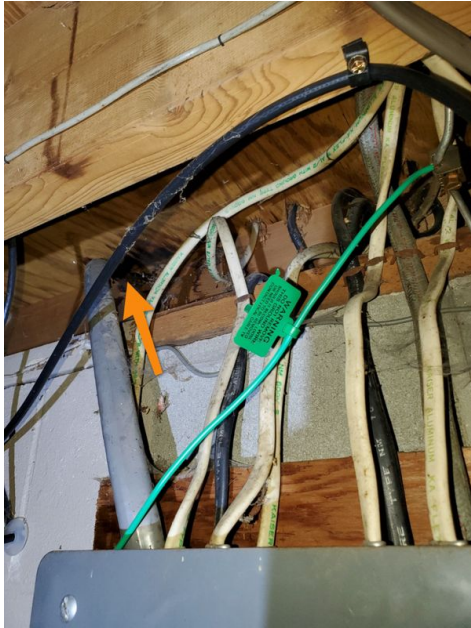
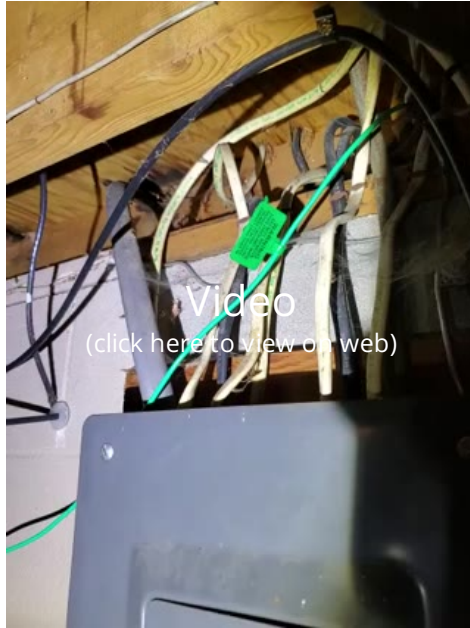
We observed what appeared to be scorch marks near the electrical panel. We recommend this is further evaluated by a qualified professional.

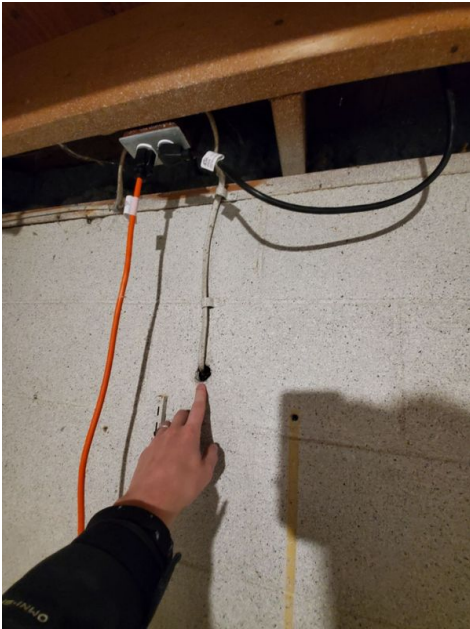
We observed wiring installed through concrete and/or underground without visible conduit.

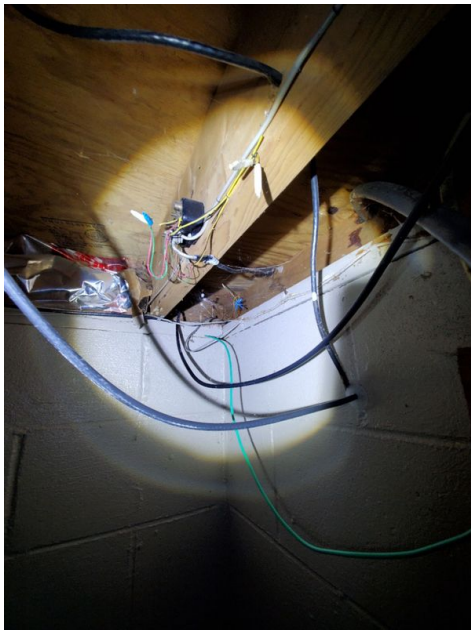
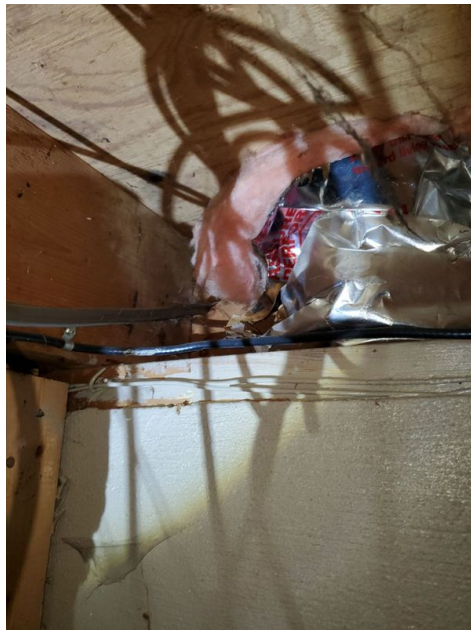
RECOMMEND MORE INSULATION

We observed the general absence of insulation in the basement. We highly recommend insulation in the rim joists, as this is a major heat loss area.
