ELEVATE HOME INSPECTION

123 Court St
Columbus OH 43221

NOVEMBER 4, 2021

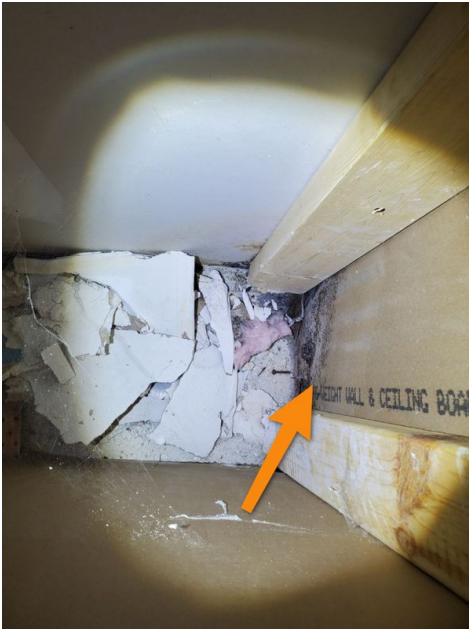
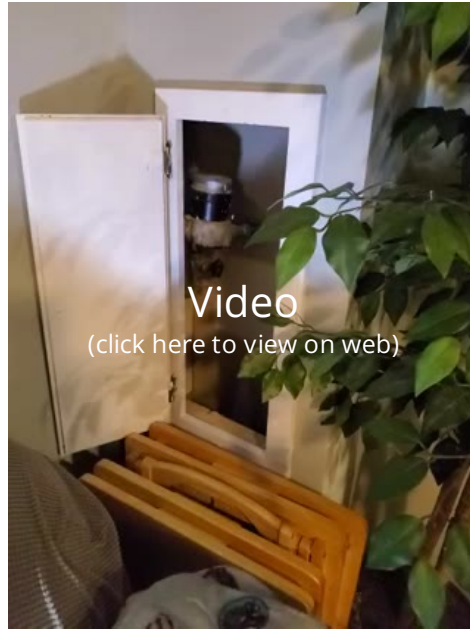
POSSIBLE ORGANIC GROWTH

We observed excessive moisture/humidity in the basement and indications of organic growth. We recommend that this area be further evaluated by a qualified mold professional. This is a safety concern.

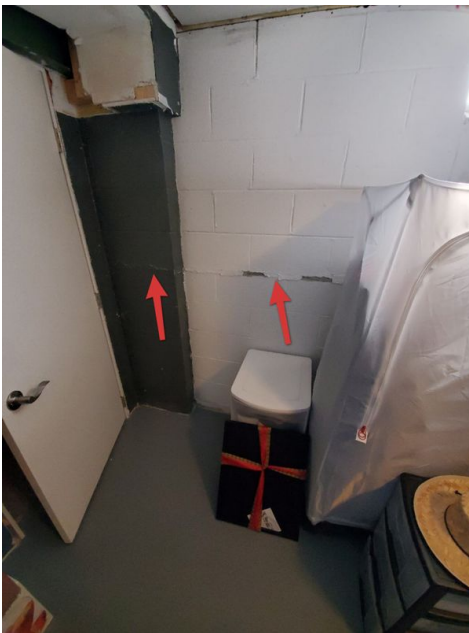
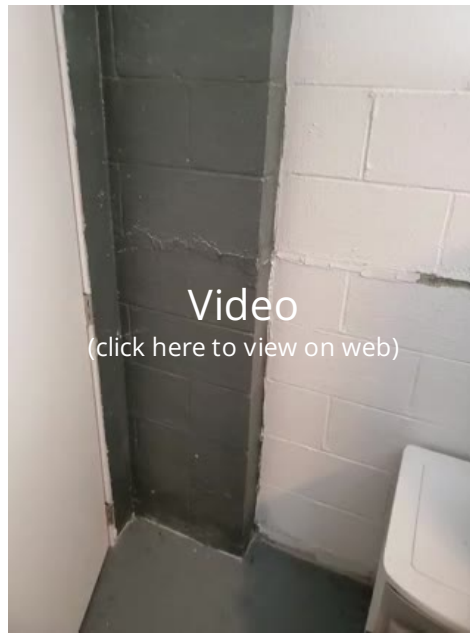
MAJOR CRACK

We observed major cracking at the foundation. This is a potential structural issue. This should be further evaluated and corrected by a qualified professional and/or structural engineer.

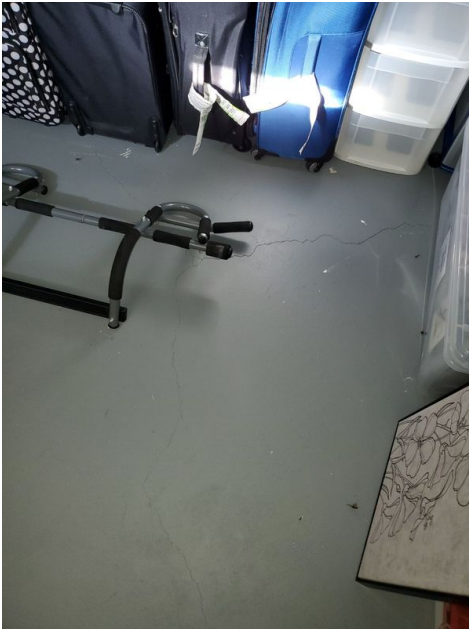
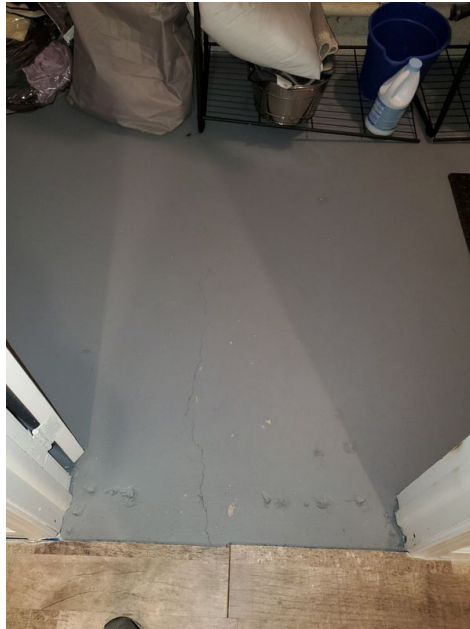
MINOR BASEMENT FLOOR CRACK(S)

We observed minor cracking of the basement floor. At the time of the inspection these were not structural concerns. We recommend sealing the cracks and monitoring for additional cracking.

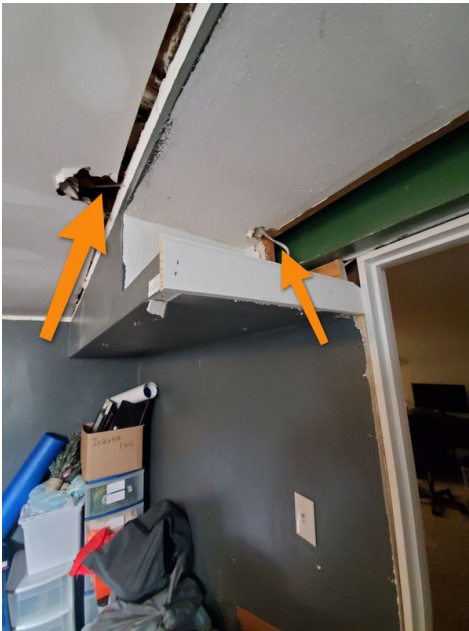
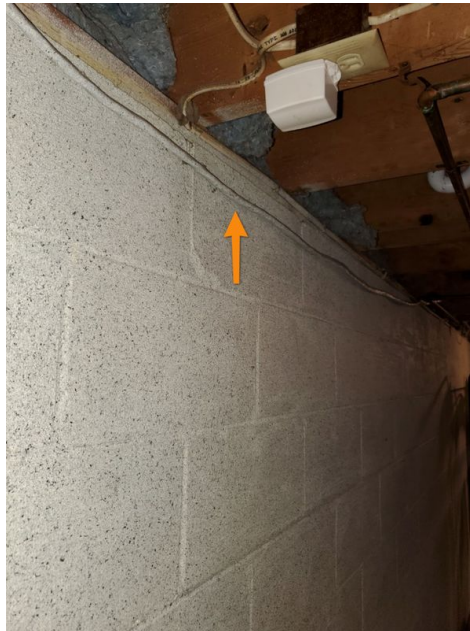
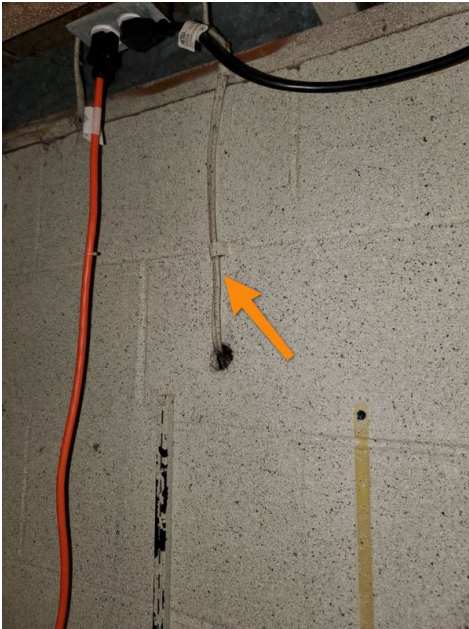
UNPROTECTED ELECTRICAL

We observed electrical wiring that is subject to damage and should be protected inside a finished wall or a conduit. This is a safety concern.

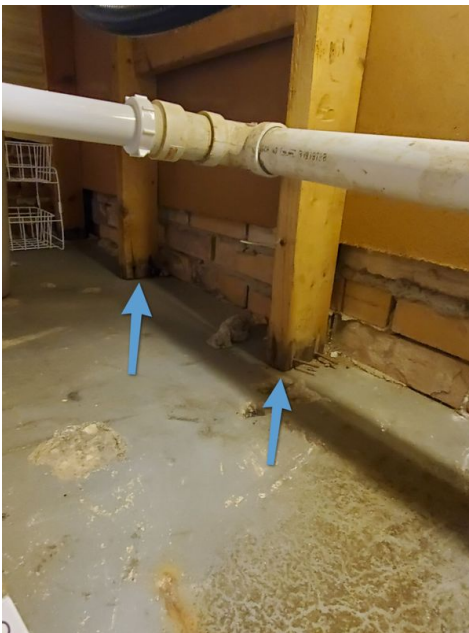
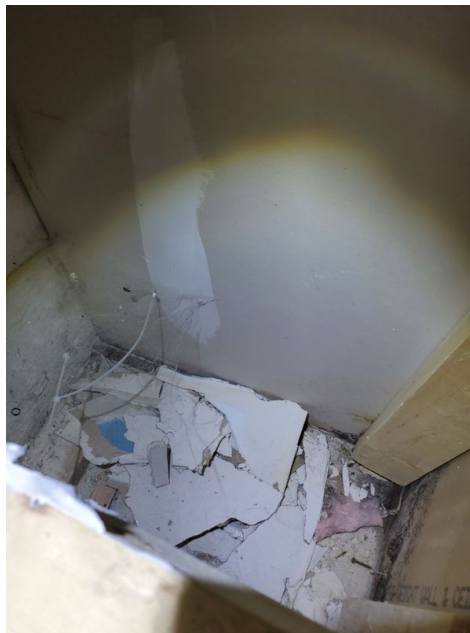
EVIDENCE OF PREVIOUS WATER ISSUES

We observed an area with indications of past water issues. No water or dampness was observed in this area.
