MOUNTAINS TO SOUND HOME INSPECTION LLC

HOME INSPECTION REPORT

10506 22nd Ave E
Tacoma WA 98445

Kim and John Smith
JUNE 9, 2020

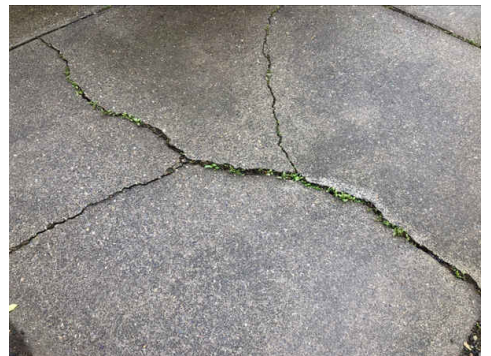
PATIO FLOOR CRACKS

There are cracks in the rear patio floor that you should view for yourself and correct as desired.

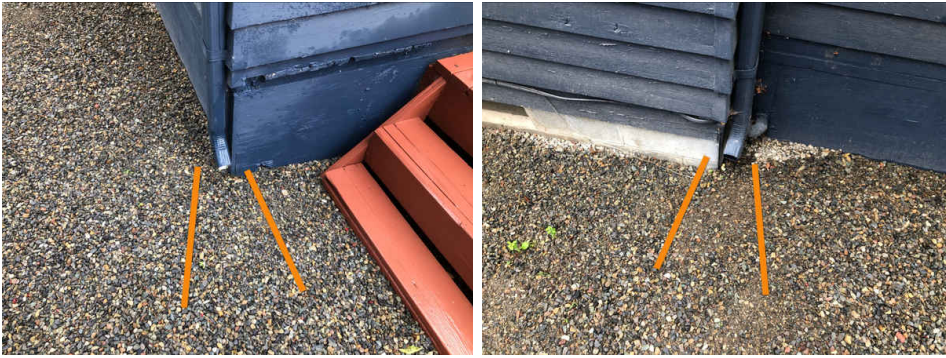
DOWNSPOUTS MISSING COMPONENTS

The downspouts are missing parts. Recommend repairs to allow for proper drainage away from the structure.

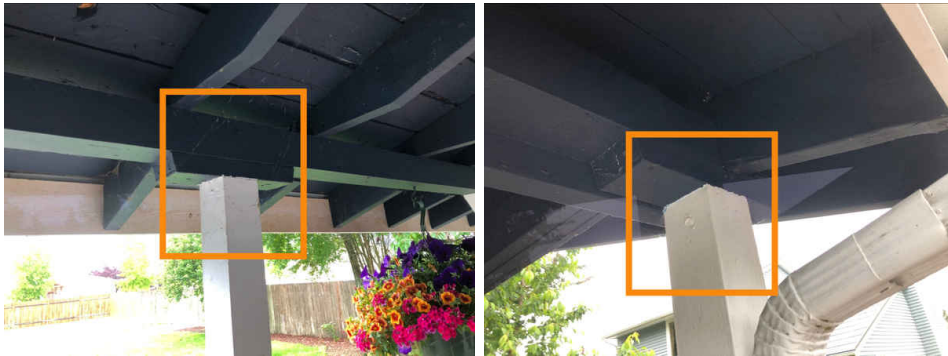
There are no brackets for the posts on the overhang. Recommend upgrading posts with brackets for added security.

Contact a qualified professional.

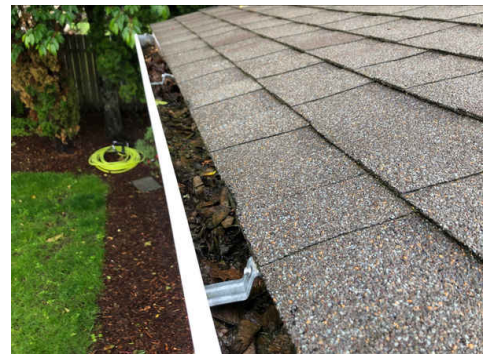
Trees near the dwelling have overhanging branches and/or branches in contact with the roof surface, which may cause damage to the roof surface. This condition may also cause the obstruction of roof water runoff and is a access for rodents, animals and carpenter ants. All overhanging or touching branches in contact of the roof surface should be trimmed to eliminate this condition.

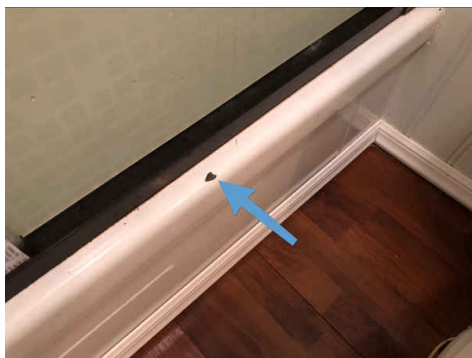
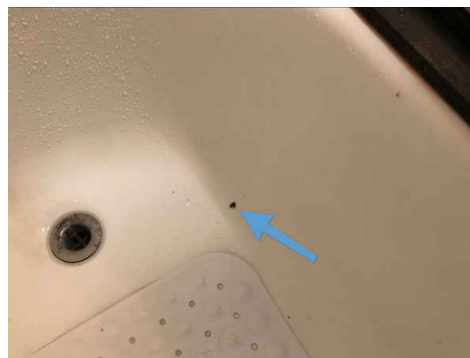
11.4.2 Tub-Shower

TUB AREA COSMETIC DAMAGE

Contact a qualified handyman.

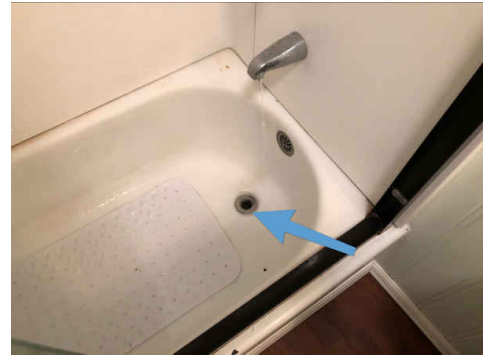
11.4.3 Tub-Shower

TUB STOPPER IS MISSING

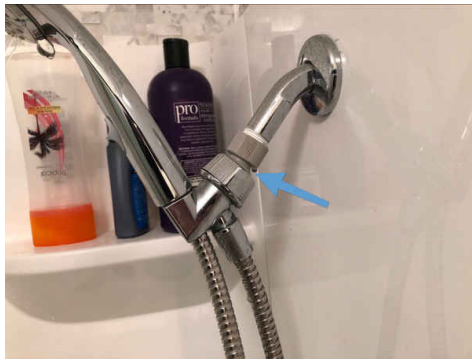
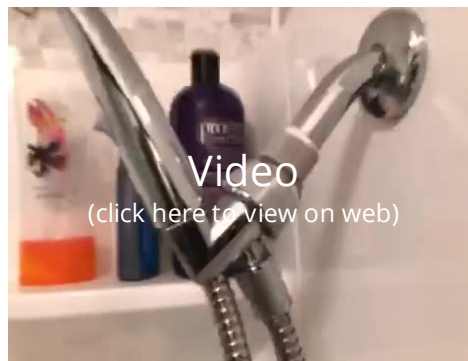
11.4.4 Tub-Shower

SHOWER HEAD LEAK

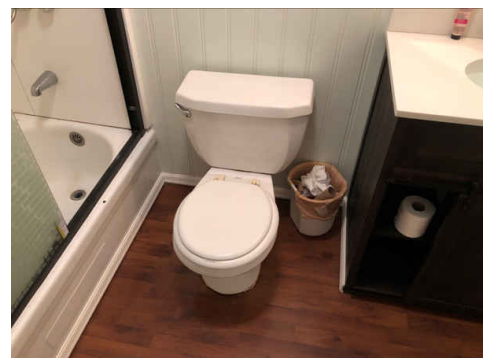
11.5.1 Toilet

FUNCTIONAL BUT LOOSE

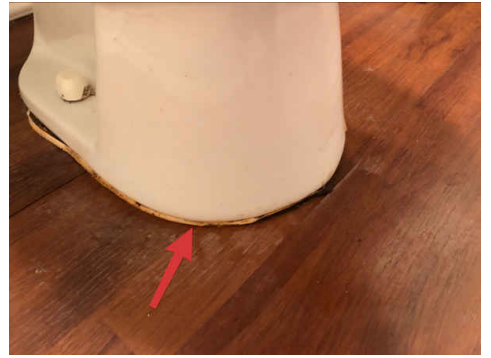
11.5.2 Toilet

TOILET LEAKING

Contact a qualified plumbing contractor.

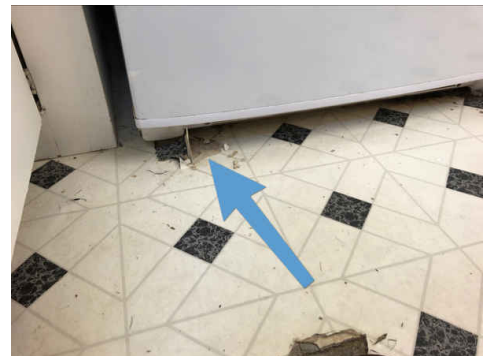
13.3.1 Flooring

FLOOR WORN OR COSMETICALLY DAMAGED

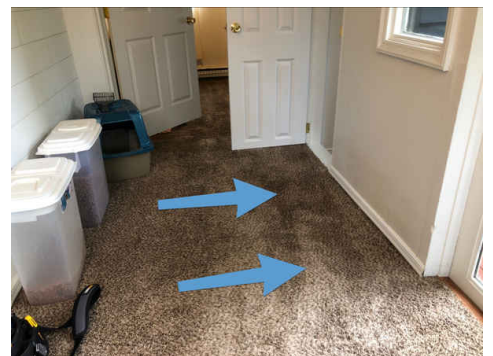
13.3.2 Flooring

FLOOR IS OUT OF LEVEL

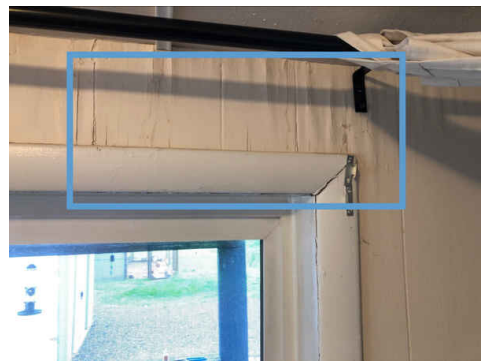
13.4.2 Walls and Ceiling

MOISTURE STAIN

Moisture stains were observed and the wall was soft. Recommend monitoring this area and making repairs as needed.

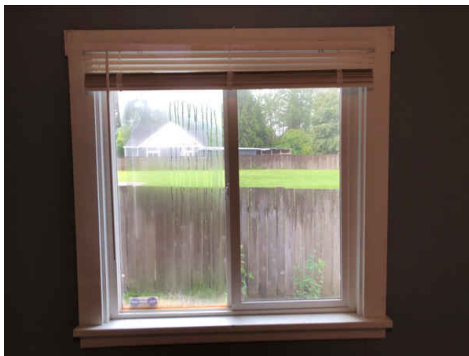
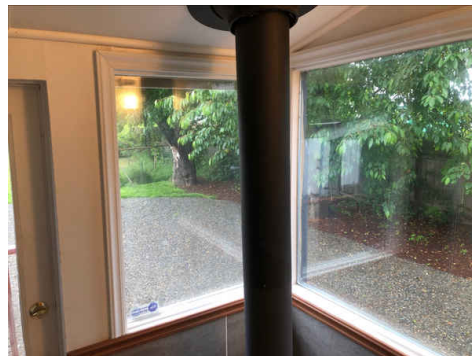
13.5.1 Windows

BROKEN SEALS

A window(s) has broken hermetic seals, and should be replaced. This is evident from fogging, or condensation forming between the panes of glass, that confirm that the seal has failed. If you are concerned we recommend that you have a professional check out all the windows within the residence.

Contact a qualified window repair/installation contractor.

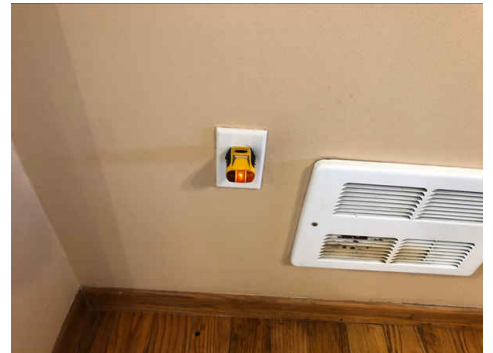
Several of the Interior Outlets are ungrounded. This is common in older homes. Grounding all Outlets would be a beneficial and recommended update.

Contact a qualified electrical contractor.

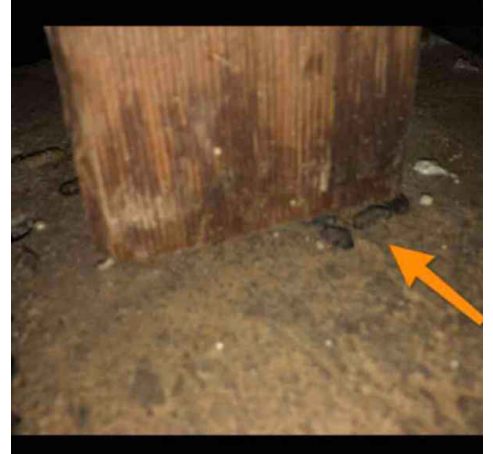
Evidence of rodent activity in the form of feces or urine stains was observed in the crawl space. We recommend sealing all access points and eliminating any active infestation.

Contact a qualified pest control specialist.

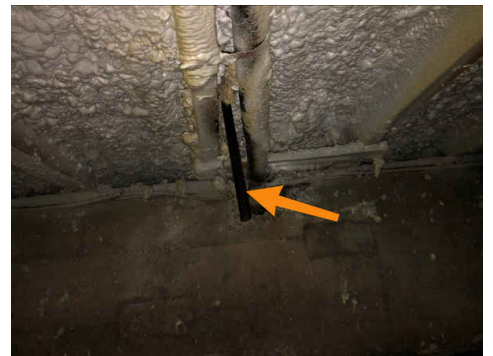
The pressure relief pipe from the water heater terminated in the crawl space. Recommend diverting to the exterior.

Contact a qualified professional.

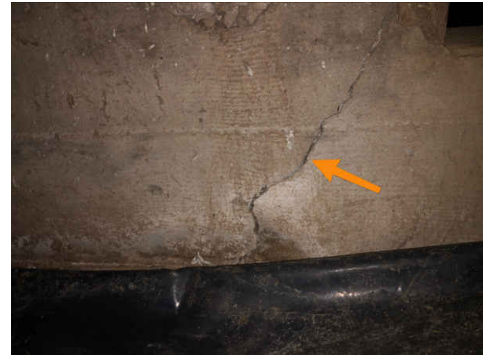
15.2.1 Foundation

CRACKS MODERATE

Moderate sized cracks were observed on the Exterior foundation. This suggests unstable or settling soils. Recommend a soil or structural engineer should be consulted for corrective repairs. This may include sealing the pieces back together with a concrete or similar patch. Sealing is to deny possible moisture entry. a structural engineer evaluate and provide a report on course of action and remedy.

Contact a qualified professional.
