MOUNTAINS TO SOUND HOME INSPECTION LLC

HOME INSPECTION REPORT

3300 NE 7th Pl
Renton WA 98056

Rachelle Cinque
JULY 23, 2019

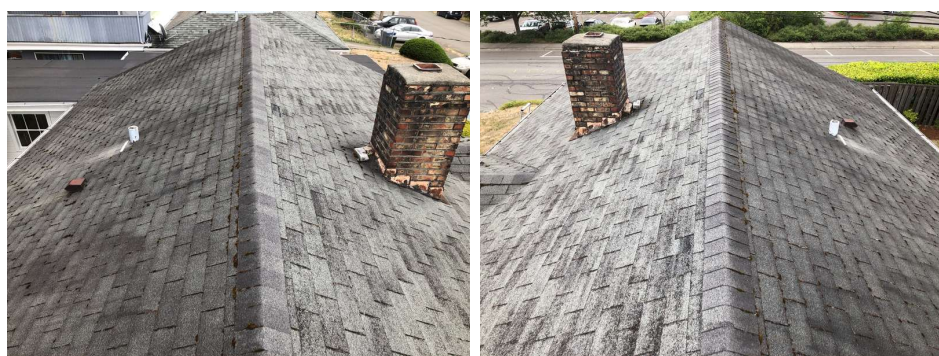
Method of Evaluation & Photos: Method of Evaluation & Photos

Walking on its surface

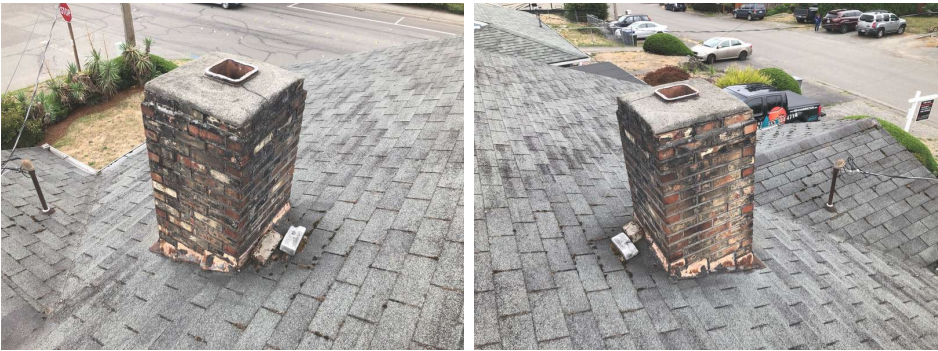
Chimney On Roof & Photo: Chimney Photo

Chimney On Roof & Photo: Acceptable

The the chimney above the roof is in acceptable condition. Any exceptions will be noted.

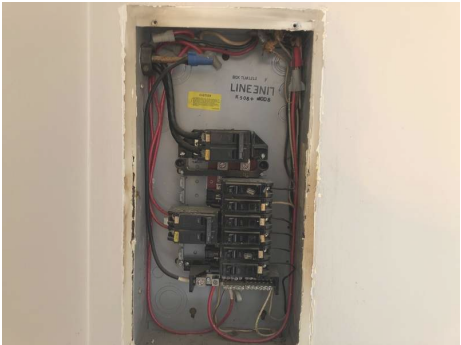
Service Entrance: Main Lines Overhead	Service Entrance: Main Lines Acceptable The electrical service entrances are acceptable	Panel Size, Location & Photo: Panel Amps, Location and Picture Inside, 100 Amp

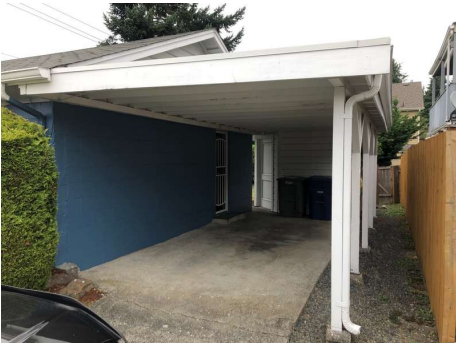
Picture of carport

Carport condition: Acceptable

The carport and it's supports were in acceptable condition.

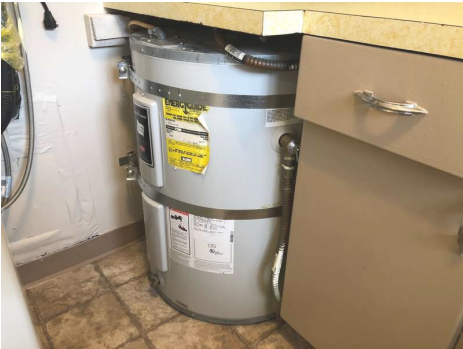
Water Heating System: Manufacturer and picture
Bradford & White

I recommend flushing & servicing your water heater tank annually for optimal performance. Water temperature should be set to at least 120 degrees F to kill microbes and no higher than 130 degrees F to prevent scalding.
[Here is a nice maintenance guide from Lowe's to help.](#)

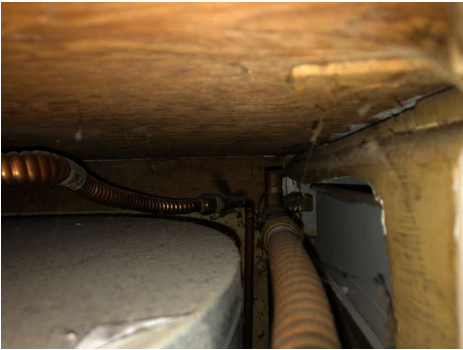
Water Heating System: Water Shut-Off Valve & Connectors
The shut-off valve and water connectors appear functional but was not tested.

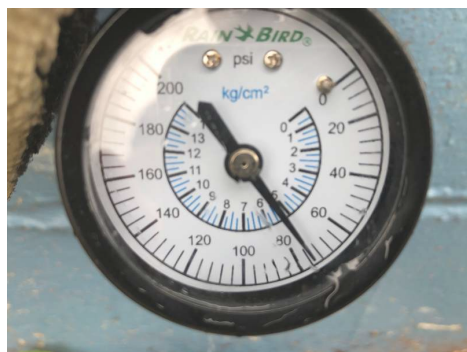
Main Water Shut-Off, Distribution & Supply: House Pressure PICTURE-Acceptable

The pressure at the street was within industry standards, between 40 and 80 and a regulator is not required on the plumbing system.

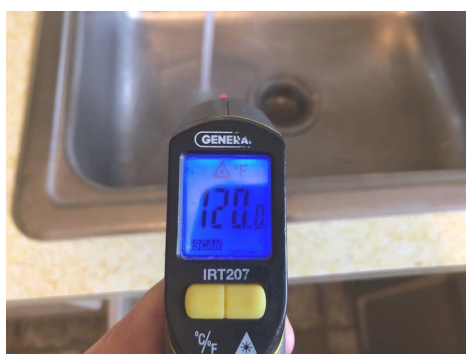
Sink and Faucet: Water temp

The Water temp at the Kitchen Faucet is Currently noted in the photo below. The U.S. Consumer Product Safety Commission (CPSC) urges all users to keep their water heater temps at 120 degrees Fahrenheit to prevent scalding and bacteria prevention reasons.

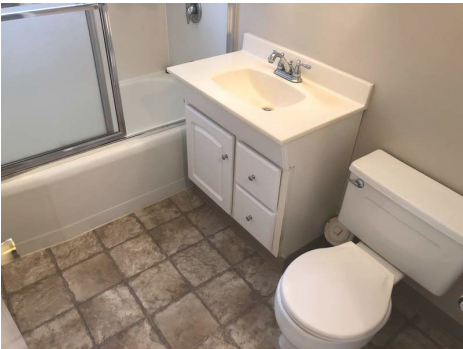
Bathroom Photos

These photos are to show the condition of the bathrooms at the time of the inspection.

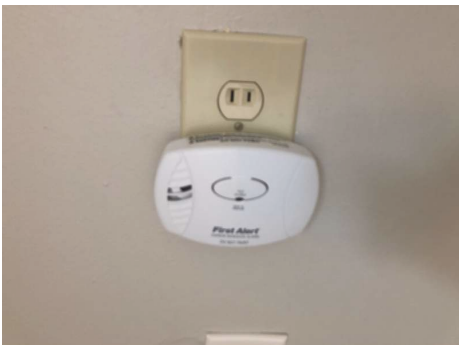
**Smoke & CO Detectors Notes:
Carbon monoxide detectors present**

Carbon monoxide detectors were present where required.

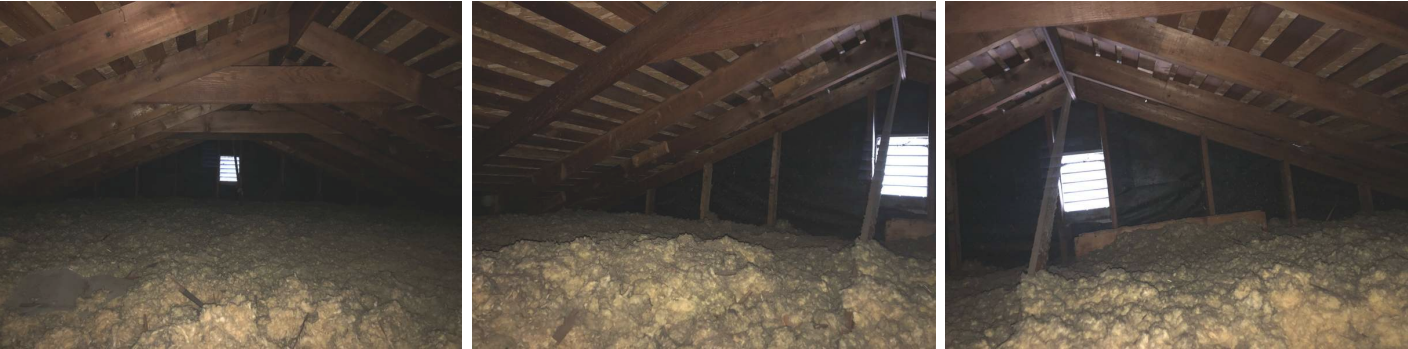
Attic Photos

Attic Access Location Hallway	Insulation Notes: Acceptable Insulation is acceptable	Insulation Notes: Insulation Type Loose-fill, Fiberglass
Exhaust Ducts: Acceptable The visible portions of the exhaust ducts appear to be functional.	Plumbing Vents: Acceptable The accessible plumbing vents were in acceptable condition.
