MOUNTAINS TO SOUND HOME INSPECTION LLC

HOME INSPECTION REPORT

7510 131st St Ct E
Puyallup WA 98373

APRIL 18, 2018

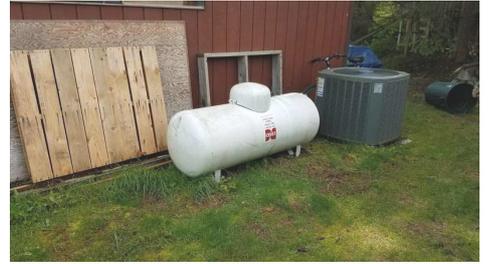
Air Conditioning/Heat Pump

NOT TESTED

Because outside temperature was below 60 degrees, we are unable to test the unit. Most manufacturers recommended temperatures be at 60 degrees or above for 48 hours prior to running air conditioners. I recommend servicing.

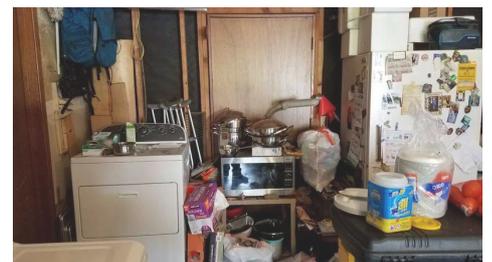
Garage Side Door

OBSTRUCTED - NOT INSPECTED

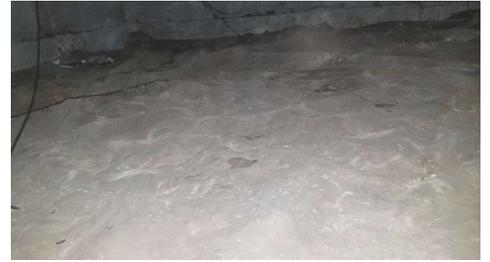
15.1.2 Crawlspace Notes

INSULATION FALLING DOWN

Contact a qualified professional.

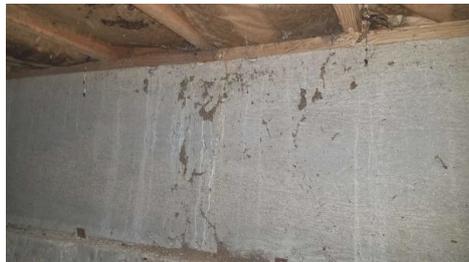
Evidence of past pest activity was observed in the crawl space. There was no evidence that this was an active infestation or signs of structural damage. Further evaluation by an exterminator would be appropriate.

Contact a qualified pest control specialist.
