RW WEST HOME INSPECTION REPORT

18548 43rd Ave NE
Lake Forest Park WA 98155

APRIL 29, 2021

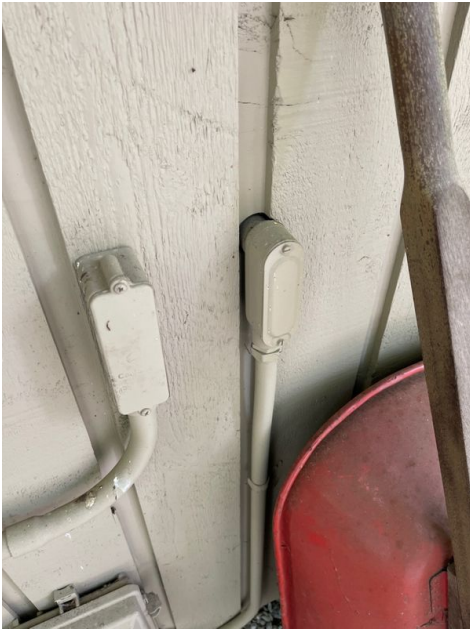
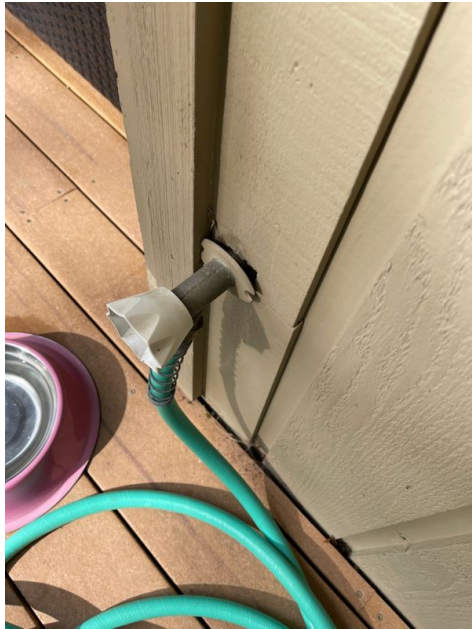
3.1.1 Siding Condition

Voids/missing caulking where piping/wiring routes through the siding, recommend sealing

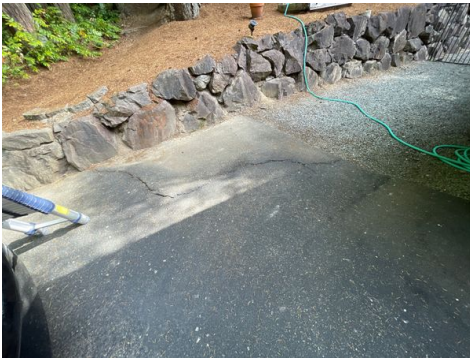
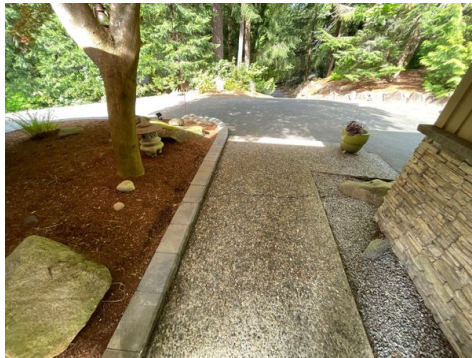
3.2.1 Driveway, Patio and Walkway Condition

CRACKING NOT UNUSUAL

Cracking at the driveway/sidewalk does not appear unusual.

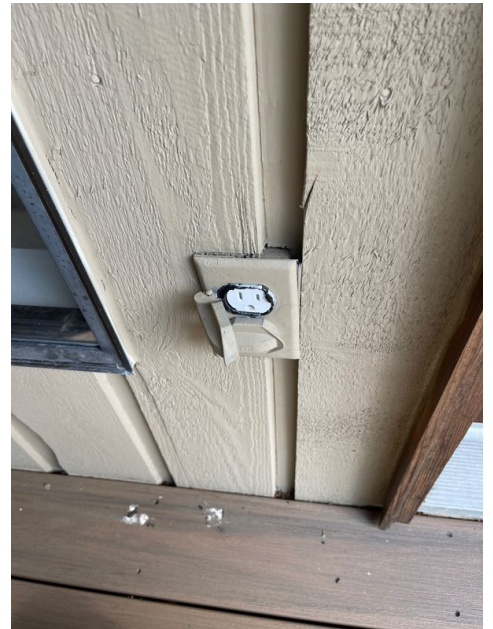
LOOSE OUTLET

Outlet loose, recommend securing

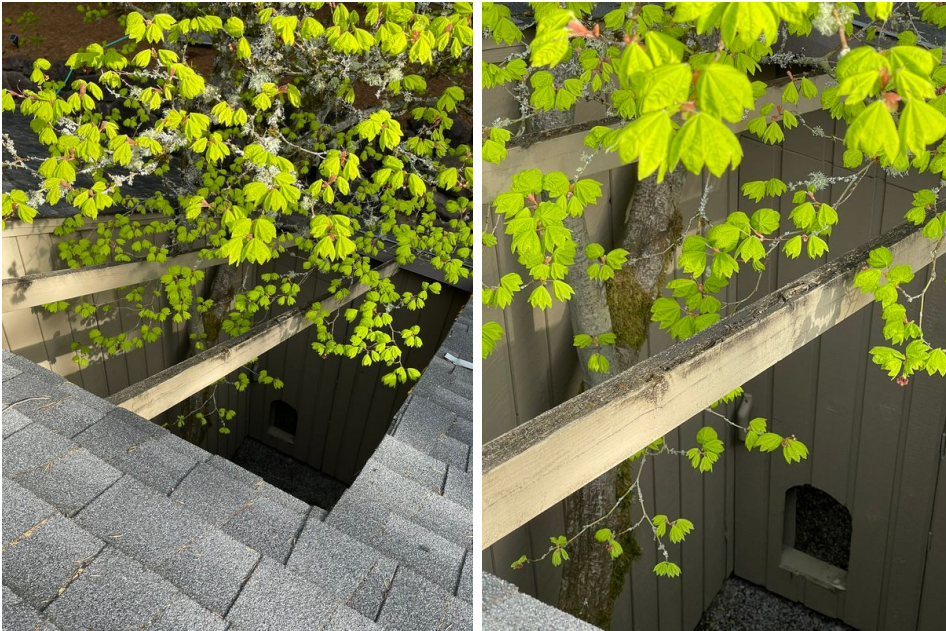
3.8.1 Soffit

TREE CONTACT

trees in contact with soffit, recommend clearance be achieved to prevent damage

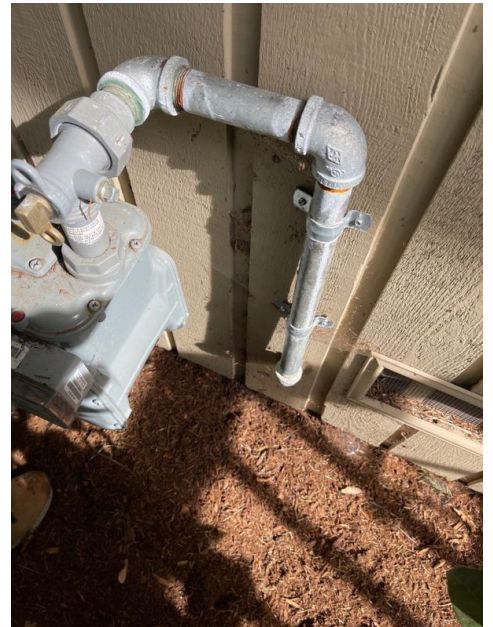
3.10.1 Gas Condition

CORROSION GAS PIPING

Corrosion to gas piping, recommend painting with a rust retarding paint as continued corrosion can result in gas leaks

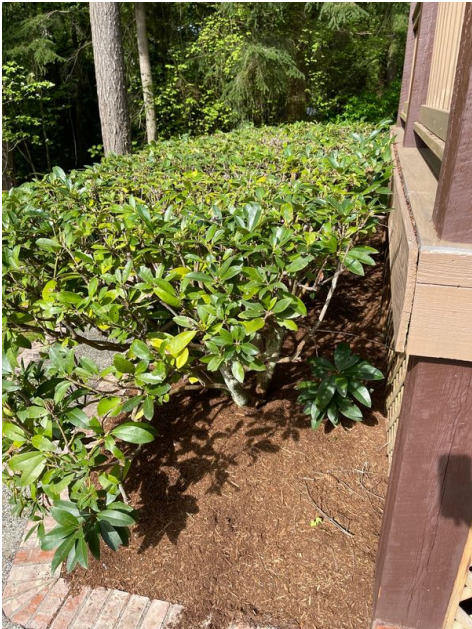
3.11.1 Grading

FOLIAGE

Foliage is touching the siding, recommend clearance is achieved as this is a conducive condition for wood destroying organisms and pests

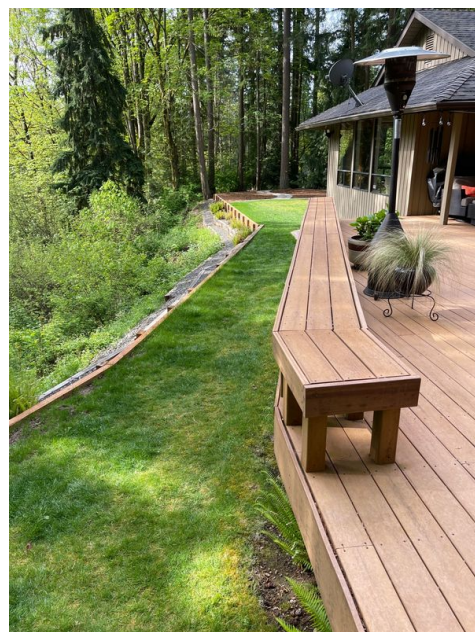
Guardrail not present, normally there should be a guardrail when deck is 30 inches or more off the ground. Recommend installing guardrail

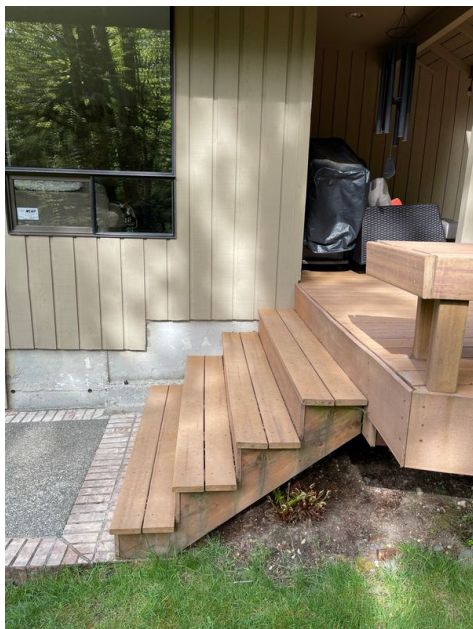
4.1.3 Deck

NO HANDRAIL

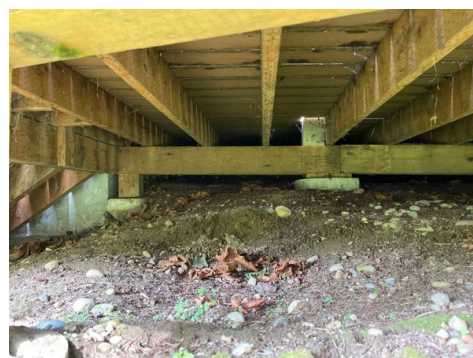
No blocking between joists where they rest on beam, recommend conditions are corrected to prevent lateral movement

Contact a qualified deck contractor.

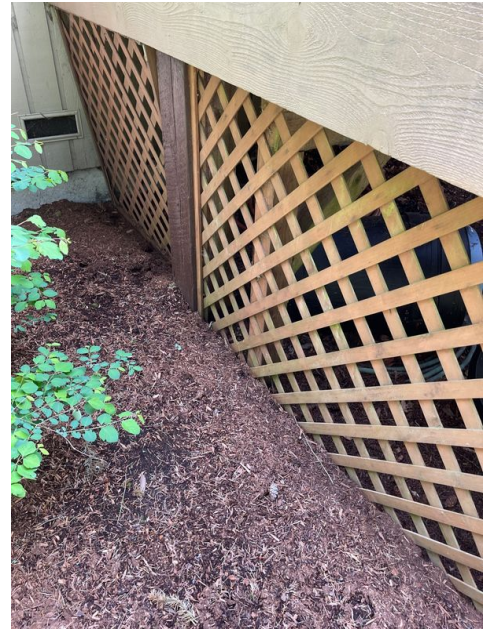
Earth to wood contact at the base of some of the support post recommend of wood contact is alleviated as it will cause decay to occur

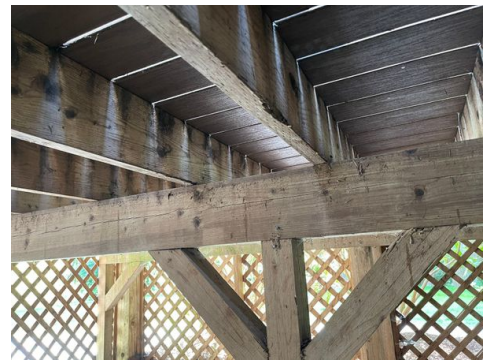
5.1.5 Deck

NO BLOCKING AT JOISTS

No blocking between joists where they rest on beam, recommend conditions are corrected to prevent lateral movement

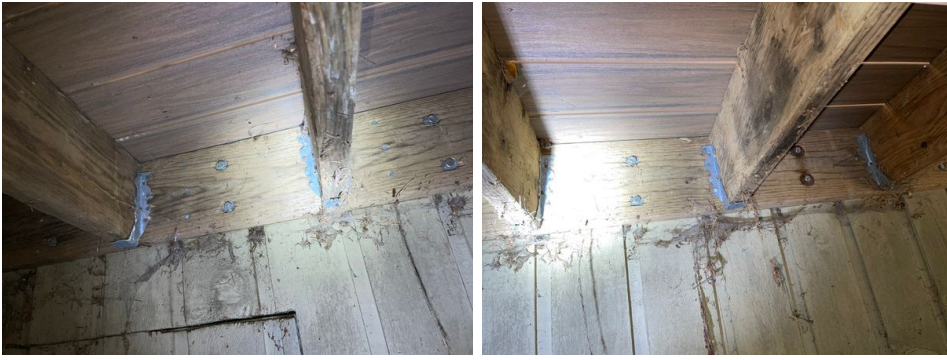
5.1.6 Deck

LEDGER BOLTS ALIGNED

Normally ledger bolts should be staggered. When installed in a straight line condition can cause ledger to split creating a hazardous condition

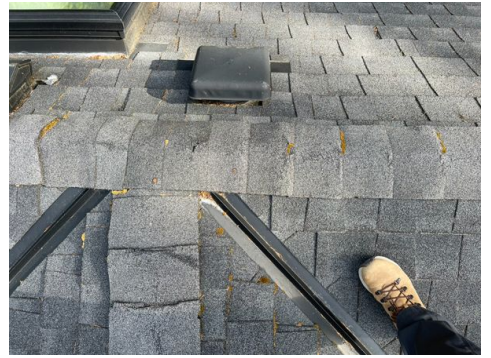
6.1.1 Roof Type

DAMAGED

Some shingles damaged, recommend extent of damage is investigated further and repaired as needed.

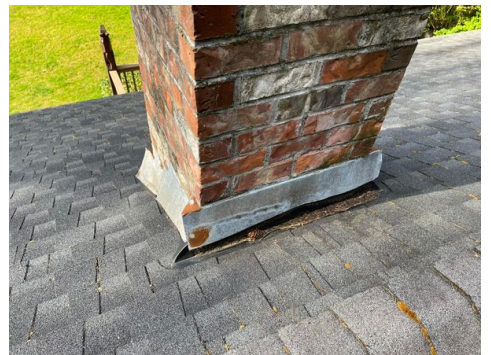
6.2.1 Flashing

CORROSION

Corrosion occurring to flashings, recommend conditions are corrected/repared

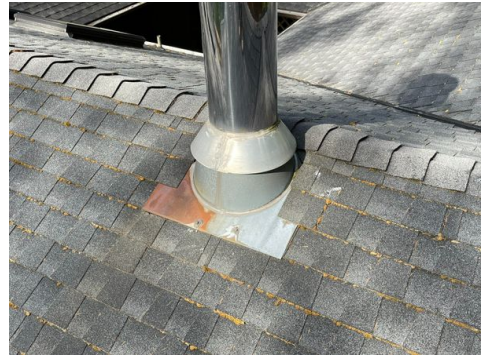
6.4.3 Chimney
CORROSION TO METAL CHIMNEY CROWN

Recommend painting with a rust retardant and or repair as needed

Contact a qualified professional.

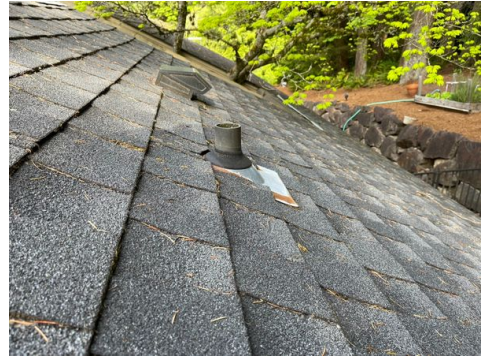
6.6.1 Vent Caps

DRAIN VENT TOO SHORT

Further Evaluation

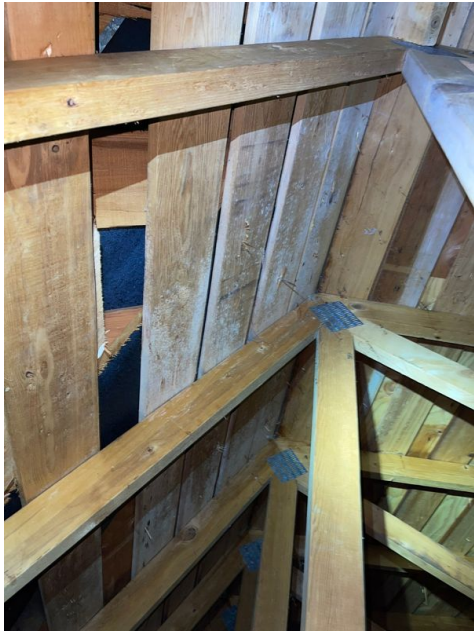
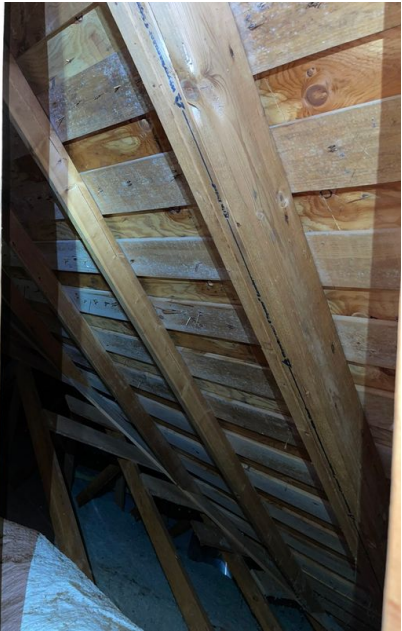
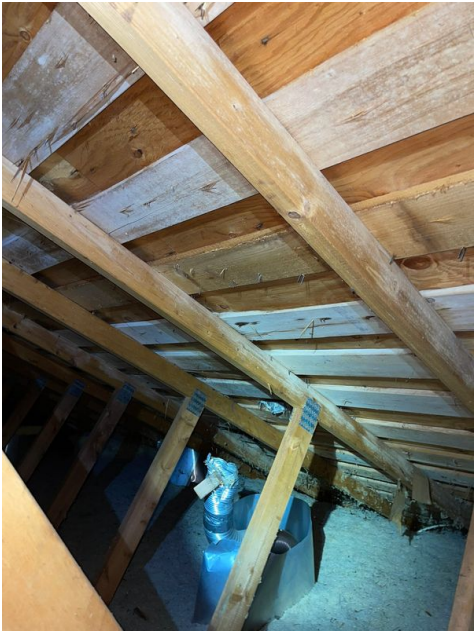
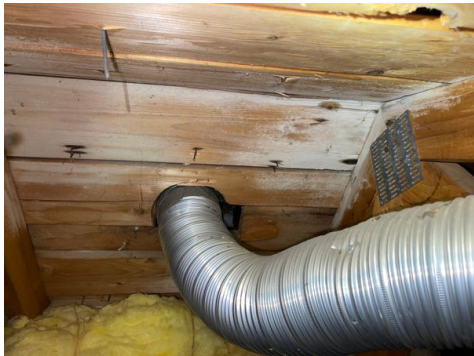
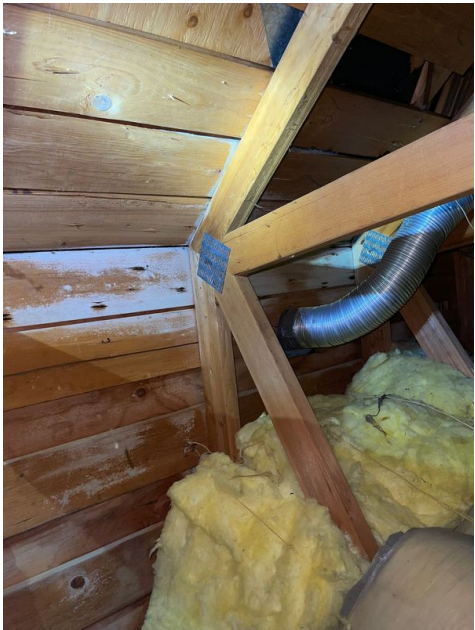
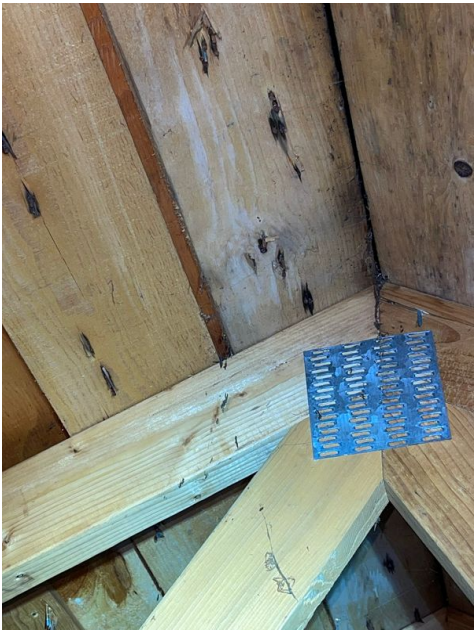
7.2.1 Framing

Slight Fungal type growth at some of the sheathing at a few areas, recommend treating with a fungicide. There are fogging methods that are now available for treatment

Contact a qualified professional.

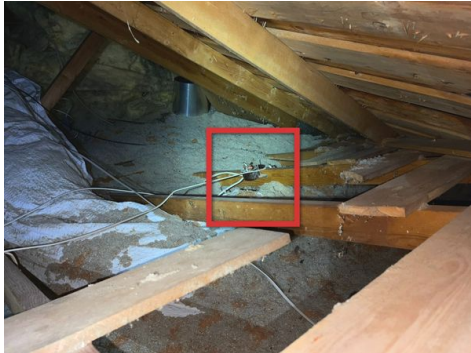
7.4.1 Electrical

COVERPLATES

Electrical switch/Junction Box Covers missing or damaged, which is a potential shock is hazard, recommend cover plates are installed as a safety precaution. Easily correctable

Contact a handyman or DIY project

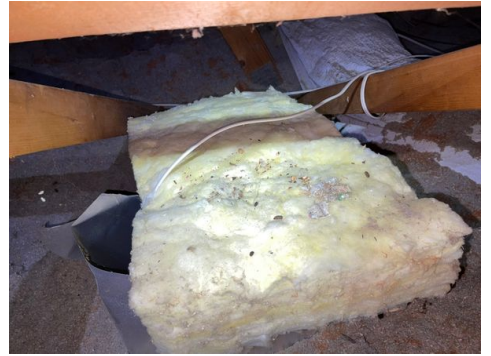
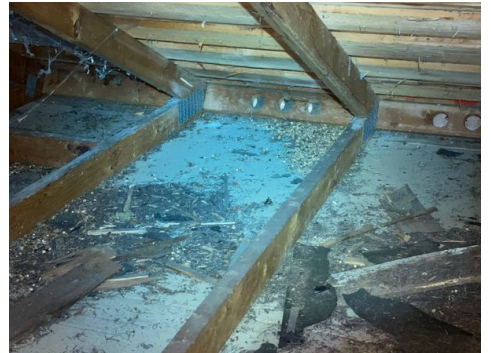
Indications of Rodent activity. Droppings and/or Urine/Carcasses. Rodent droppings can carry disease. rodents can also cause damage to insulation. Recommend conditions are investigated further by licensed Pest Control Company.

Contact a qualified pest control specialist.

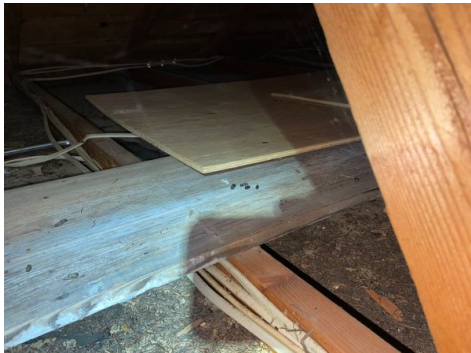
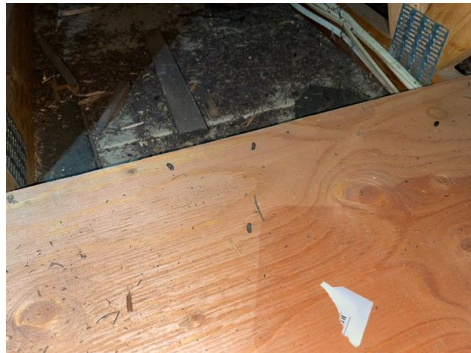
7.8.2 Rodents/Pests

BURROWING

Burrowing in the insulation indicating rodent activity. Recommend further investigation by licensed pest control company

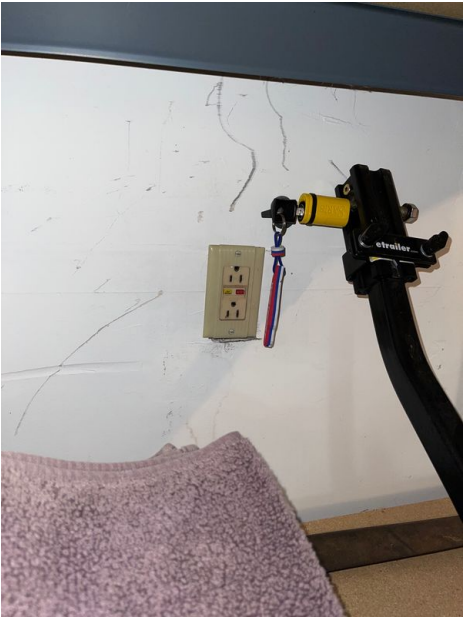
1
Garage south side

Electrical: GFCI reset

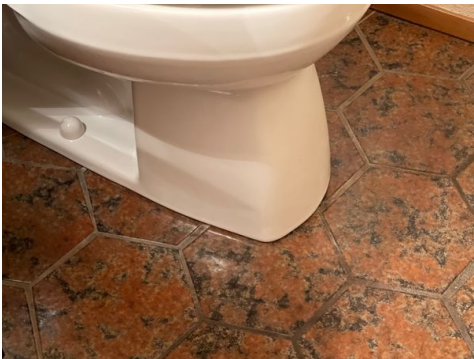
Toilet is not caulked to the floor: Toilets caulked at the floor are less likely to have leaking wax seals. Caulking reduces the potential for movement, limiting forces on the seal which might cause it to leak

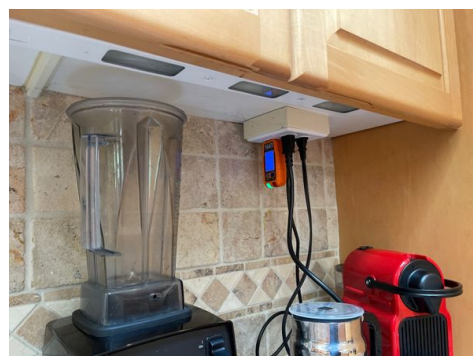
All outlets

**Observations****18.4.1 Electrical****NO GFCI (REQUIRED SINCE 1978)**

GFCI outlets have been required for Kitchens (since 1987) No GFCI protection present, strongly recommend GFCI outlets are installed as a safety precaution.

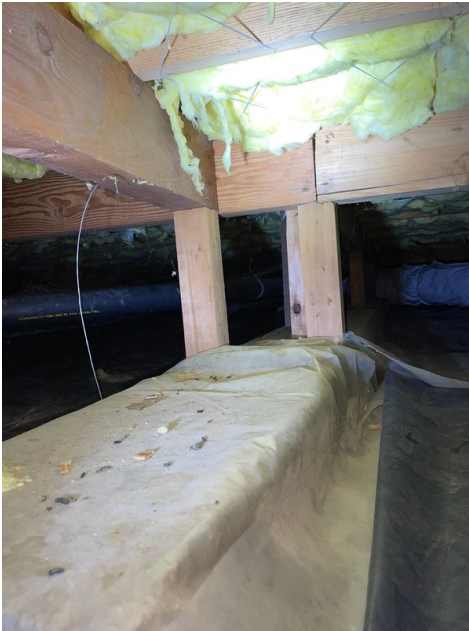
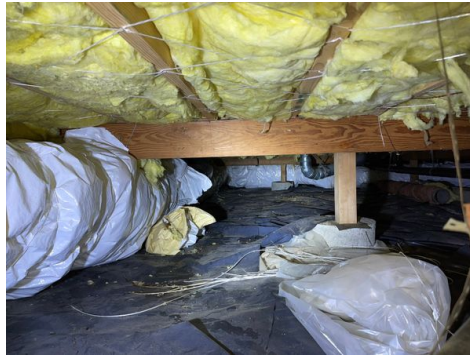
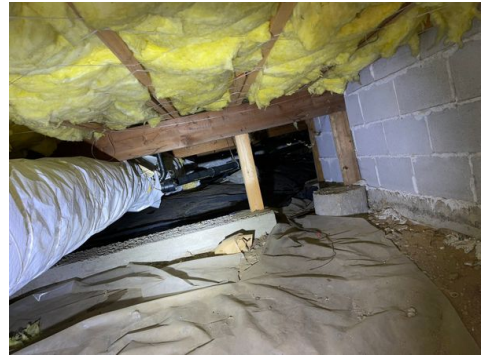
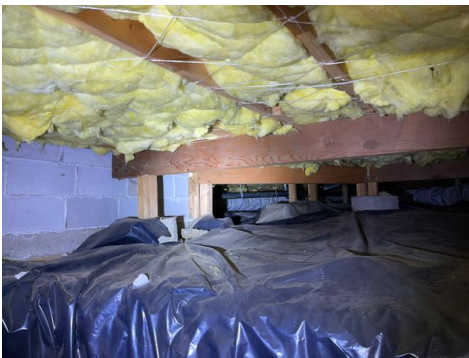
23.2.1 Framing

Post and beam connections not gusseted or strapped, recommend conditions are corrected.

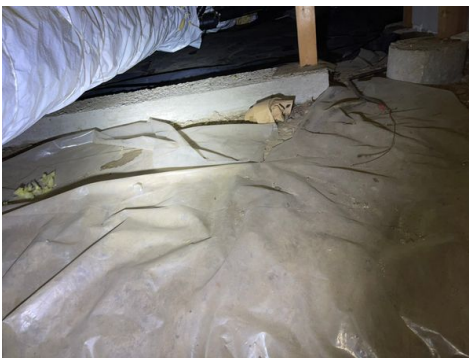
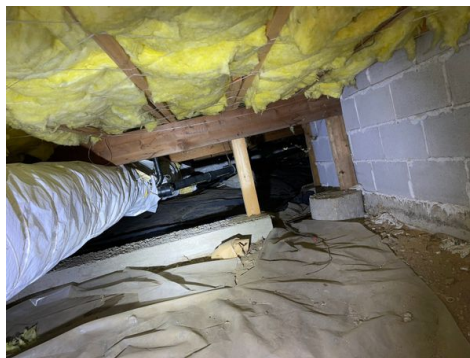
23.6.1 Vapor Barrier

CLEAR PLASTIC

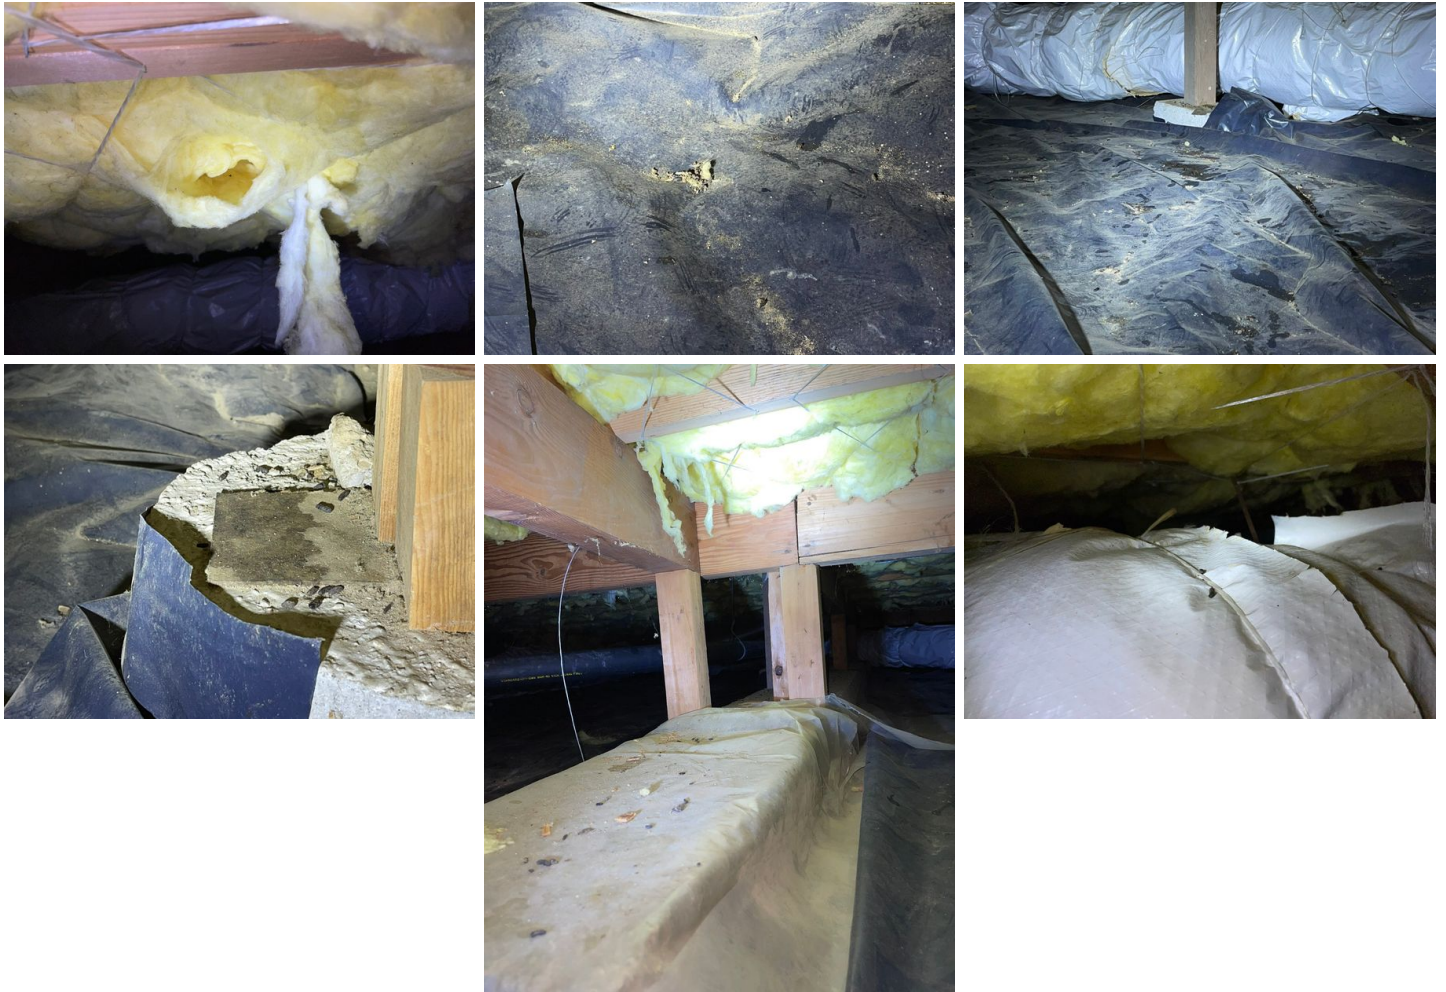
23.9.1 Rodents/Pests

RODENT ACTIVITY

Indications of Rodent activity. Droppings and/or Urine/Carcasses. Rodent droppings can carry disease. rodents can also cause damage to insulation. Recommend conditions are investigated further by licensed Pest Control Company.

Contact a qualified pest control specialist.

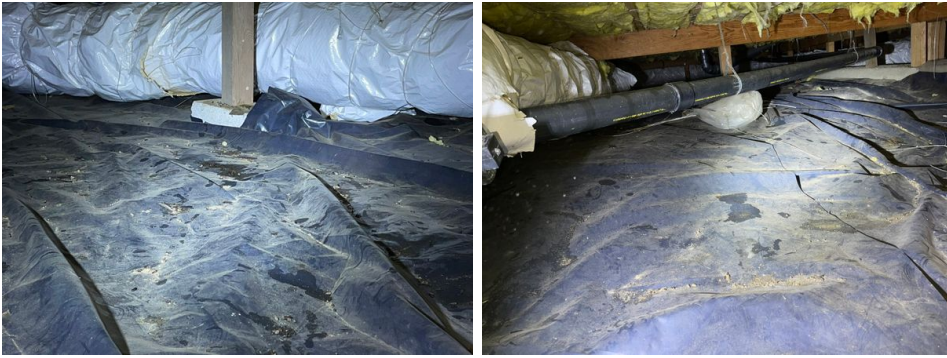
23.9.3 Rodents/Pests

URINE STAINING

Contact a qualified pest control specialist.

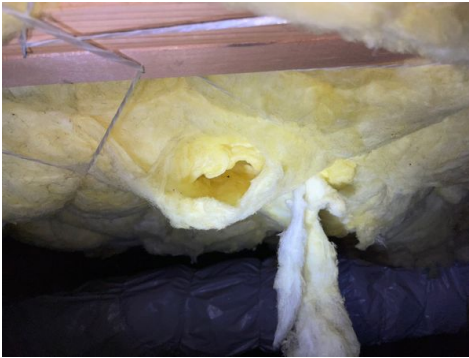
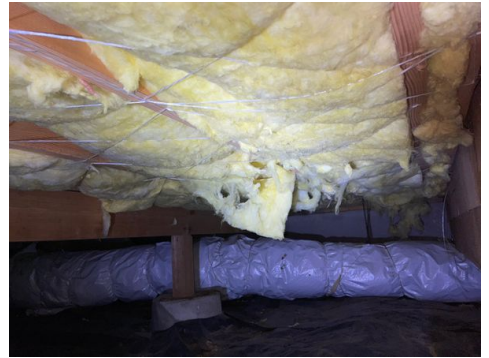
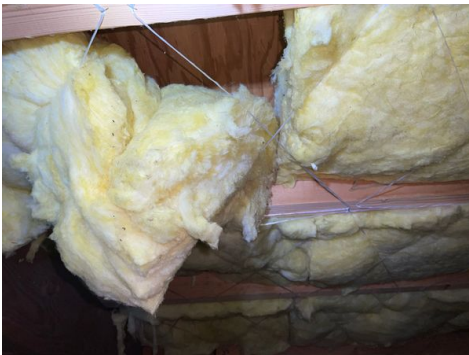
23.9.4 Rodents/Pests

BURROWING

Burrowing in the insulation indicating rodent activity. Recommend further investigation by licensed pest control company

Contact a qualified pest control specialist.

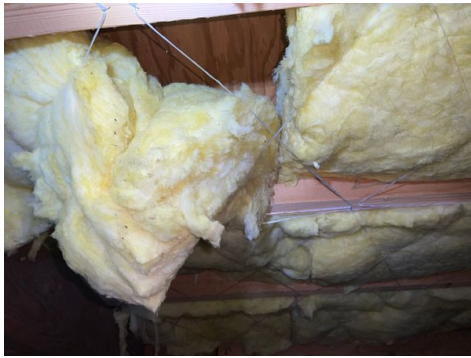
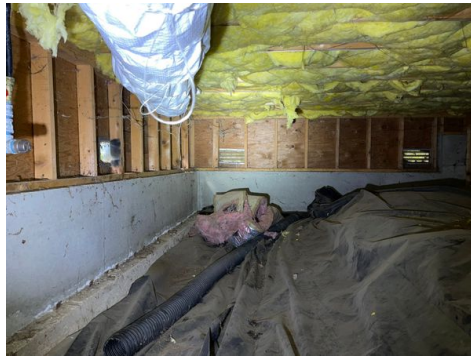
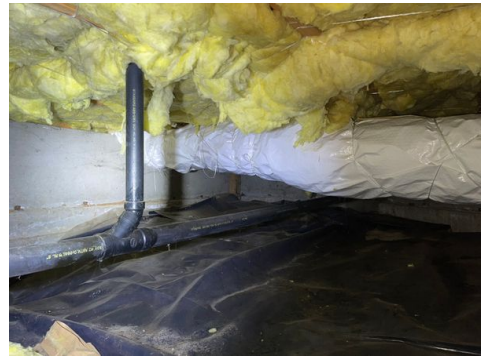
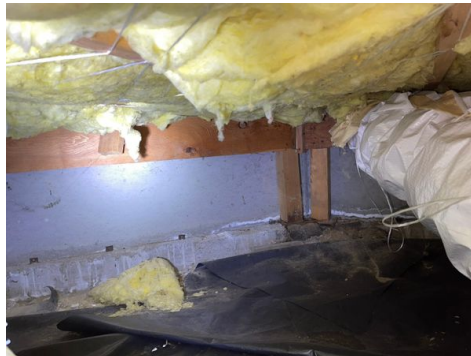
23.10.1 Insulation Condition

DAMAGED/MISSING

Insulation damaged/missing in areas of the crawlspace, recommend damaged/missing insulation be replaced

Contact a qualified professional.

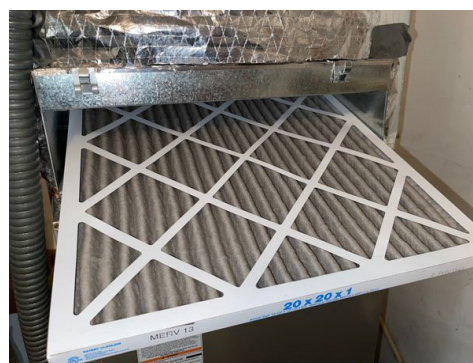
The furnace filter is dirty. Filters clean the air before it passes through the blower and heat exchanger. This helps to keep these furnace components working efficiently. Dirty Filters lessen life span of the Heating/AC equipment. It is recommended to change the filter every 3 months and then regular inspection & maintenance is advised.

Recommended DIY Project

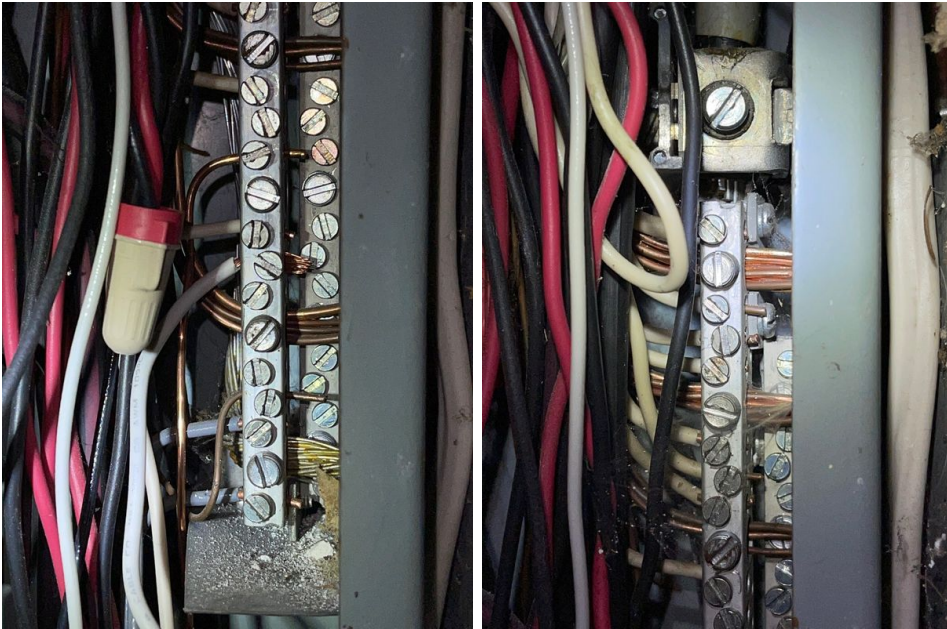
Dissimilar size wires under main lug, This condition is a potential fire hazard. Recommend further investigation and correction by licensed electrical contractor

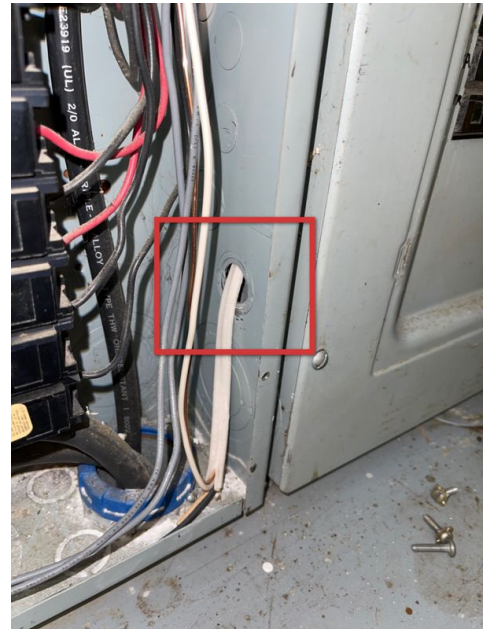
26.1.2 Electrical Panel

RESTRAINTS MISSING

Bushings/restraints missing from around branch wire(s) entering panel box. Recommend correction by licensed electrical contractor

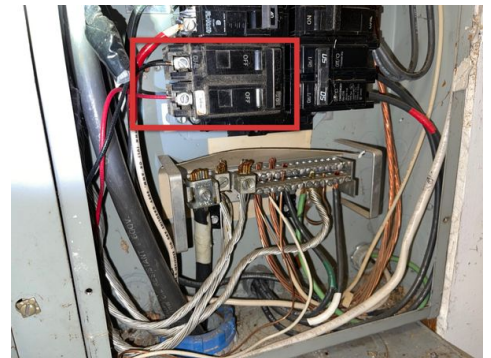
27.3.1 Wiring Type

INCORRECT SIZE

Some wiring sizes are incorrect for the size breaker stay connect too. This condition is a potential fire hazard. Recommend further investigation by licensed electrical contractor.

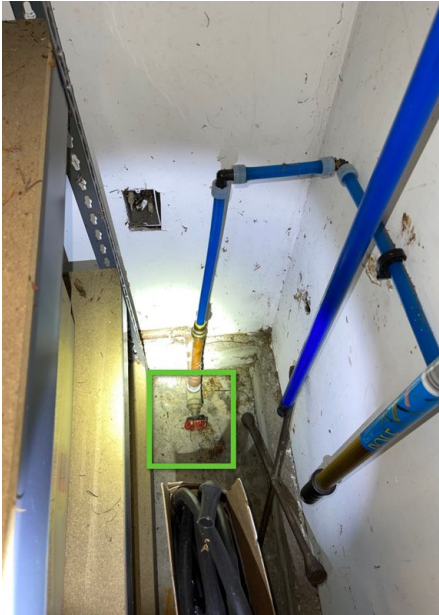
West wall of garage

Main water shut off located at east wall of garage
