HOME INSPECTION REPORT

12742 SE 282nd Way Kent WA 98030

Blue Creek Properties, LLC APRIL 20, 2018

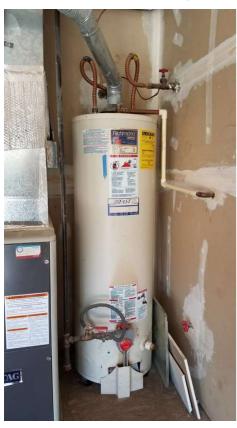
I recommend flushing & servicing your water heater tank annually for optimal performance. Water temperature should be set to at least 120 degrees F to kill microbes and no higher than 130 degrees F to prevent scalding.
