HOME INSPECTION REPORT

1930 S Sheridan Ave
Tacoma WA 98405

John Lund
JUNE 21, 2019

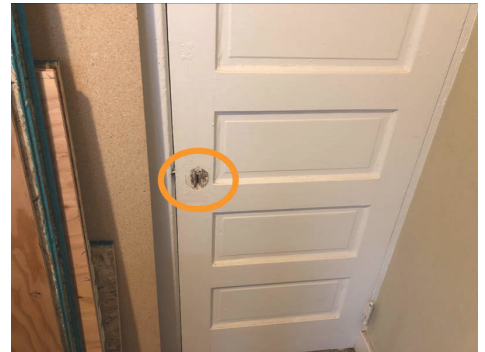
12.2.2 Doors

DOOR CASING MISSING/DAMAGED

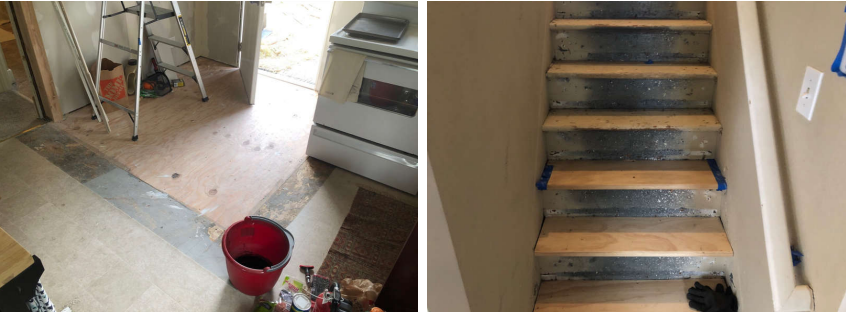
12.3.2 Flooring

MISSING BASEBOARD TRIM

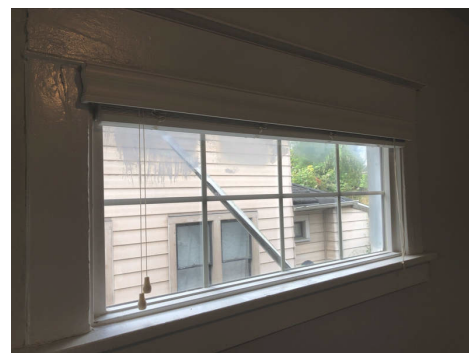
12.5.2 Windows

SCREENS DAMAGED/MISSING

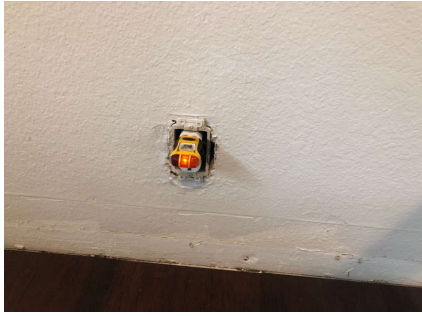
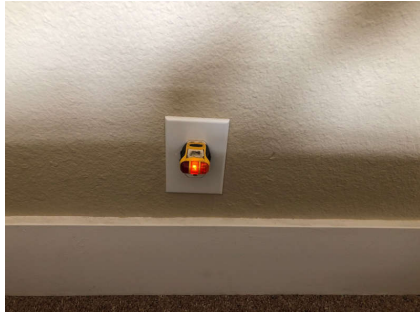
12.11.2 Outlets, Electrical

MISSING COVERS

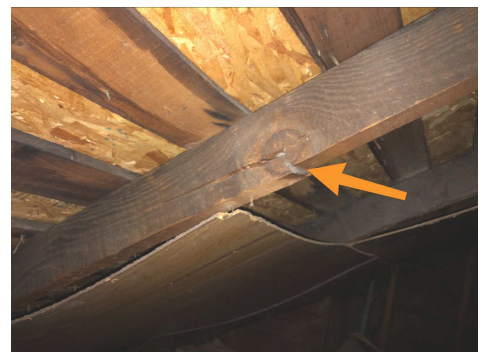
13.5.1 Insulation Notes

ATTIC FLOOR INSULATION IS MINIMAL-LOOSE

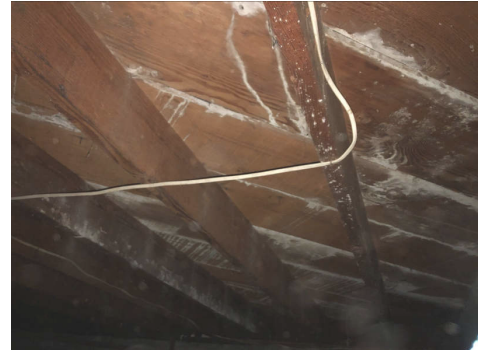
No subfloor insulation was installed. This is common for the age of the home. We recommend installing as a beneficial efficiency upgrade.

Recommendation

Contact a qualified professional.

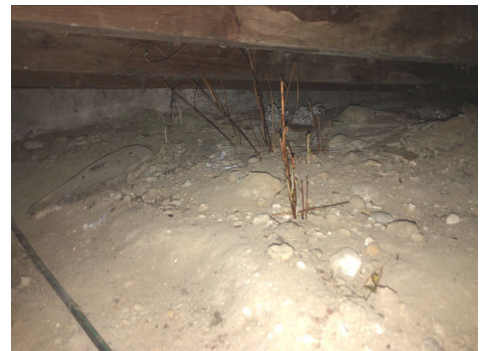
14.1.3 Crawlspace Notes

Medium Priority**VAPOR BARRIER MISSING**

Vapor barrier was missing from one or more sections of the crawl space. We recommend styling black vapor barrier over these areas.

Recommendation

Contact a qualified professional.

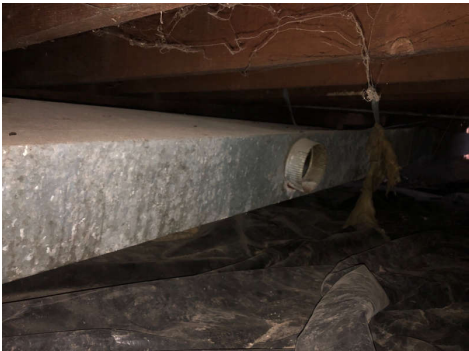
14.1.4 Crawlspace Notes

There is old abandoned heating ducting. Recommend removal.

Recommendation

Contact a qualified professional.
